# Preliminary results on contamination in SRF cavities mass production

TTC meeting

DESY

24 - 27th March 2014

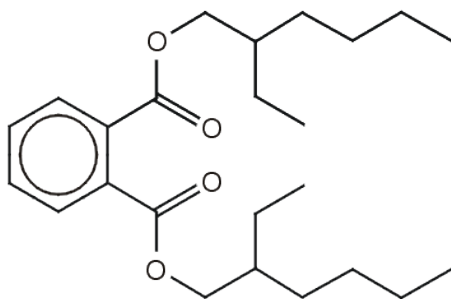
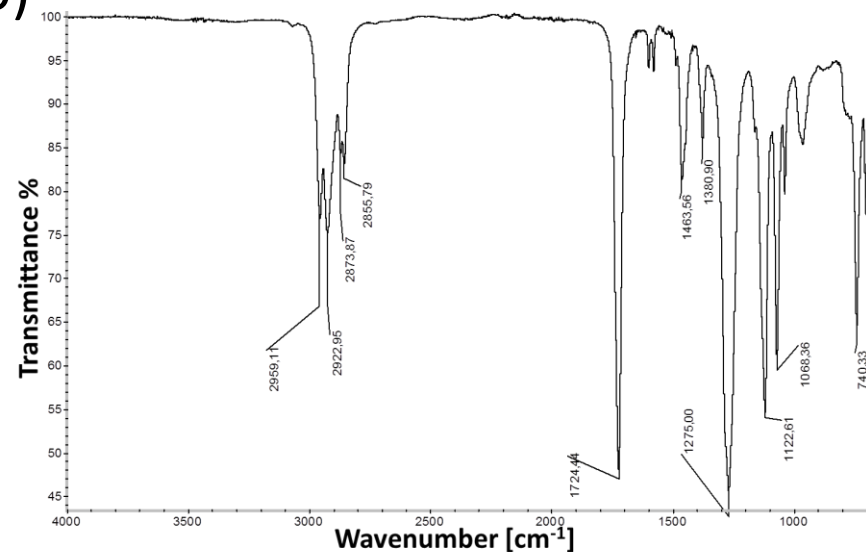
# DEHP

Viscous residues found in ethanol rinsing filters

FT-IR analysis determines DEHP (diethylhexyl phthalate)

- Ethanol-soluble PVC plasticizer
- Present in ethanol rinsing PVC piping
- RGA gives no evidence ( $m/z < 100$ )

## Corrective action:

- Use of PVC free piping

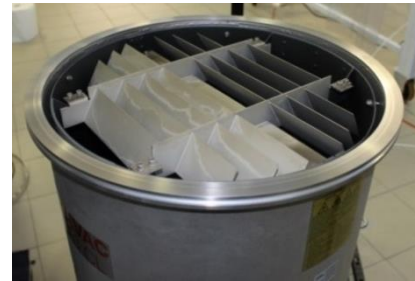
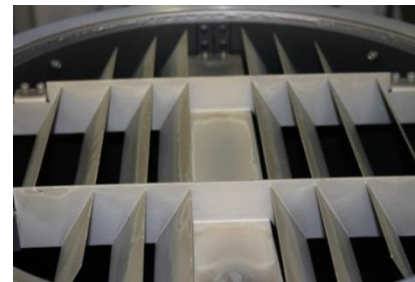
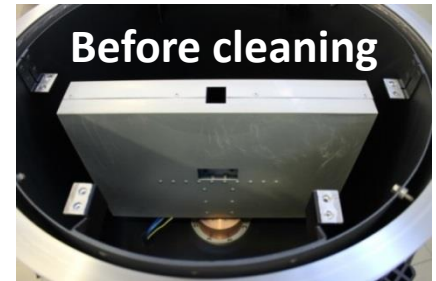
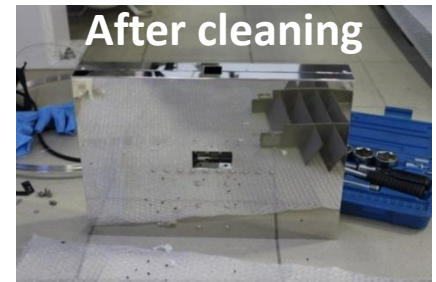
## Sulphur in 800°C oven's cryopump

1st stage

2nd stage

### Corrective actions:

More 1100°C oven cleaning cycles  
HPR after EtOH rinsing and after 800°C

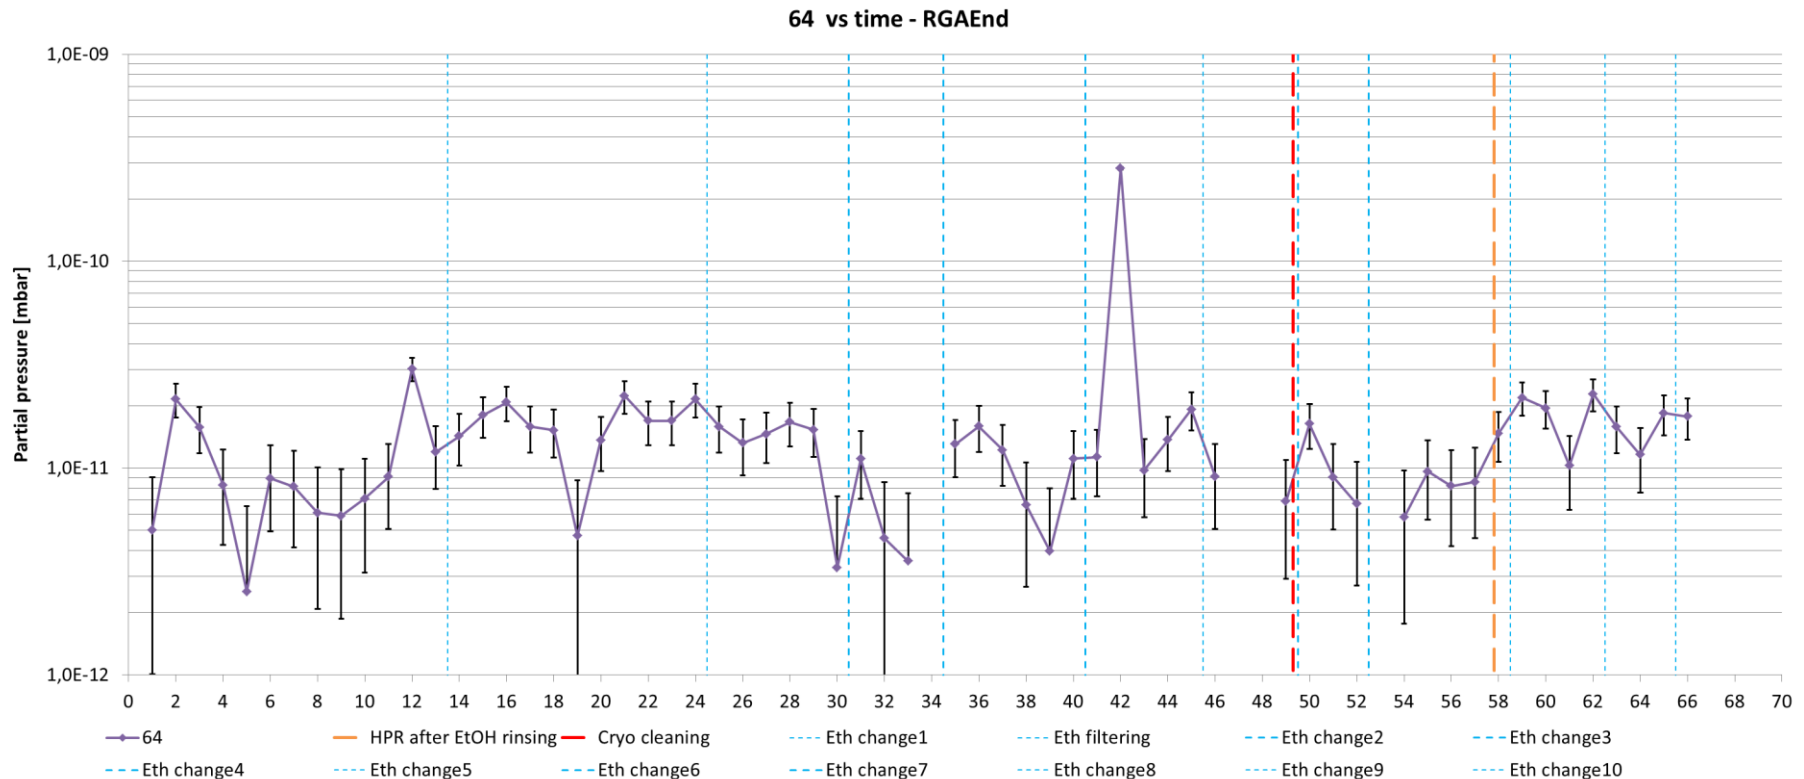
# After 800°C treatment

800°C oven - Tracking of sulphur as mass 64 ( $S_2$ ,  $SO_2$ ) with RGA

RGA after TT: 64 pp slightly increasing at ultimate pressure ( $1e-7$  mbar range)

**Oven is accumulating sulphur**

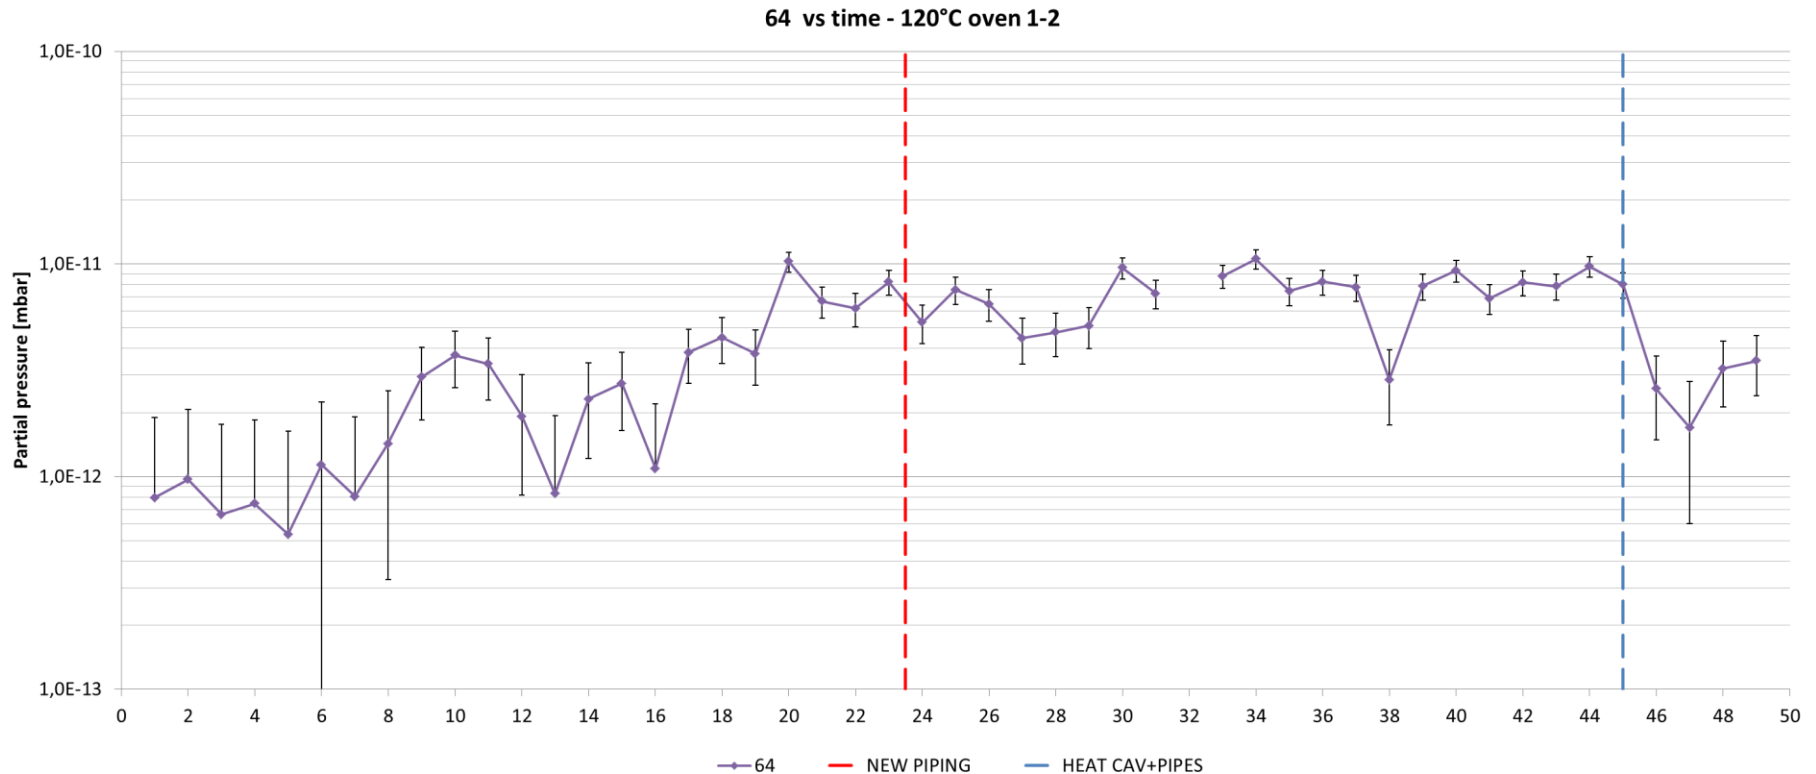
# 120°C oven

120°C oven - Tracking of sulphur as mass 64 ( $S_2$ ,  $SO_2$ ) with RGA

Total pressure at some  $1e-9$  mbar. Sulphur & hydrocarbons pps at some  $1e-12$  mbar.

Contamination grows and arrive to equilibrium with new pipes.

Improvement heating both cavities and vacuum piping.

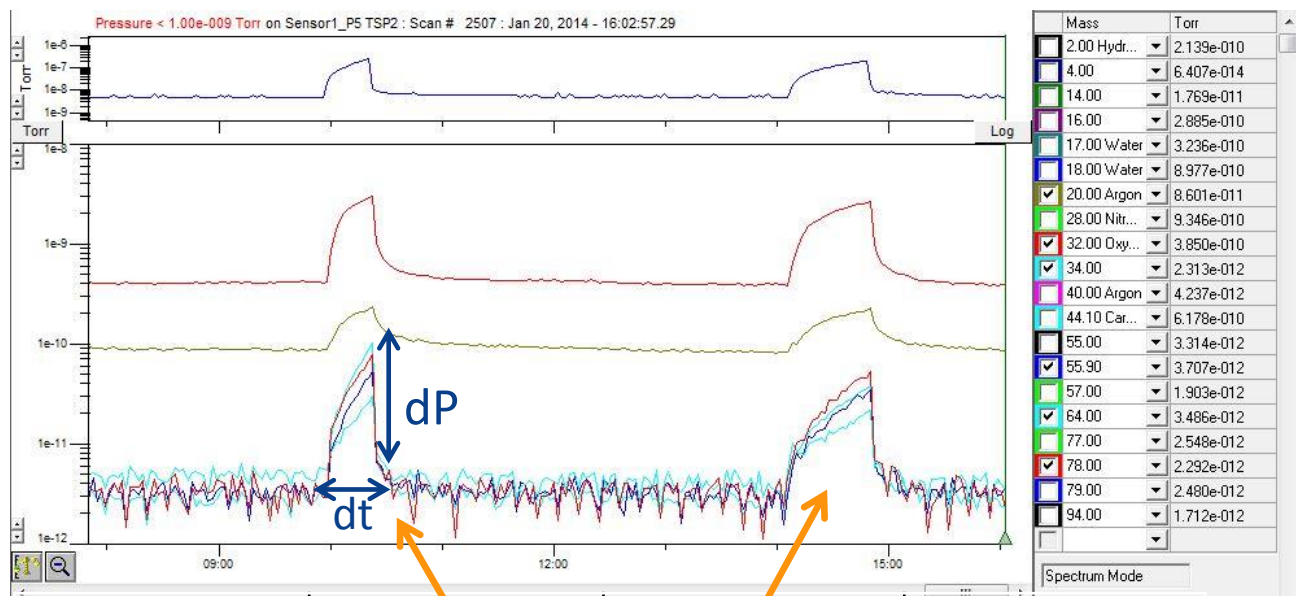
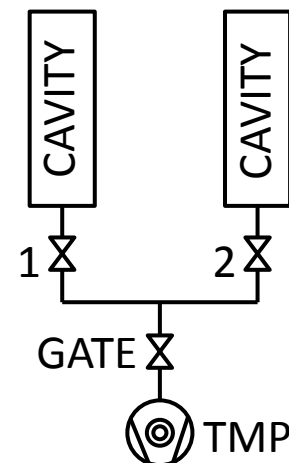
# Test on 120°C oven

Pressure rise rate decreases with cavities connected.

- M=20 & 32 rates decrease less than total pressure
- M=34 shows the biggest rate reduction

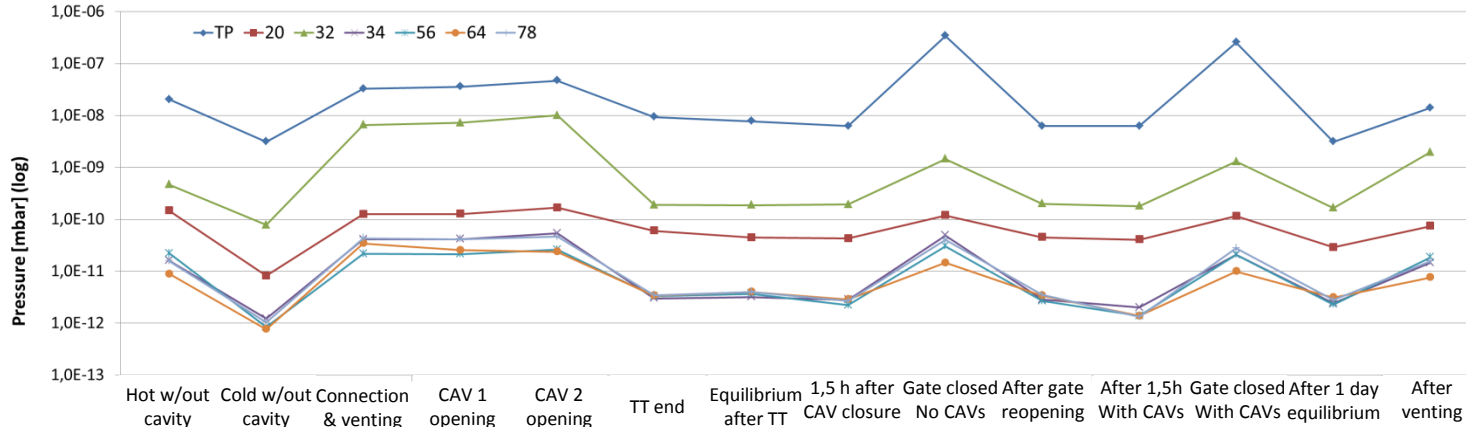
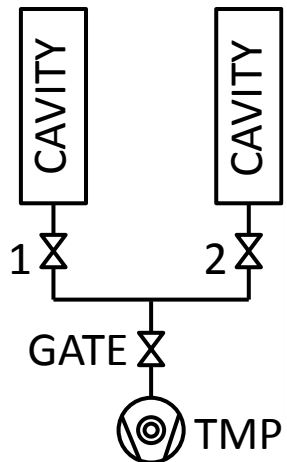
PP & TP variation

**Pollution seems to reside in piping**  
**CAVs are cleaner than piping and act as getters**

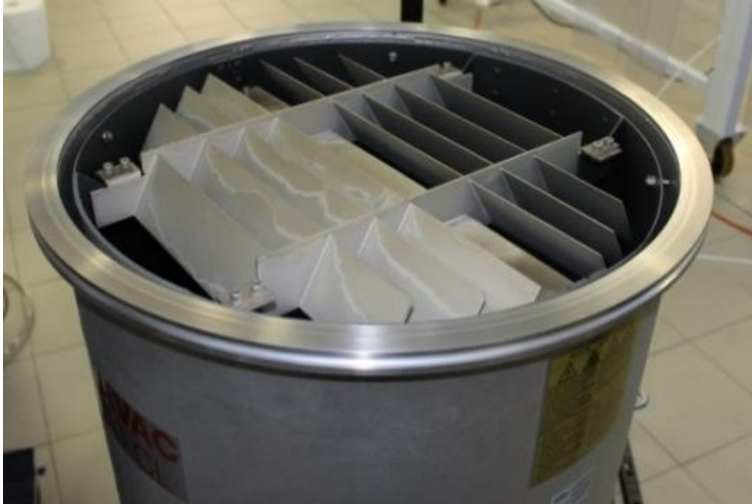
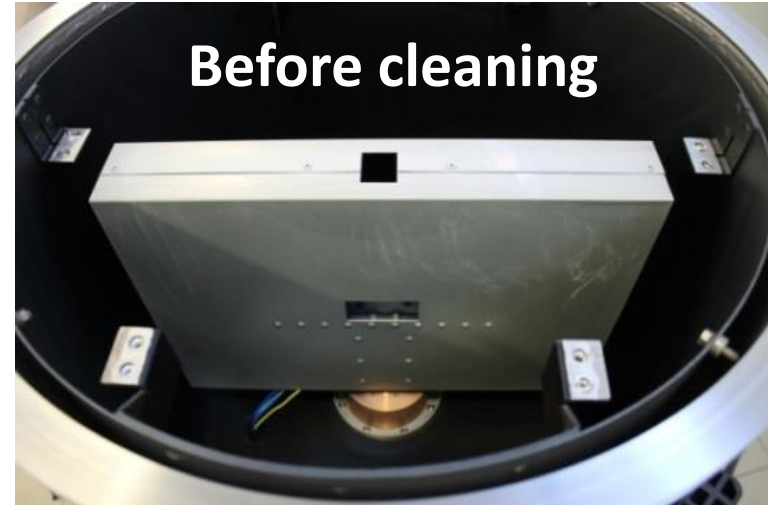
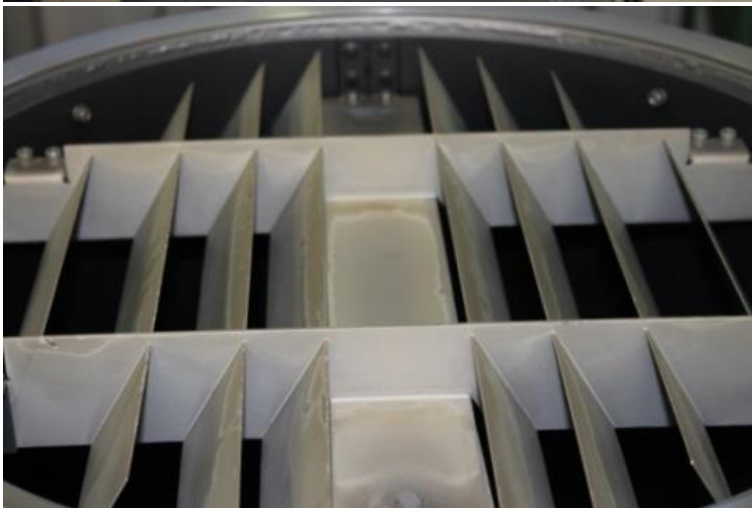
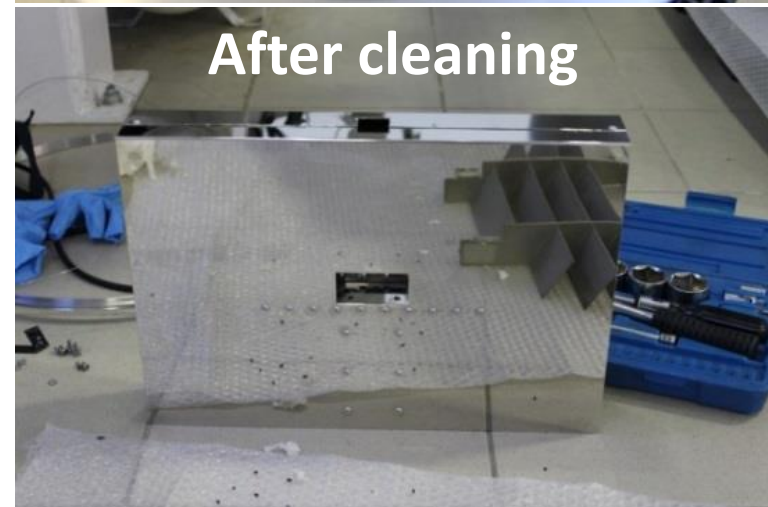
# Sulphur contamination

1st stage

2nd stage

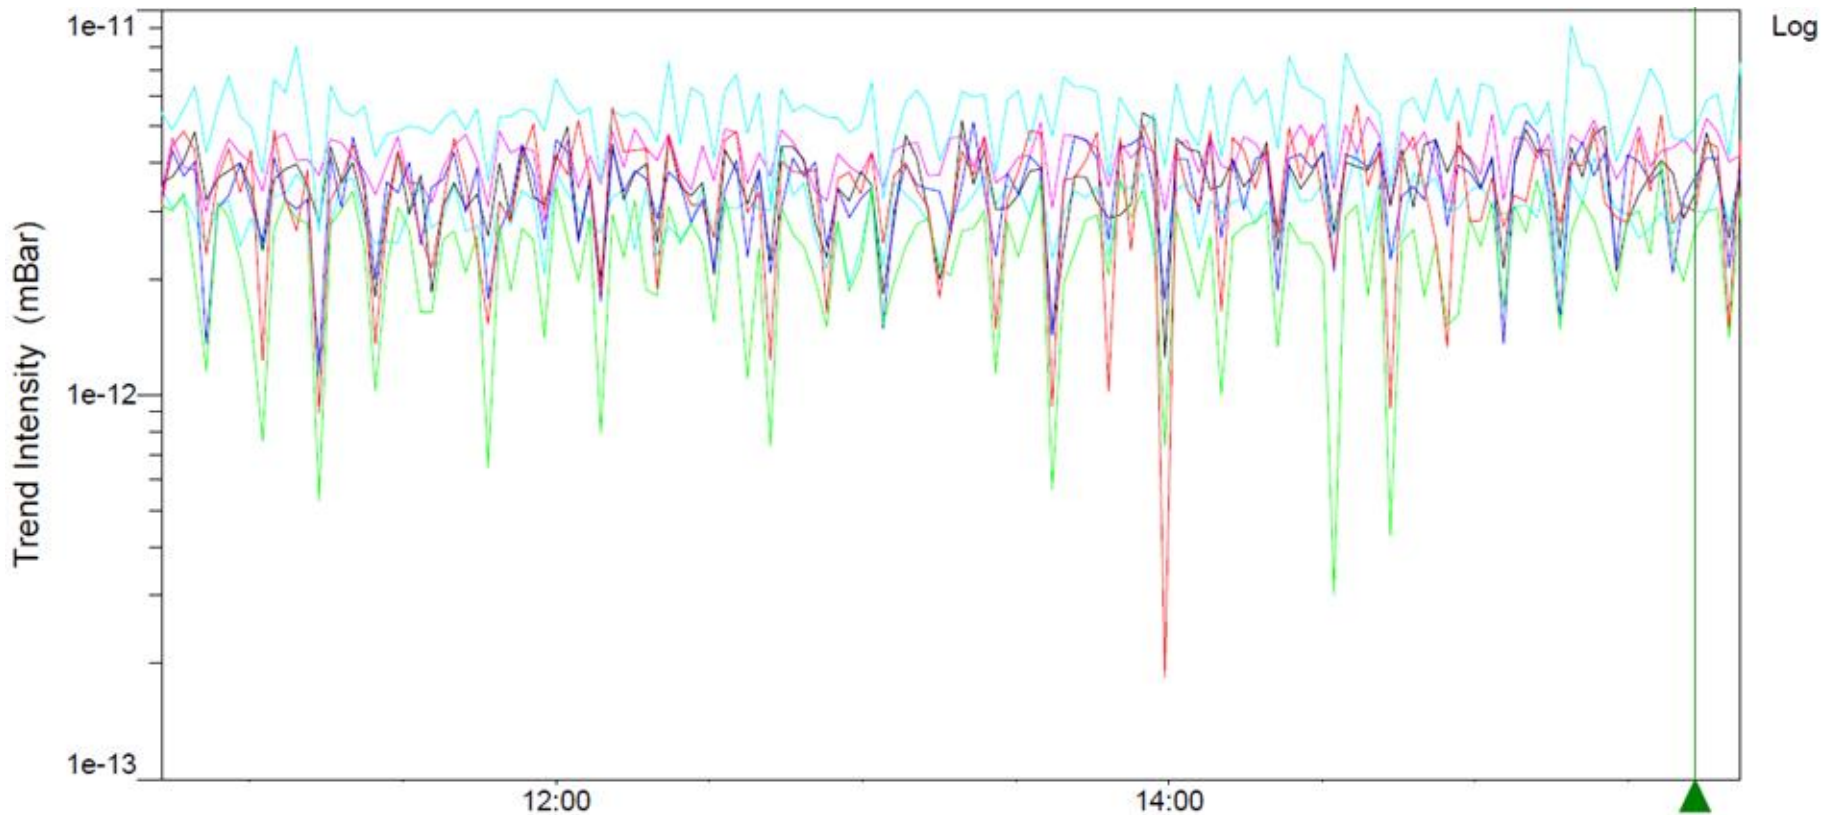
# Noise

Background signal of RGA at  $1\text{e-}9$  mbar total pressure range.

$\Delta p \approx 5\text{-}7 \text{ e-}12$  mbar

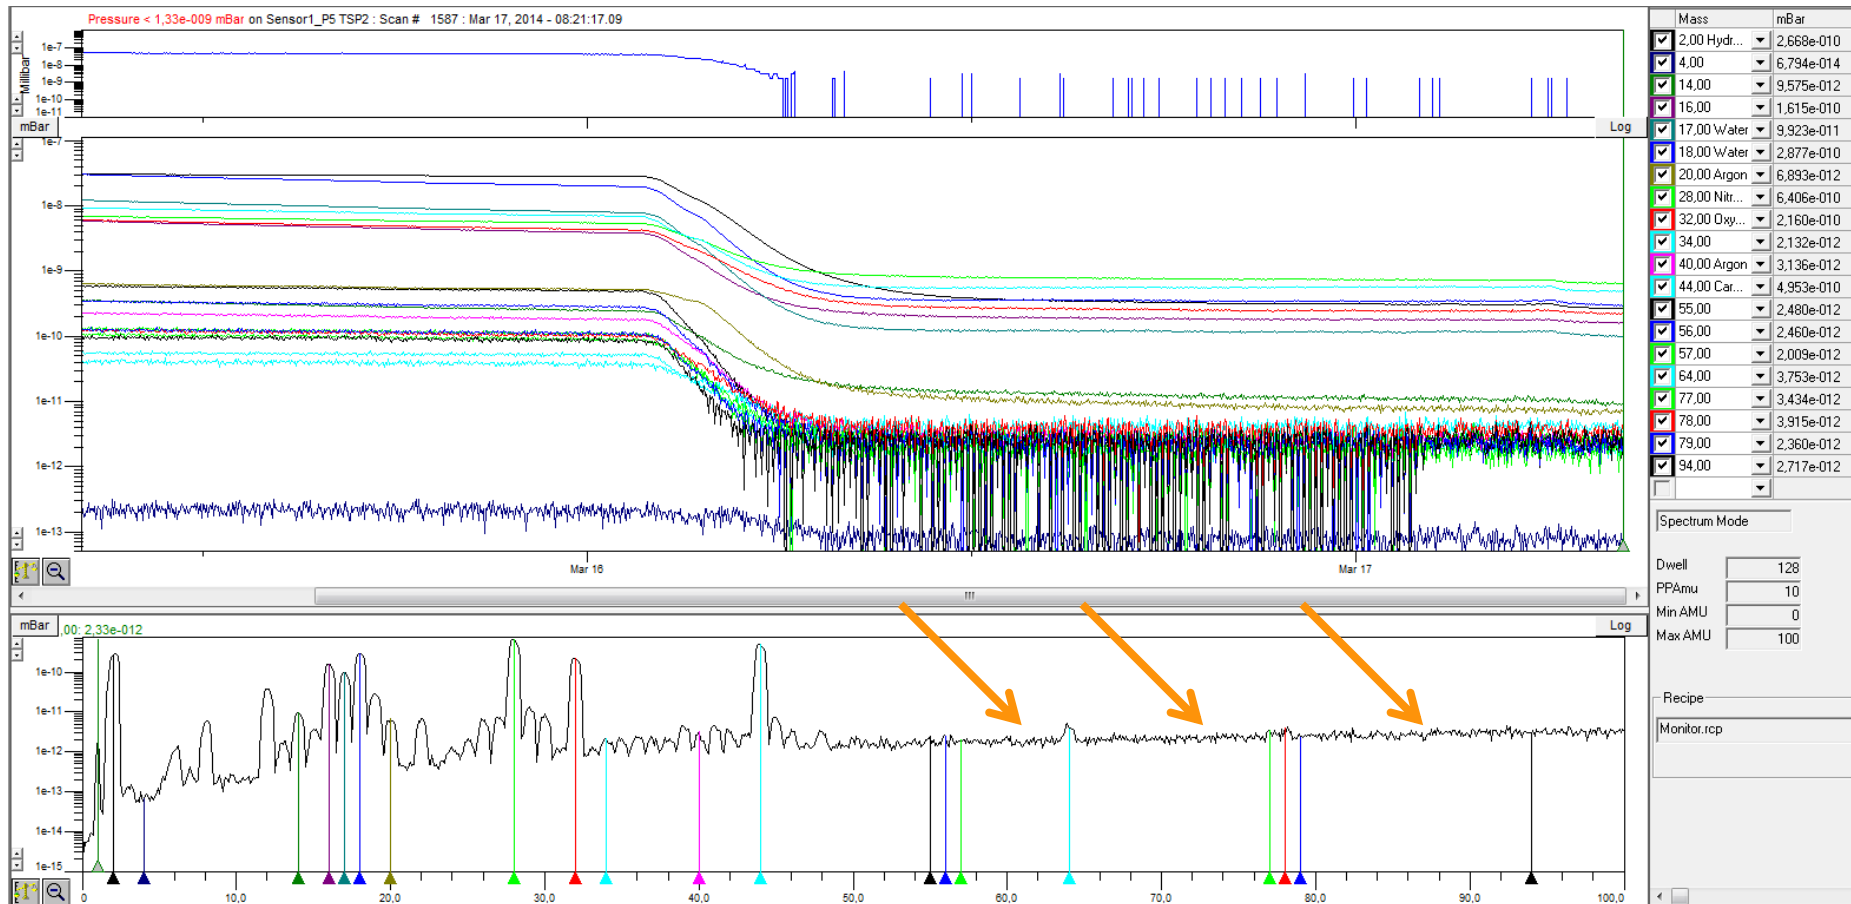
# Background increase

Background signal of RGA at 120°C TT end (1e-9 mbar range).

For  $M > 50$  background is high and increasing.
