Alternate final rinsing

K.Saito and WG-5 Asia

- 1) H₂O₂ rinsing**
- 2) Degreasing effect after EP**
- 3) Megasonic rinsing**

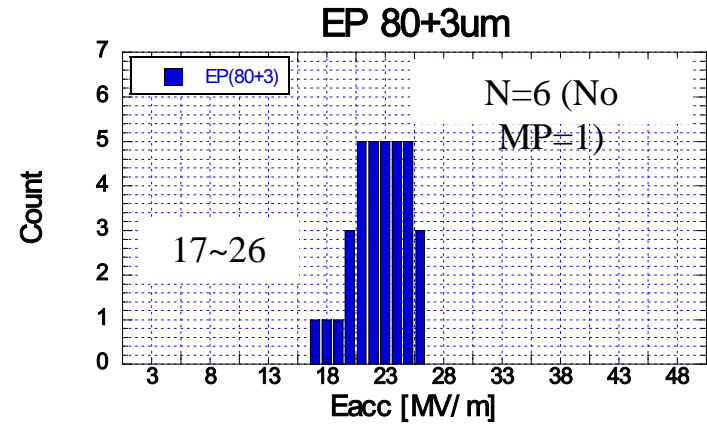
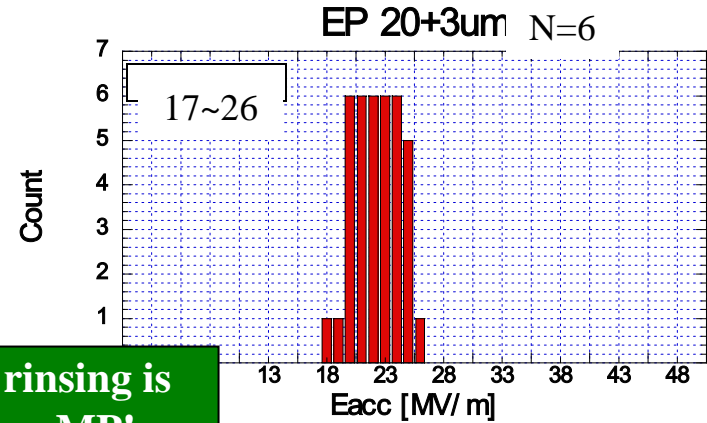
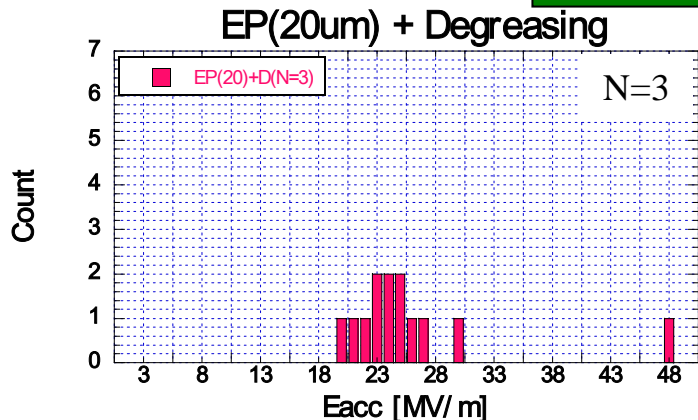
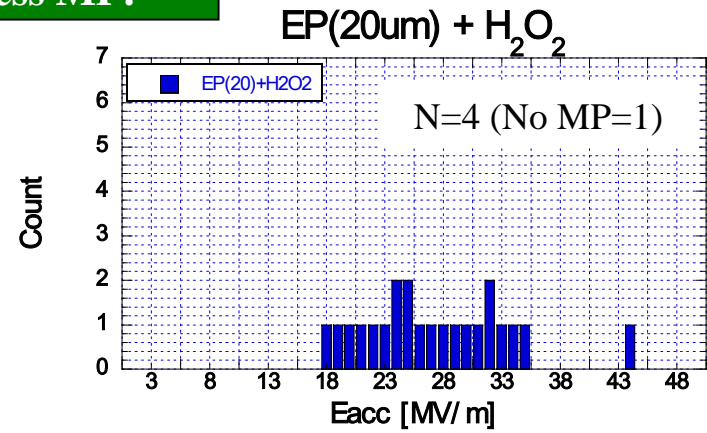
Multipacting

Degreasing or H₂O₂ rinsing is effective to suppress MP!

- 1) H_2O_2 rinsing is effective to suppress multipacting but often limits the gradient by hard quench.**
- 2) Degreasing is so promising and very effective to eliminate oil contamination.**
- 3) HPR has too much trouble at KEK now, we will start to investigate Megasonic rinsing.**

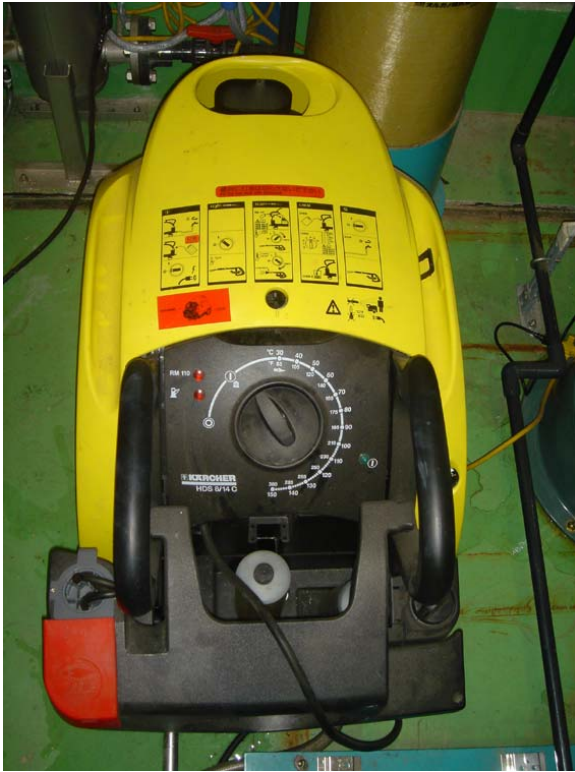
HPR pump @ KEK : KÄRCHER

HDS8/14C

Replaced to new HPR pump @ Nomura
(plunger type)

HPR final filter was contaminated due to new plunger, poor rinsing for ethylene-glycol or other reason.

**The maker shipped the pump filling
Ethylene-glycol.**

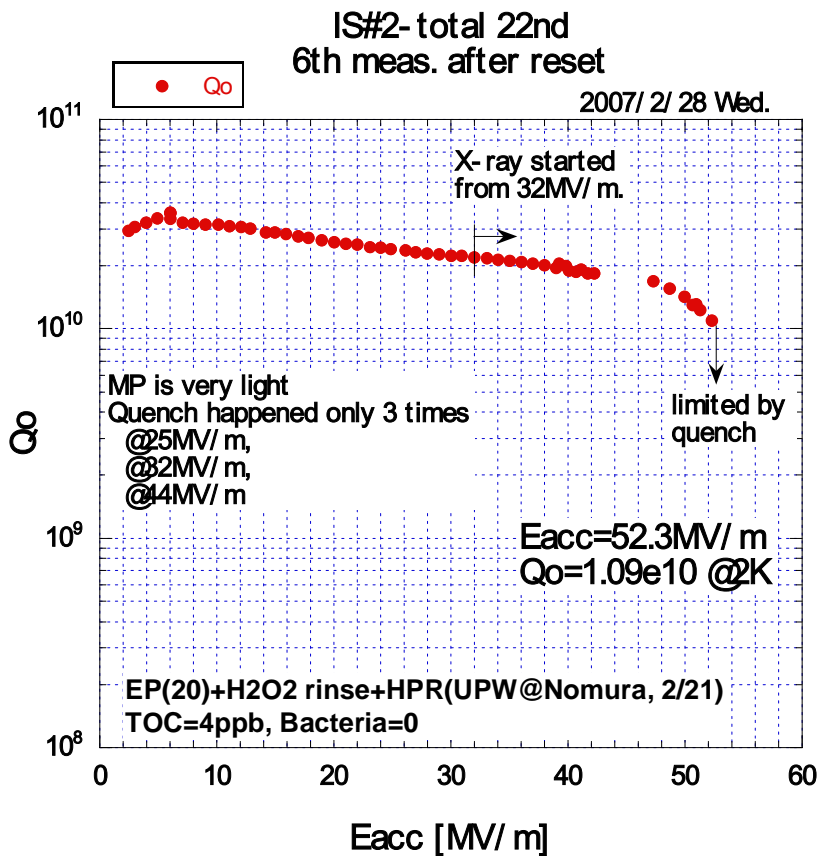
1. EP(20)+H₂O₂+HPR @Nomura

Before the HPR contamination

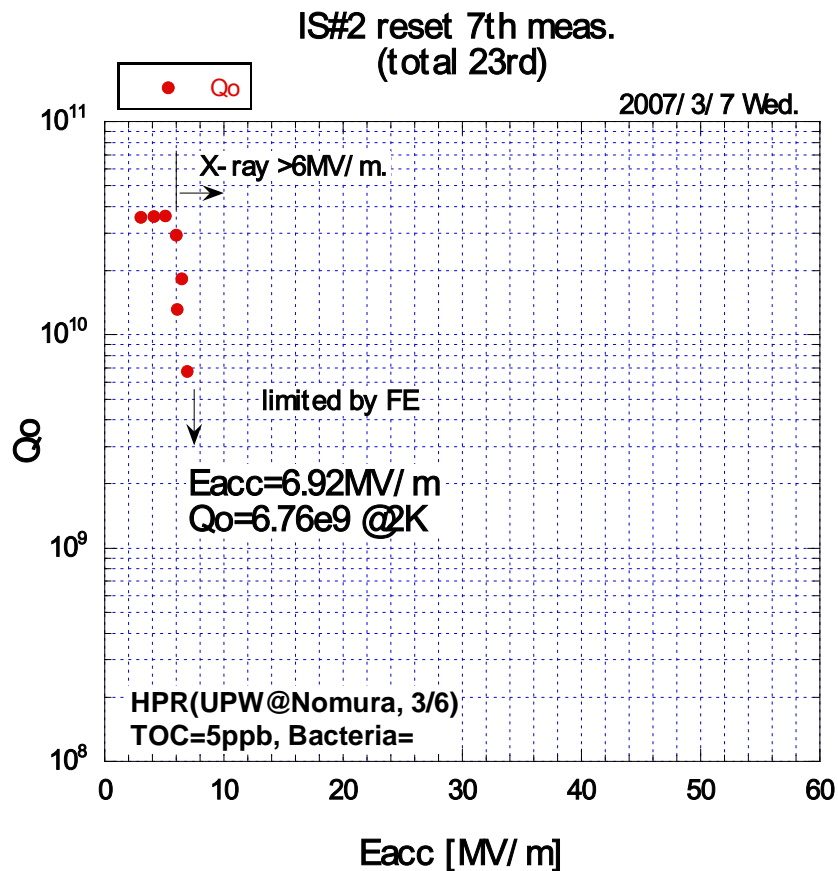
2. Additional HPR @Nomura

After the HPR contamination

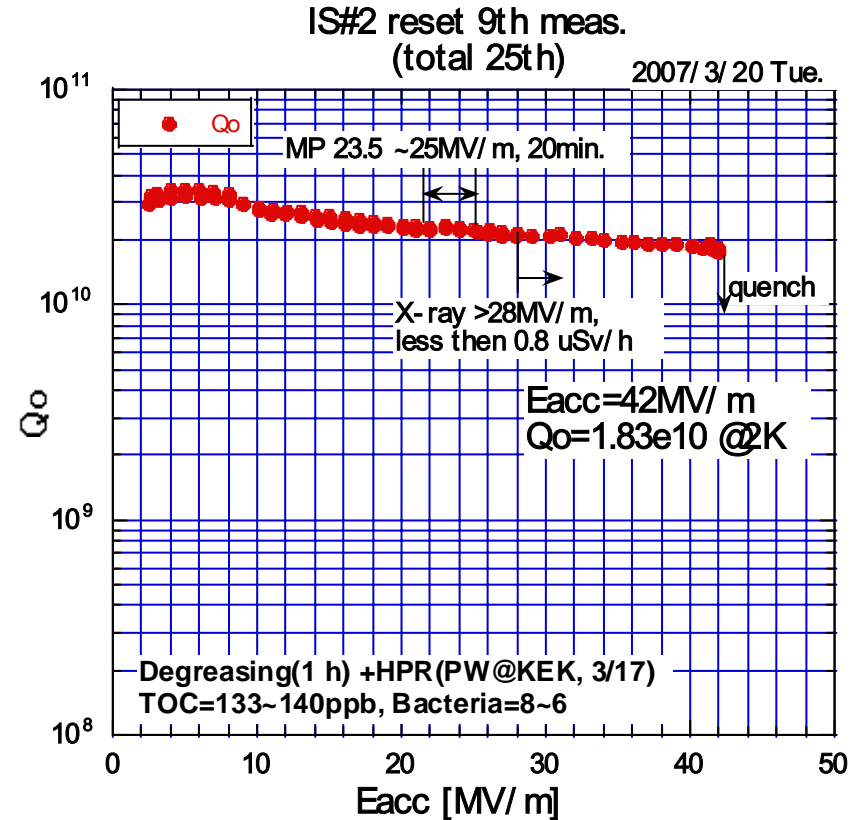
4. Additional Degreasing + HPR @KEK

(Use Japanese degreaser)

Degreasing is very much effective to eliminate contamination !
