# CO<sub>2</sub> Experience @ Belle2 VXD Test Beam

# CO<sub>2</sub> Experience @ TB: Outline

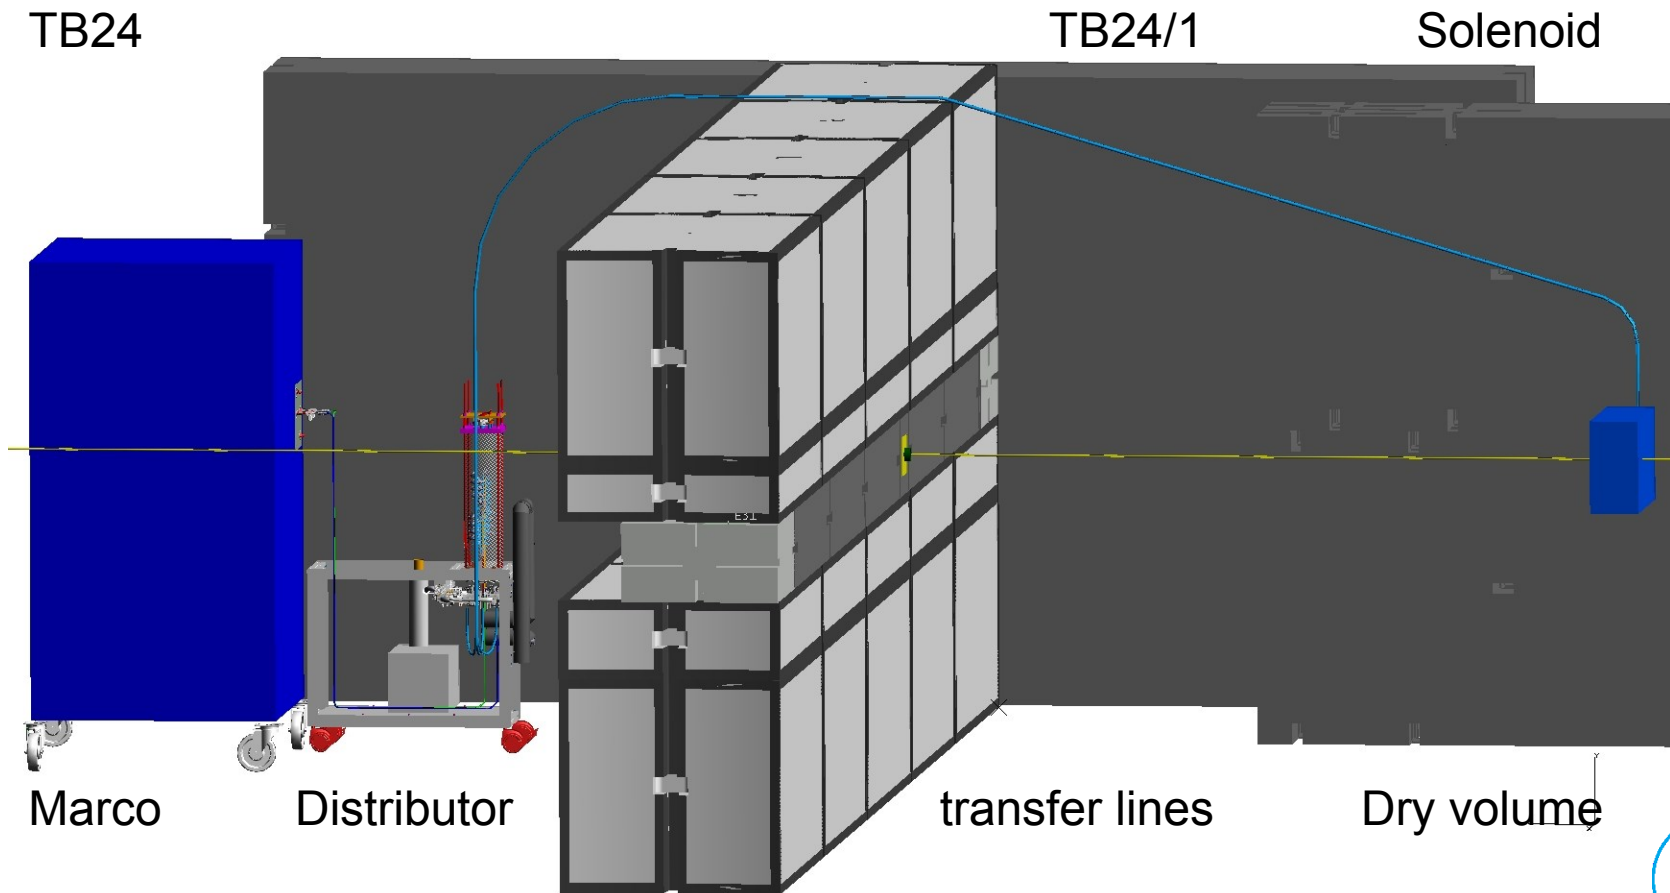
- To avoid influences of the strong magnetic field of the solenoid in TB24/1
- Marco and the distributors vacuum pump are located in the neighbouring section TB24 with 12m of vacuum insulated transfer lines reaching over the wall.

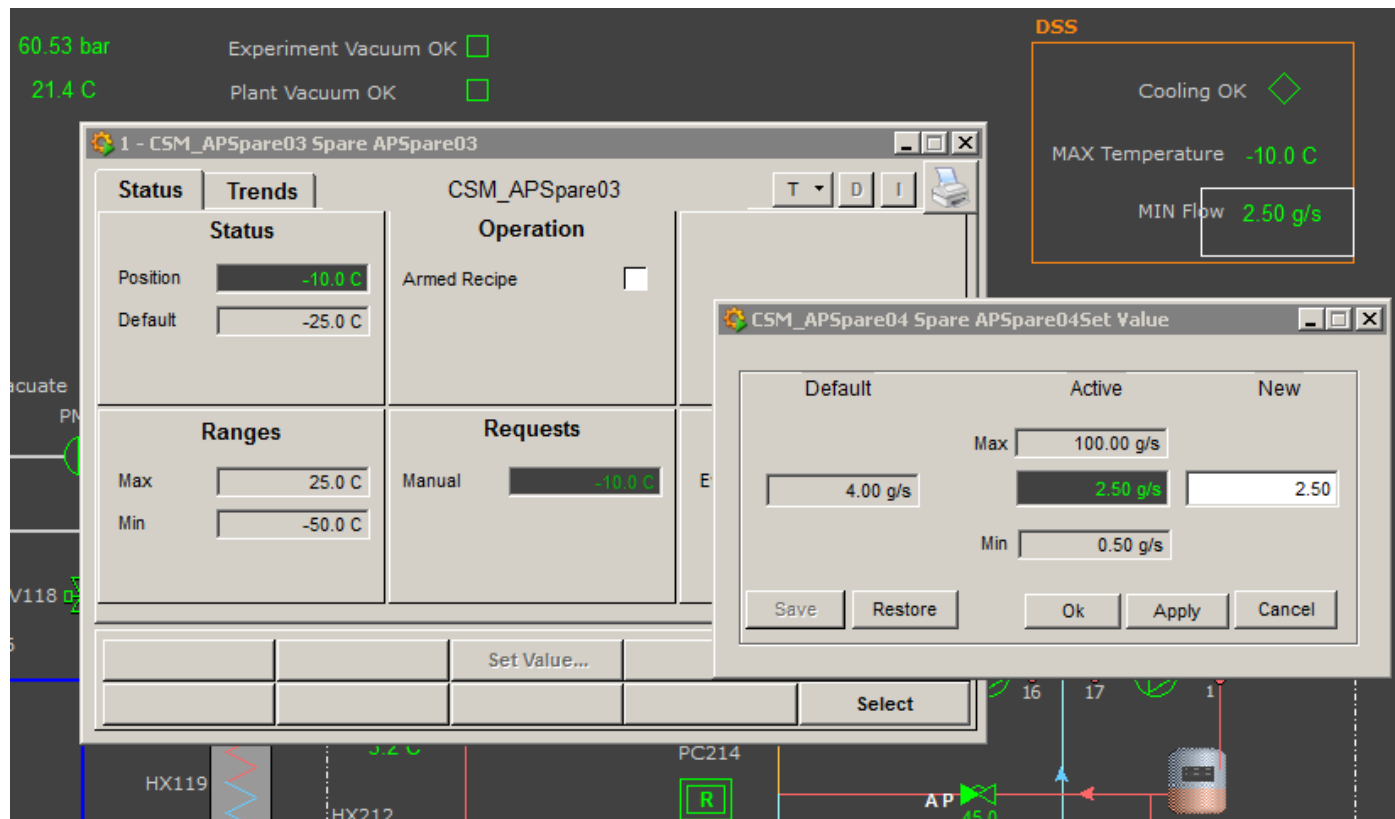
- To prevent powering the silicon sensors without cooling a relay was implemented that let through a 20mA Signal to the DAQ when
- the CO<sub>2</sub> temperature is below a temperature limit and
- the CO<sub>2</sub> mass flow exceeds minimum flow.

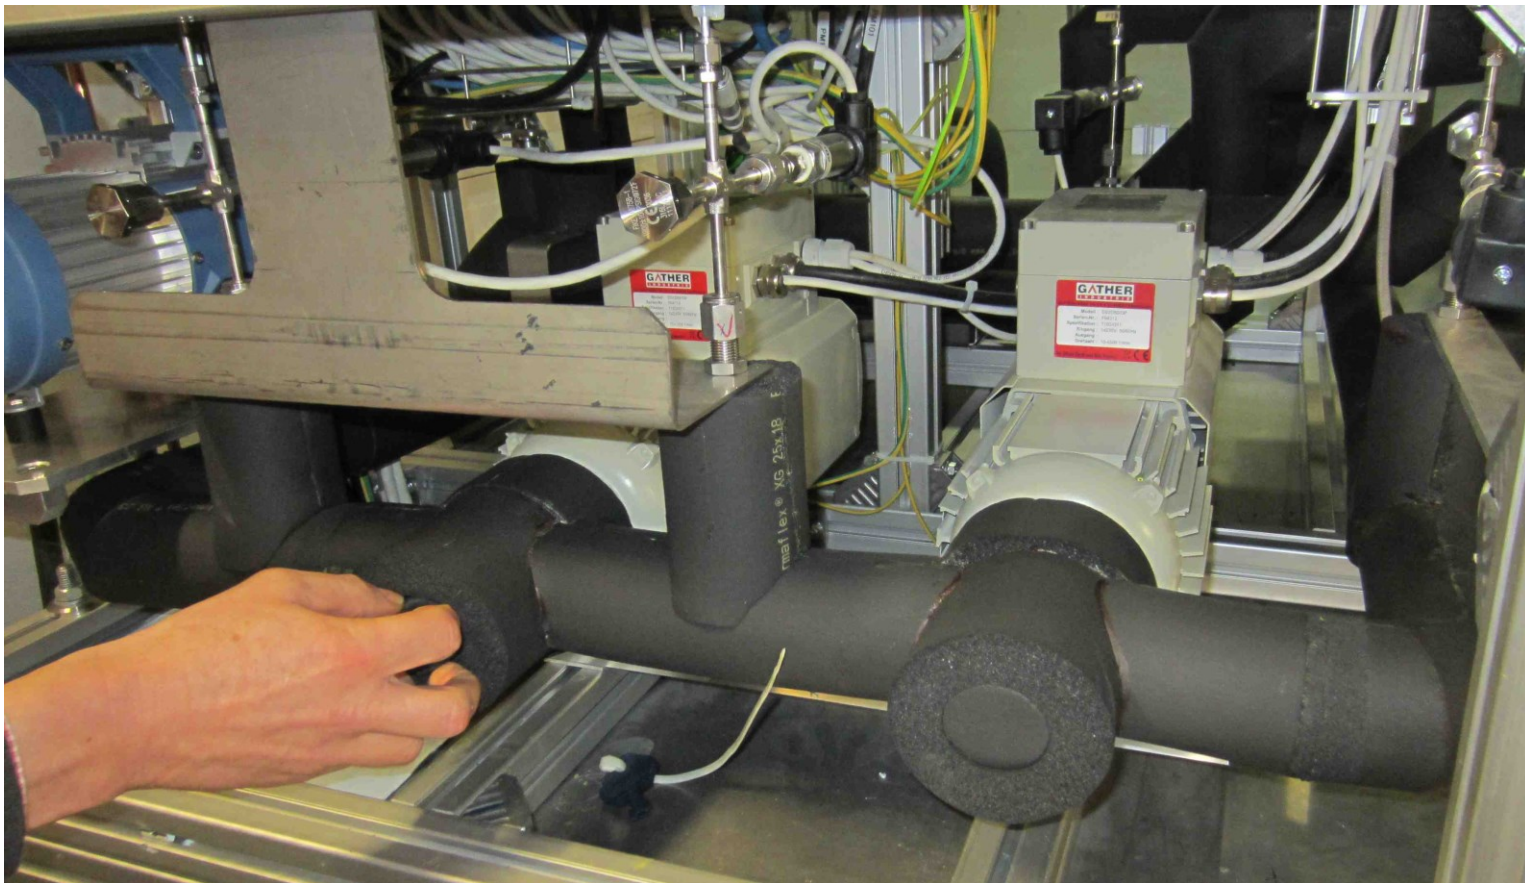
- During start up the CO<sub>2</sub> pump head leaked.
- The rapid cool down from ambient to -50°C
- let the pump head shrink more than its fixation screws
- first I tried to slow the process down in a stop and go manner

- but the chillers compressor may suffer by this.
- A firm tightening of the pump head screws helped.
- This should be done regularly.

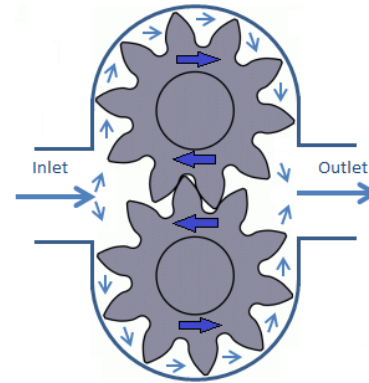
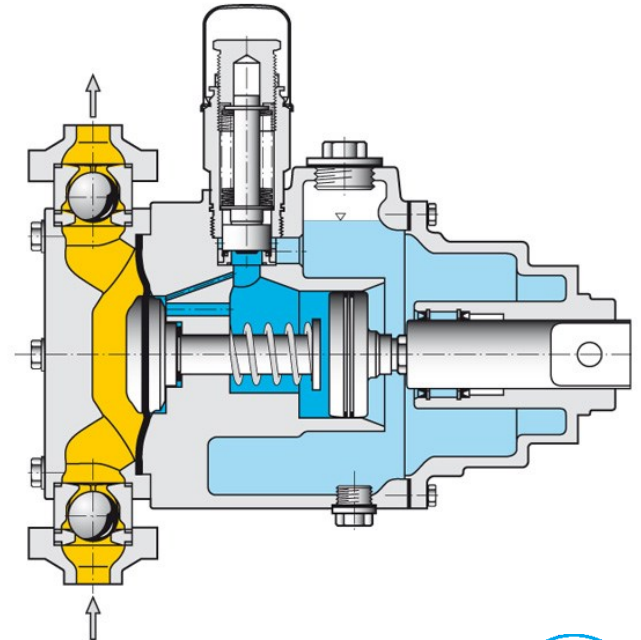
- The low viscosity of CO<sub>2</sub>
- which is beneficial for a low pressure drop
- has only a weak lubrication capacity wearing off parts under friction.
- A change of Marco's 2 Gather gear pumps to a membrane pump Lewa LDC M900 is under discussion, but
- high cost for it and a frequency converter
- and the time-consuming mechanical and electrical/control integration
- for now we stay with the Gather gear pumps and frequent filter changes and pump head monitoring and exchange.
