XFEL-Gun

F.Brinker

Short History of the XFEL Gun in HH

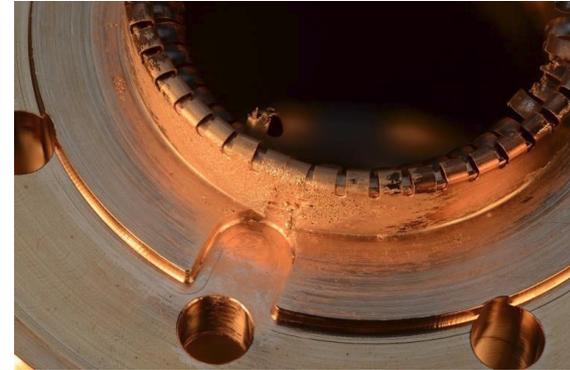
- 1. RF operation Dezember 2013
 - Successful test of RF-system
 - 5.5 MW, 650 us reached
 - Limit : light at the window
 - Massive damages on the cathode RF spring
- 2. RF operation September 2014
 - Successful test of the improved cathode spring system
 - 4.8 MW, 400us reached
 - Limit : vacuum leak at the window
- 3. RF operation Dezember 2014
 - Short test of glued window
 - 4.8 MW, 400us reached
 - Limit : vacuum leak at the window

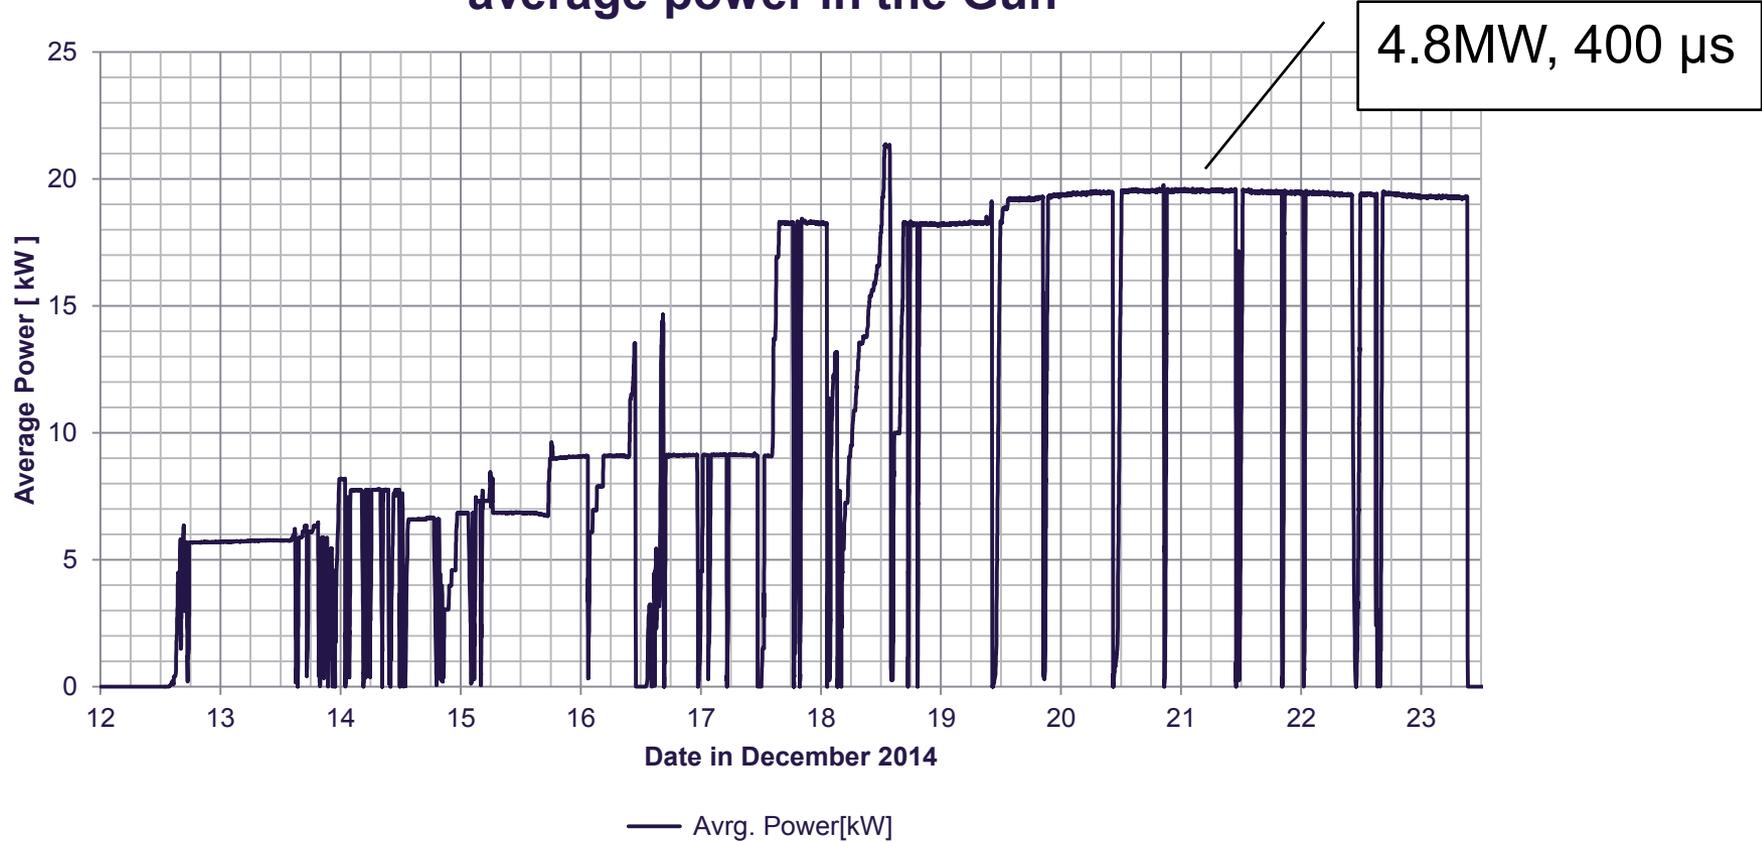
- During a short run in december '14 we verified that gluing of an RF-window does not work at high power levels

RF Window with vacuum glue before (left) and after (right) operation in Dez. 14 und February 15

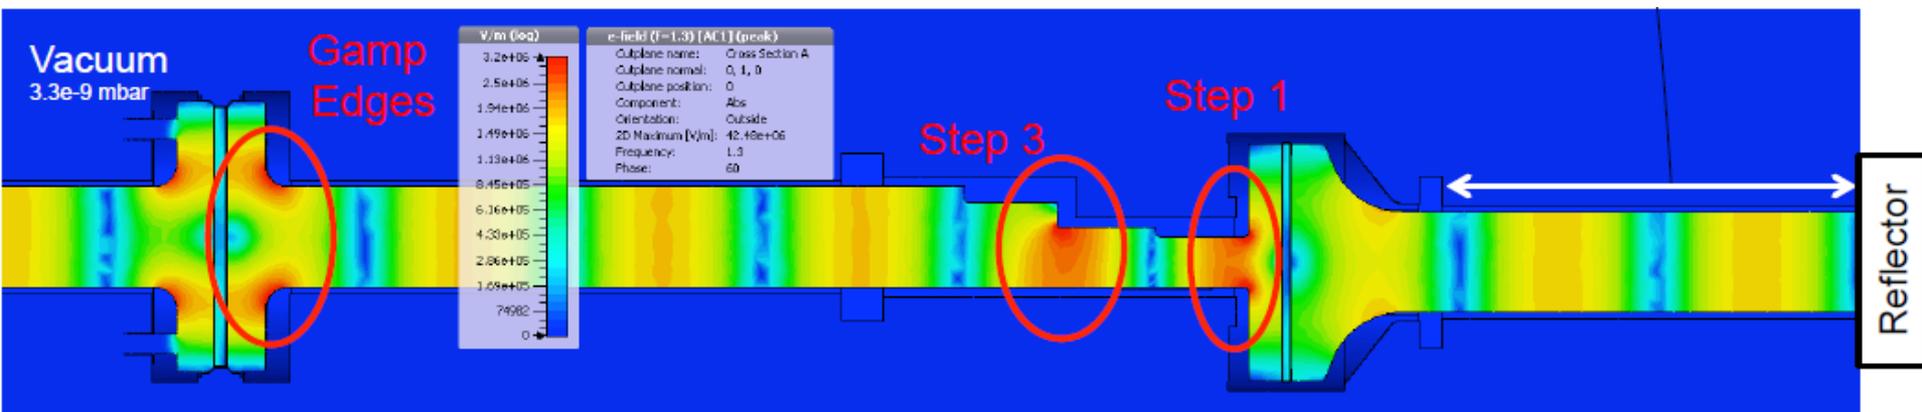
- Test with full reflection:
 - 20 μs pulse length (+ 35%)
 - 10 Hz
 - 2-6 MW RF-power
 - Distances to the reflector were varied
