Belle II Module and Ladder Failure Analysis and Repair

after Flip-chip and SMD mounting (using Probe Card)

Belle II PXD Meeting - DESY 08.10.2018

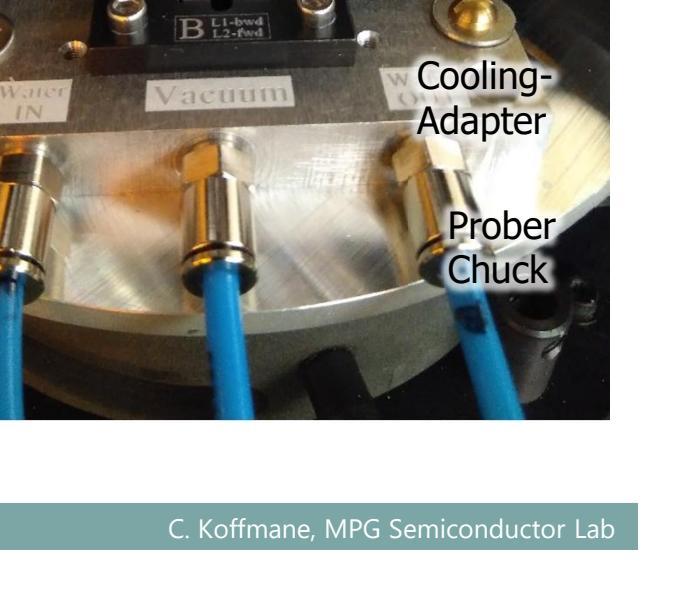
- **High SW-DVDD current** (4 times phase 3 + 3 times phase 2/pre-production)
- DHP-Core/IO short (once phase 3 + once phase 2)
- Failed boundary scan (once)

- Caused by faulty switcher
- Switchers could be identified using a thermal camera
- 4 (+2) Switchers successfully replaced

Module	Fault	Action	Result
W31_OB1	SW	SW replaced	ClearOn/Off Used for proto type ladder L2_010
W31_OB2	SW	SW replaced	OK @ KEK
W38_IB	SW rotated	SW replaced	OK Was part of L1_013
W43_OF1	SW4	SW4 replaced	OK, grade A Running in GOE
W44_OF1	SW	Matrix cracked. Mo	odule broken.
W44_OF2	SW6	SW6 replaced	ClearOn/Off in SW3 (Elog ID 7586)
W09_0B1	SW2	SW2 replaced	OK, grade A

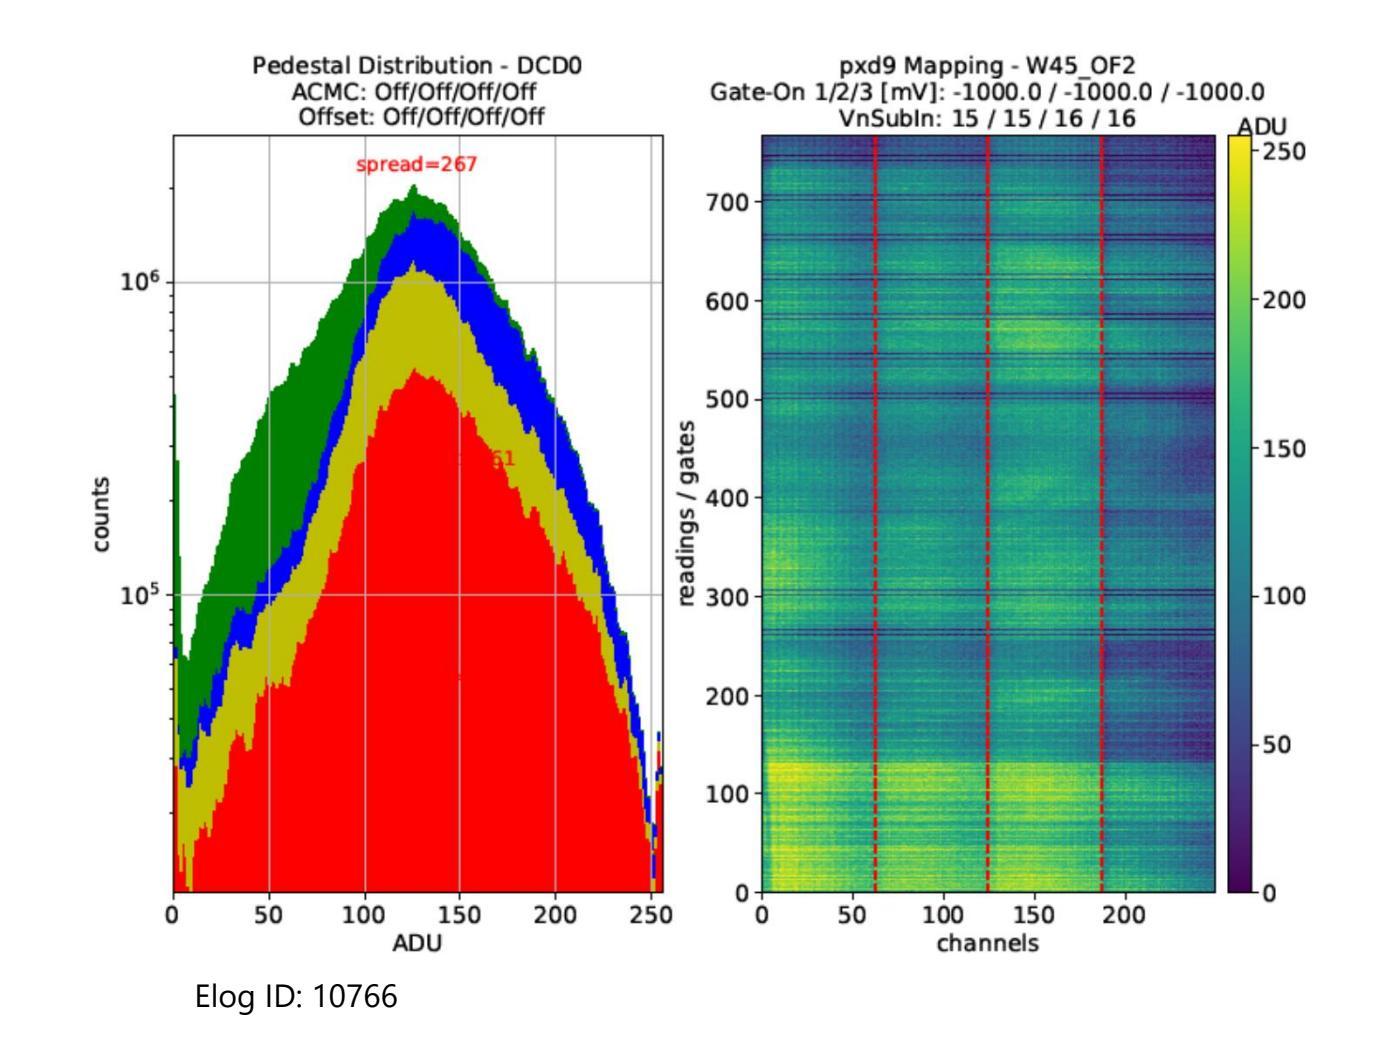
Module passed the probe card test after DHPT3 was replaced

Testing ongoing in Bonn, sanity check okay (pedestal)

Module	Fault	Action	Result
W38_OB1	ASIC not identified	None yet.	None yet.
W45_OF2	DHPT3	ASIC replaced with high temp.	OK.

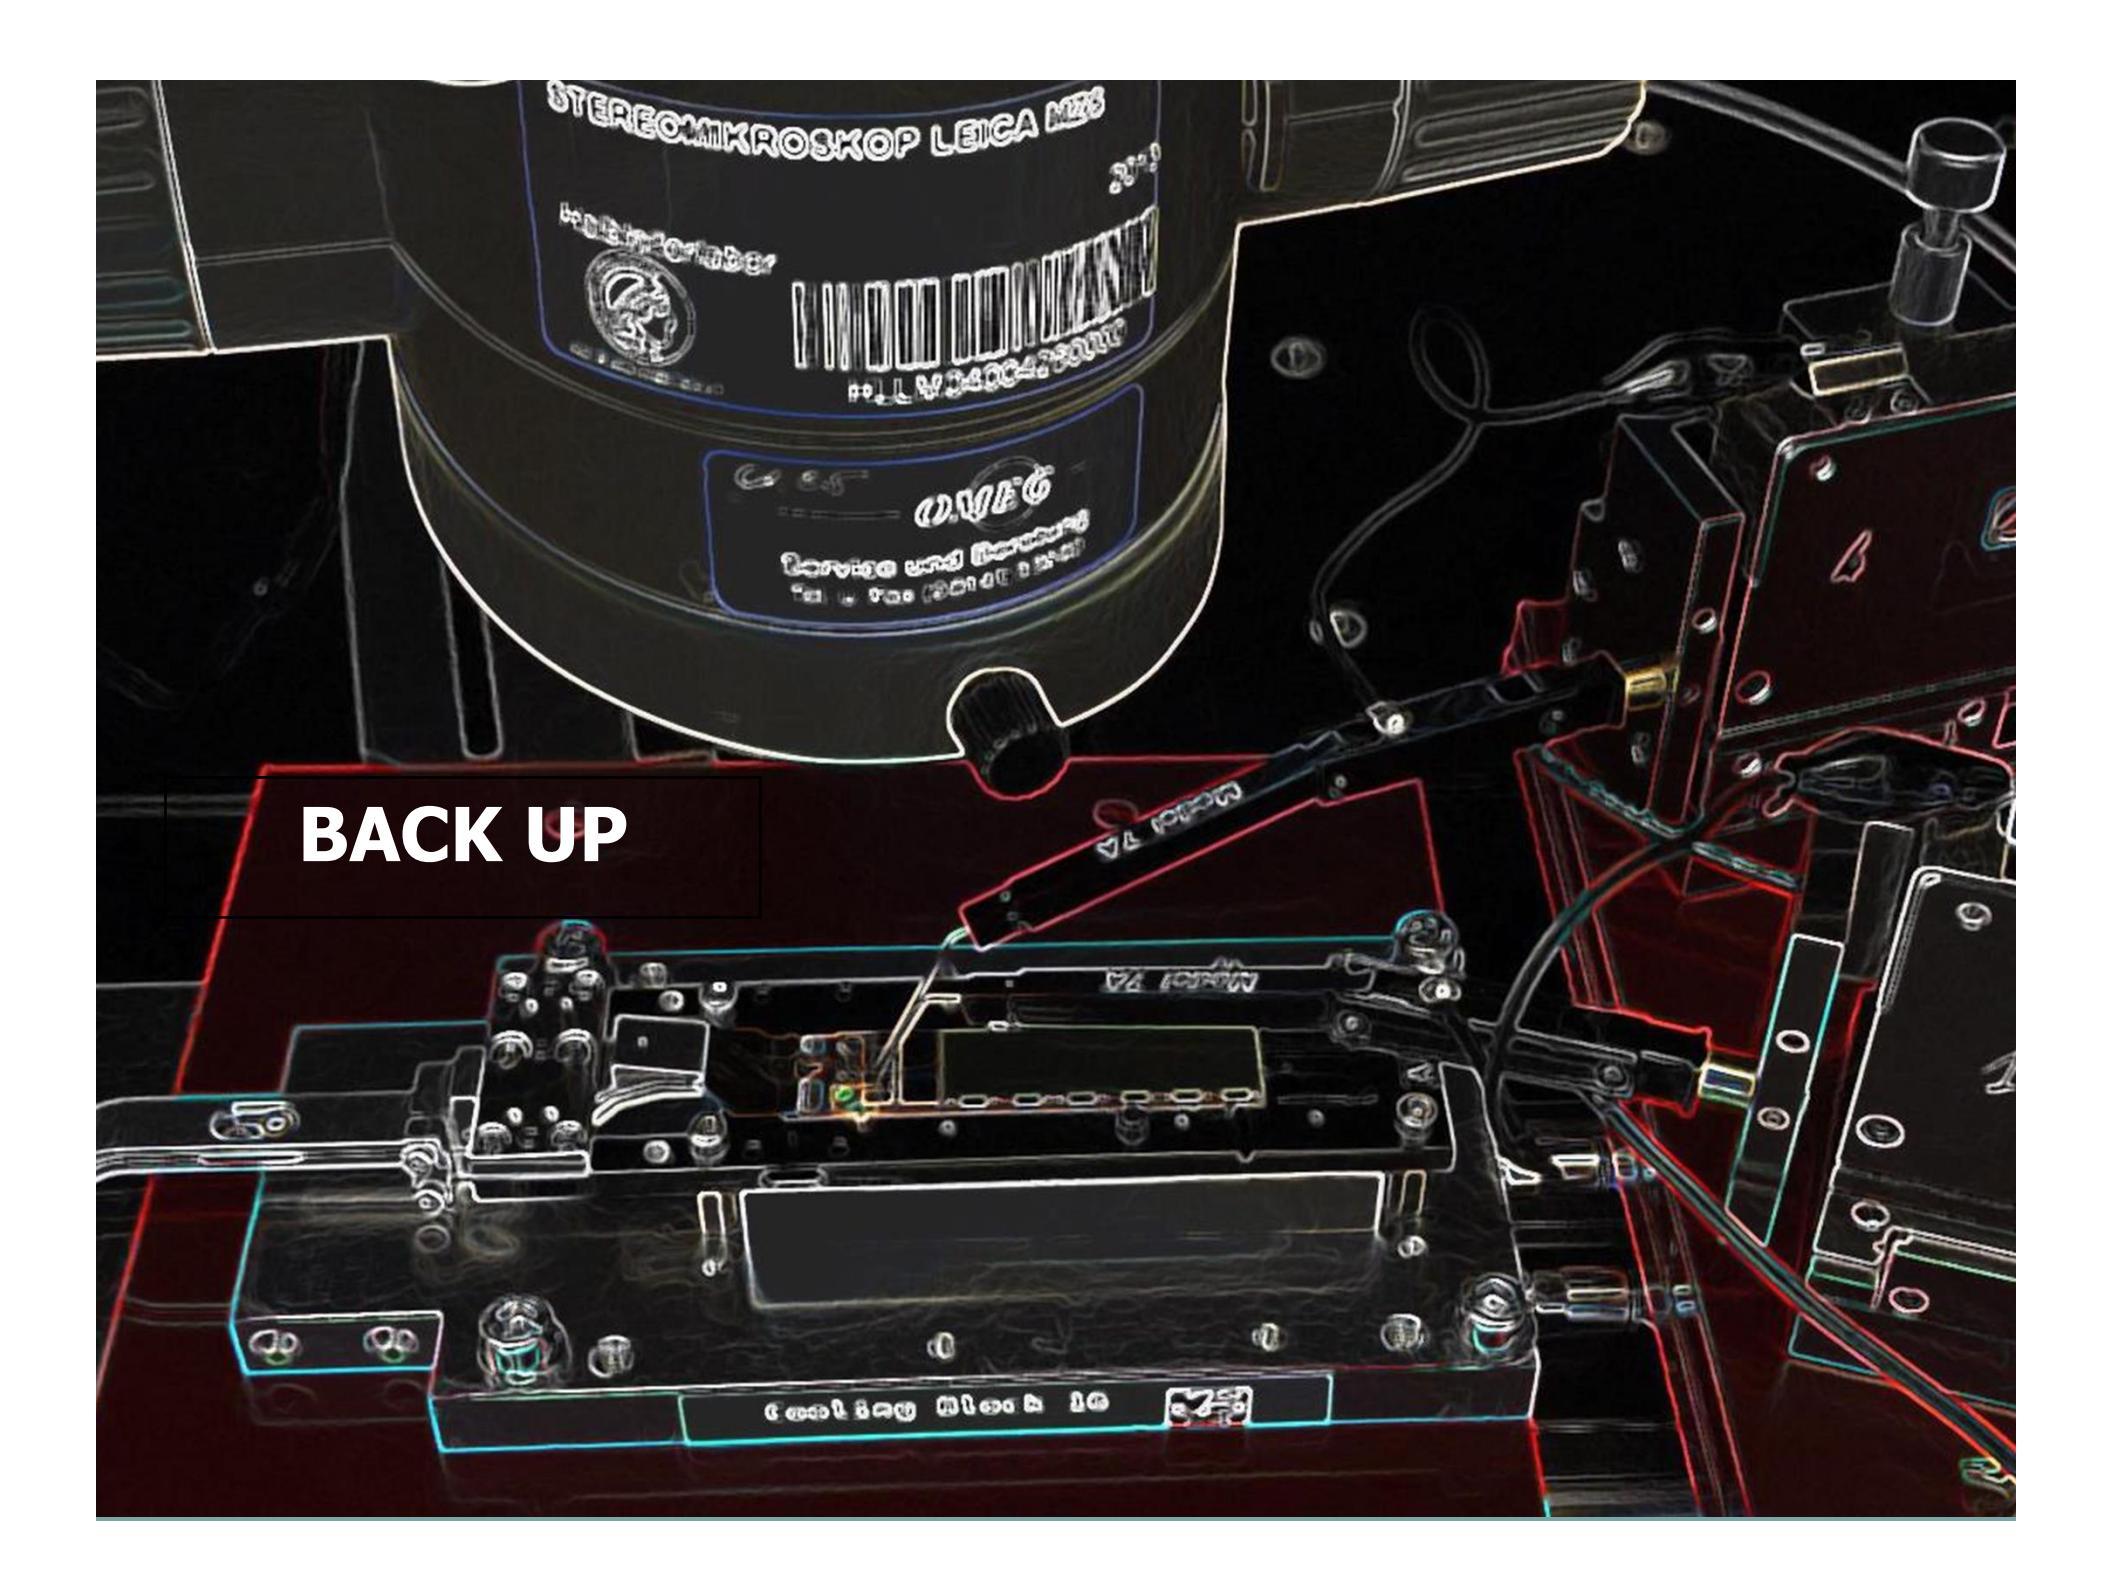
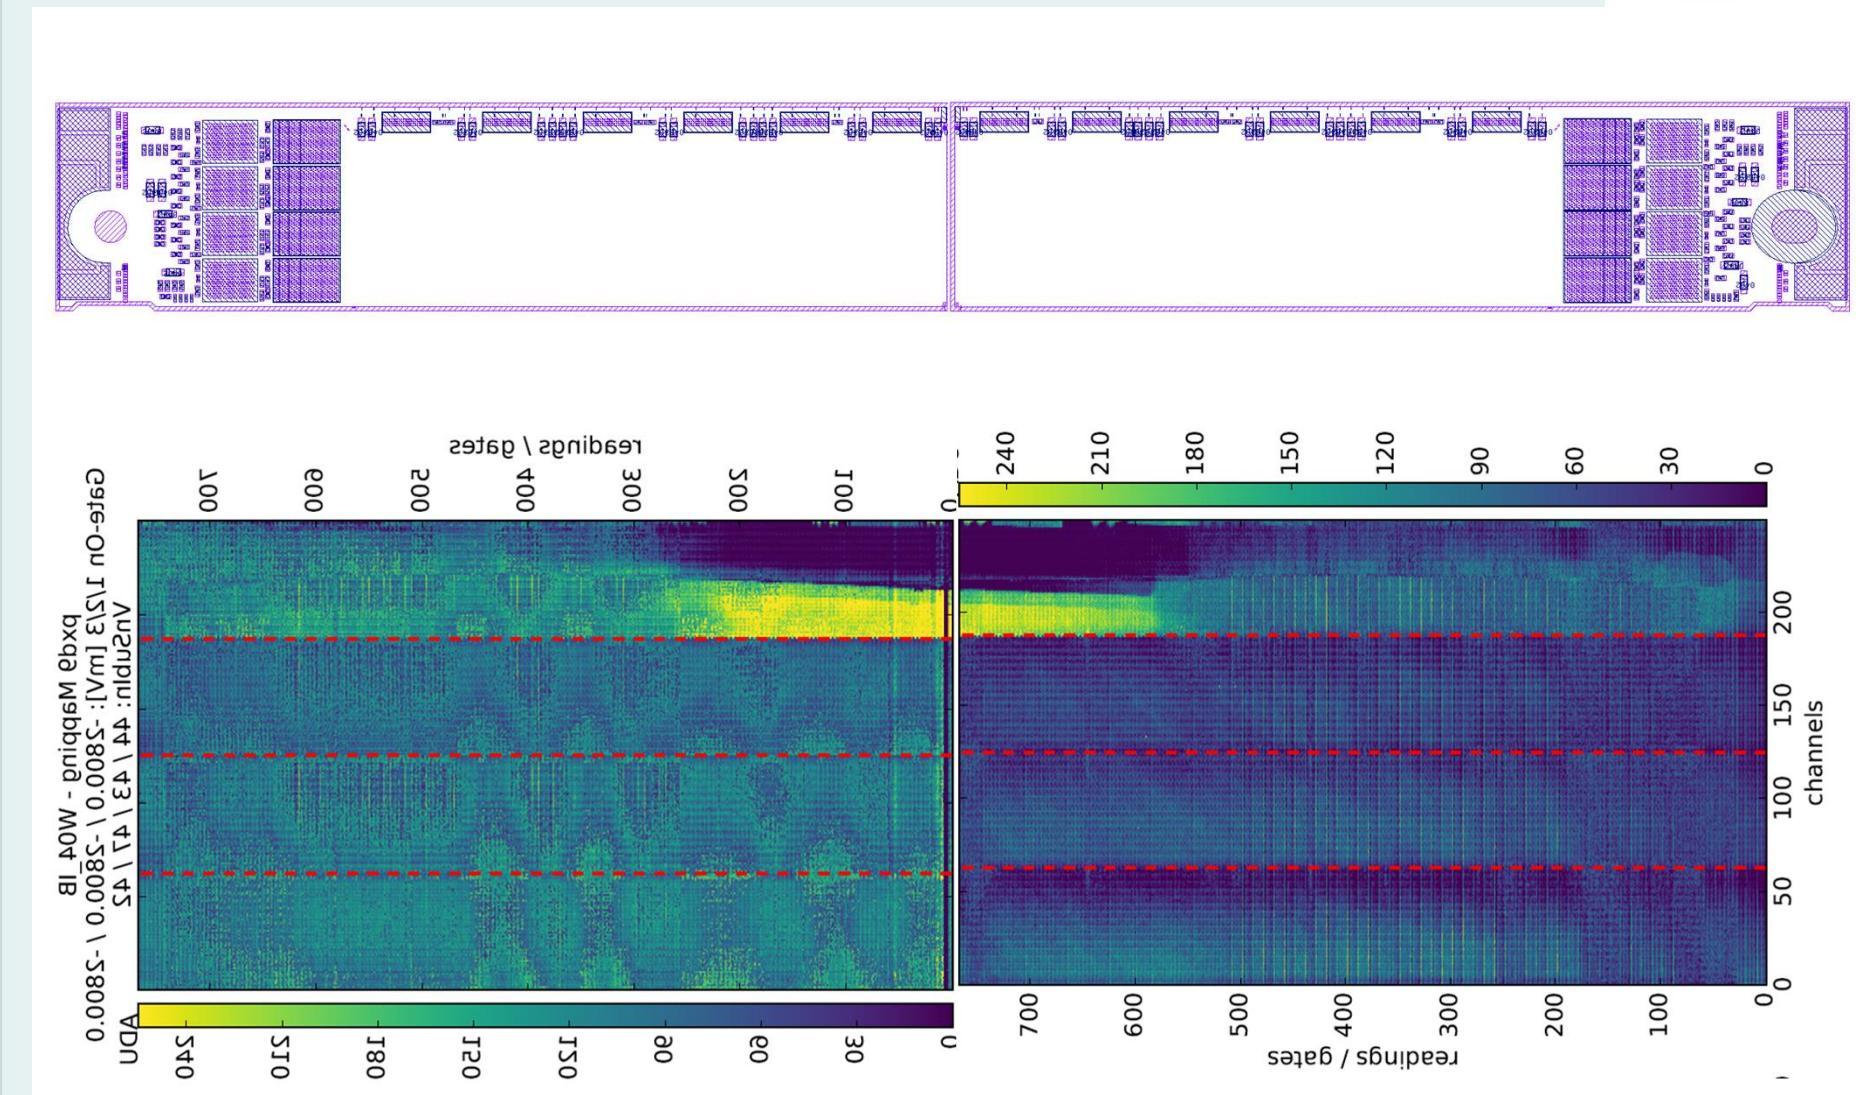
# **L1\_035:** W04\_IB and W04\_IF

- After ladder gluing the module W04\_IB shows an increased, abnormal ClearOn and ClearOff current consumption
- There is no localized ohmic short, but all Switcher channels contribute to the increased current consumption (verified using a dedicated sequences which excludes Switchers)
- Assumption: all Switcher try to switch on all the channels (Clear and Gate) all the time, caused by a broken SW\_SerIn line
- Boundary Scan Test fails for all the Switcher control signals (SW\_SerIn, SW\_CLK, SW\_StrG, SW\_StrC)
- probing the SW\_SerIn signal on the PXD9 module is not possible (generated by DHPT1, no test points)

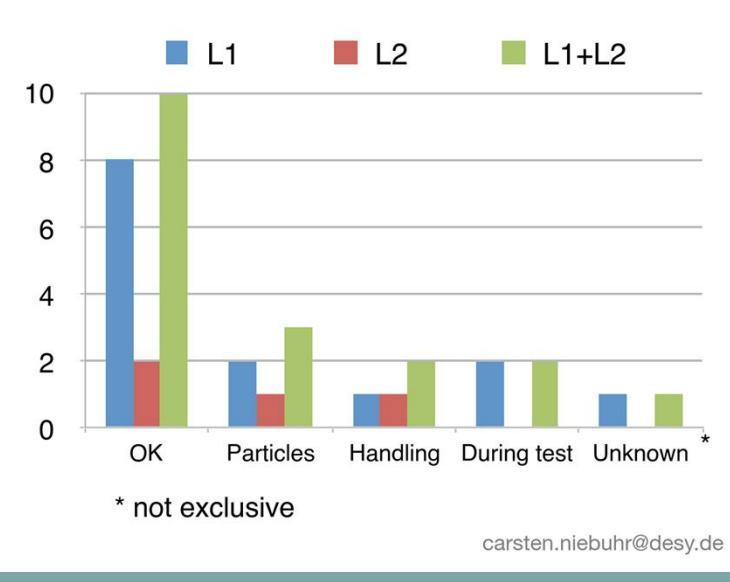
- L1-13 broken during testing (PS malfunction)
- L1-14 poor sensor quality
- L1-15
- L1-16 broken during mounting on cooling block (SCB)
- L1-17
- L1-18
- L1-19 particle problem but still ok
- L1-20
- L1-21 overheated during test  $\rightarrow$  bond height DHP replacement under study
- L1-28
- L1-30 accident with screwdriver/particle
- L1-35 short on IB (still under investigation)
- L2-22 cracked due to misalignment
- L2-24 dead, particle problem
- L2-29
- L2-34
