**HELMHOLTZ  
ZENTRUM BERLIN**  
für Materialien und Energie

# **MAGNETIC DUST PARTICLES IN THE ID CHAMBER**

**P. Kuske – for the BESSY team**

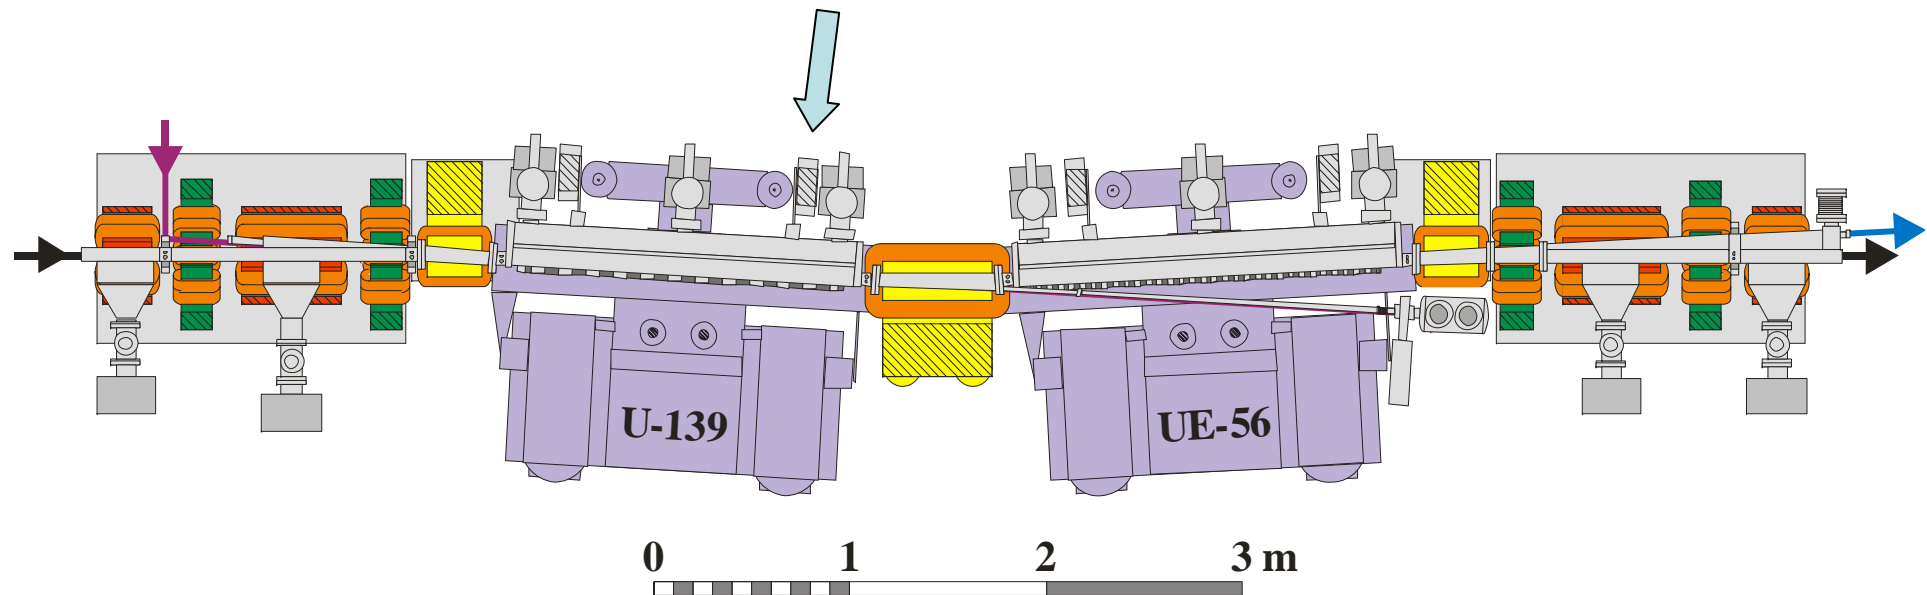
chamber exchanged in the fall shut down of 2007

## molten mirror in the slicing section caused 1 week loss of beam time

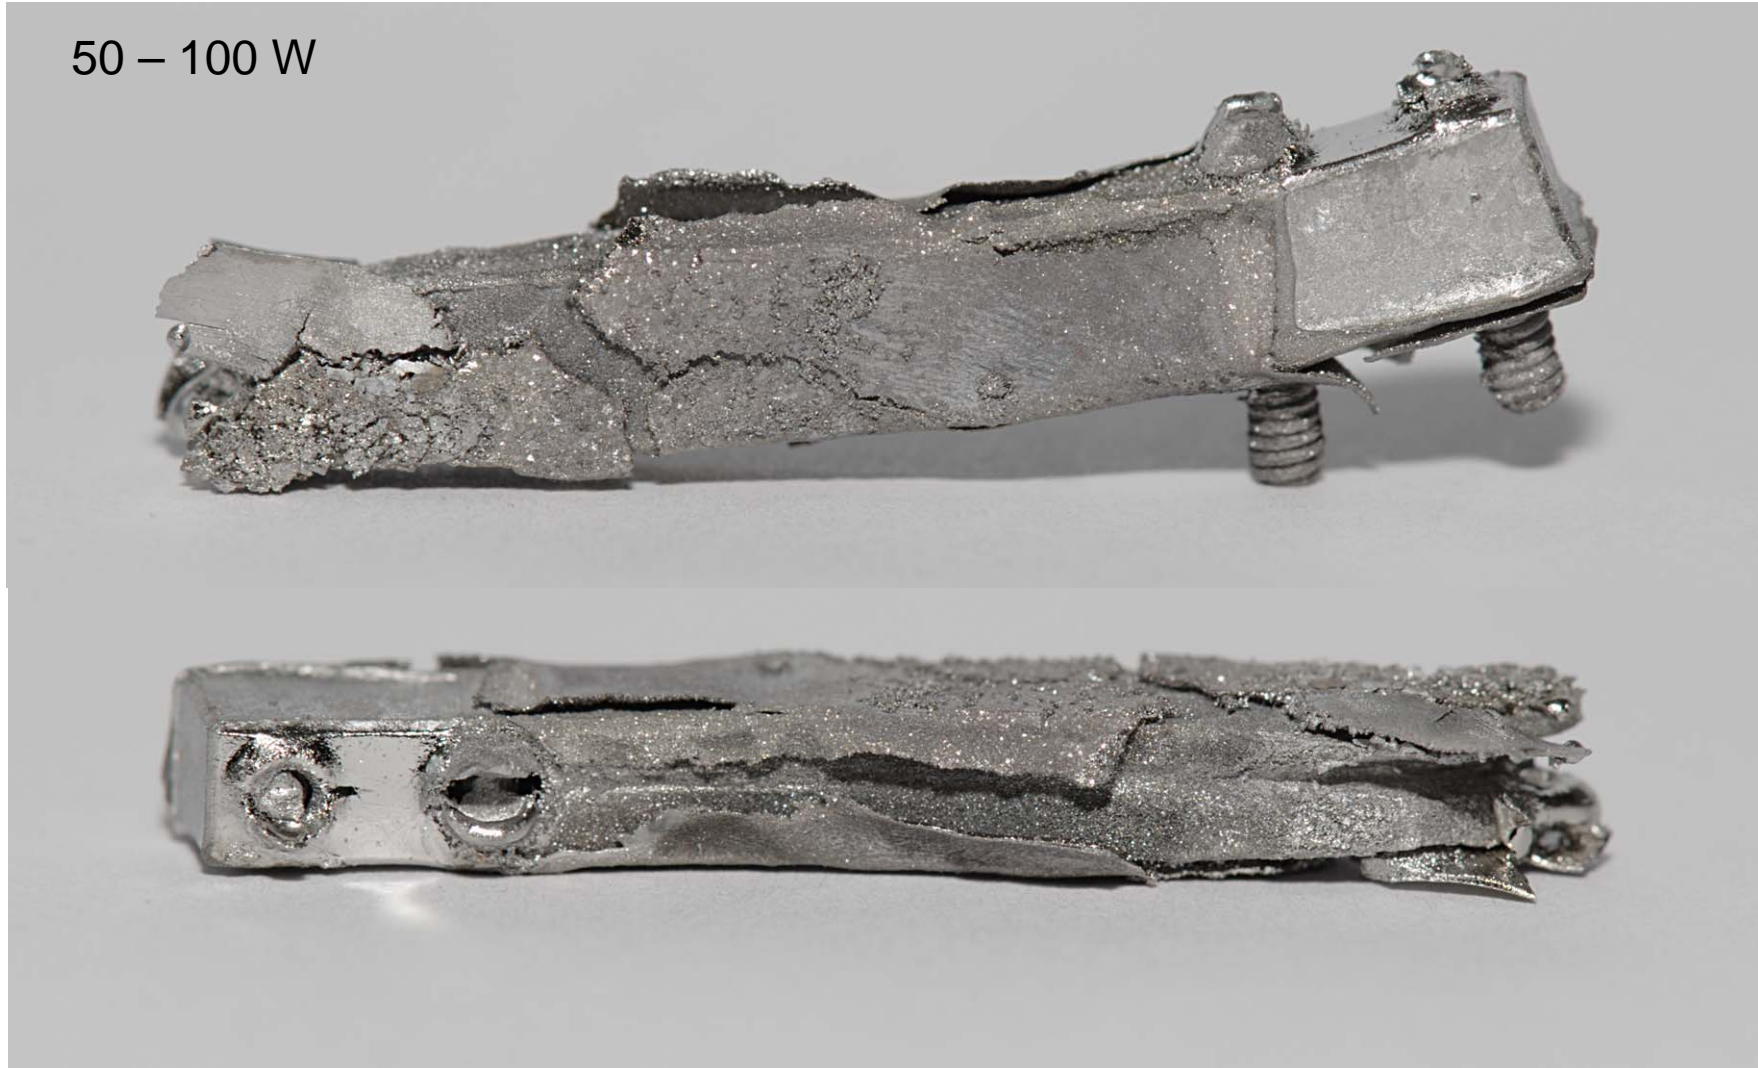
After a while at high intensity no injection any more

50 – 100 W

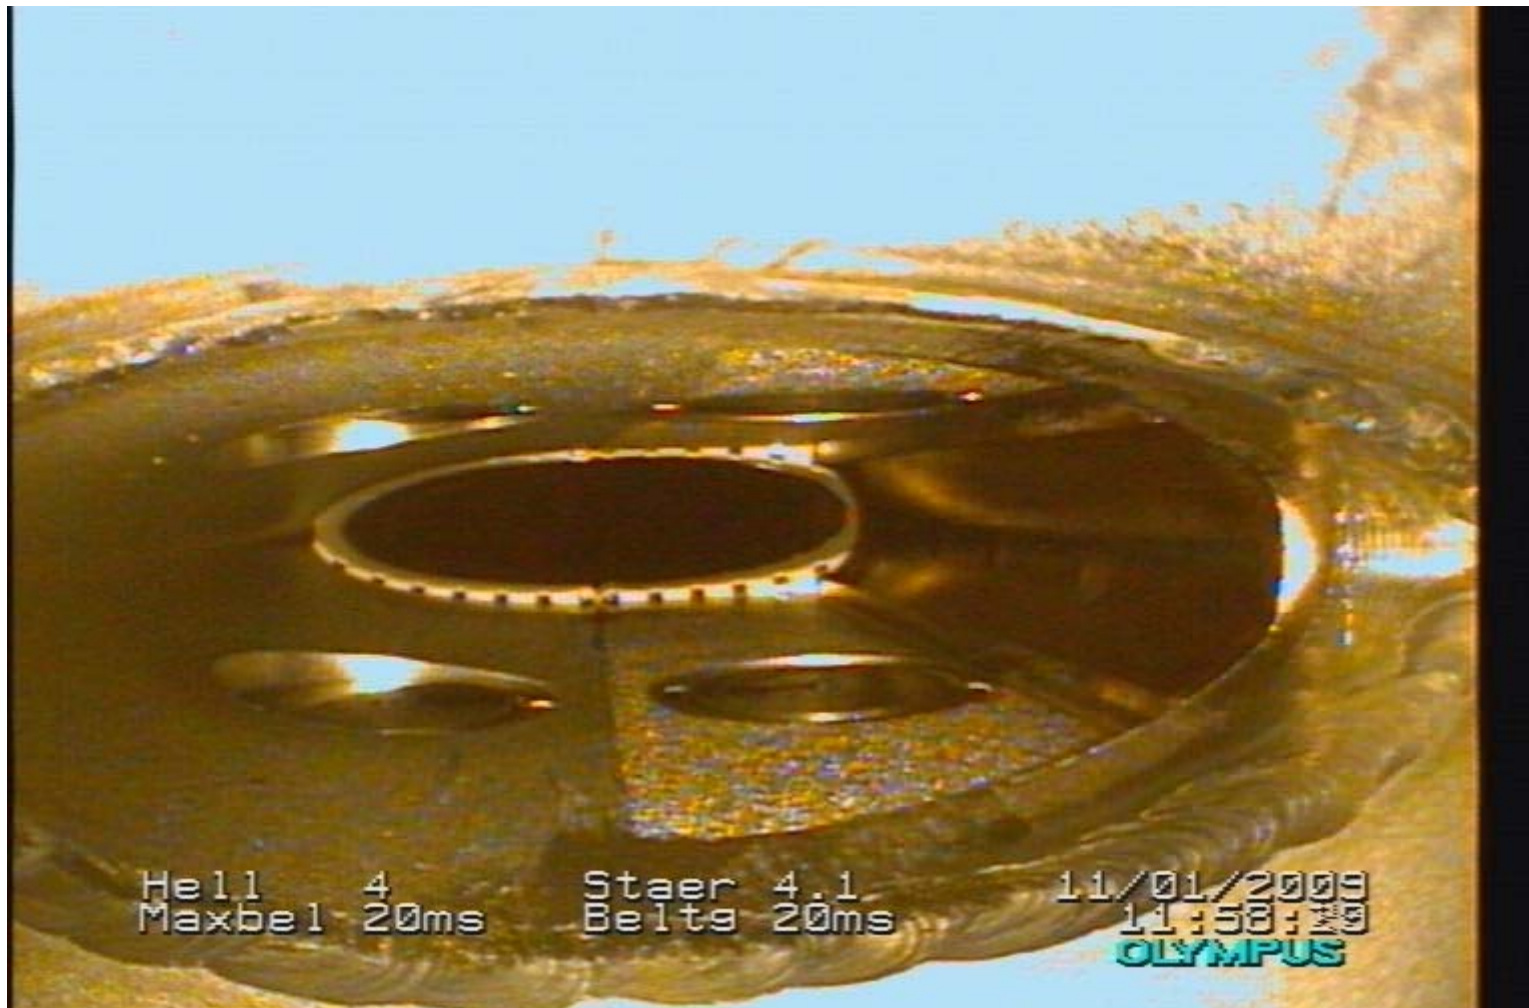
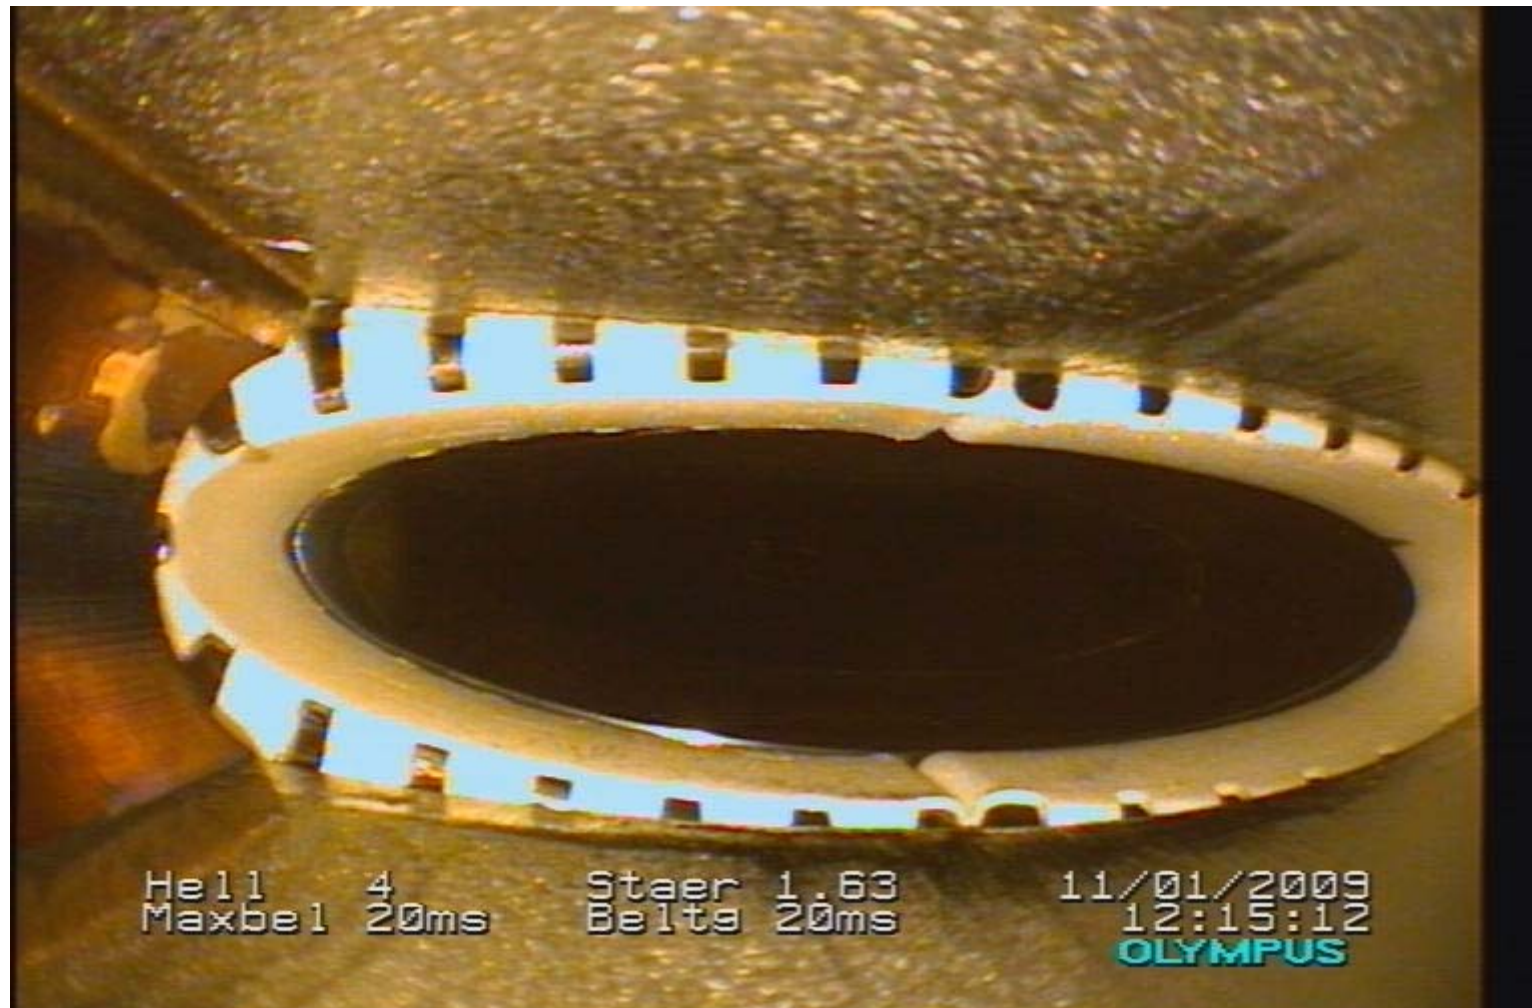
An earlier example: a too long ceramic in the single bunch gun (intended as a wall current monitor) charged up and the injection pass needed frequent readjustment
