IBBelle

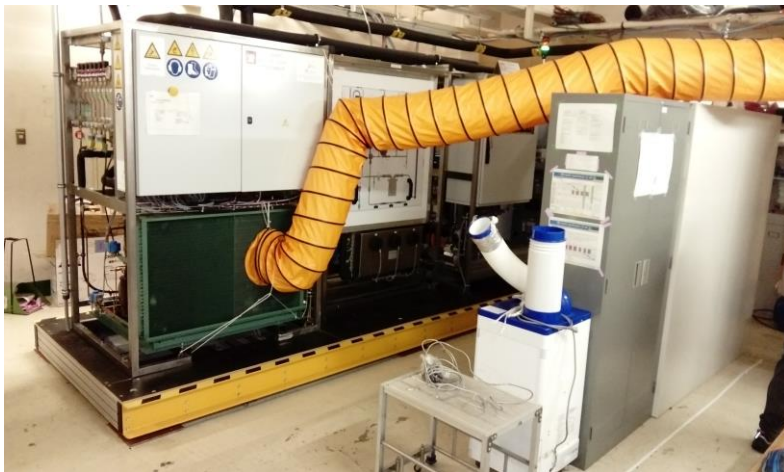
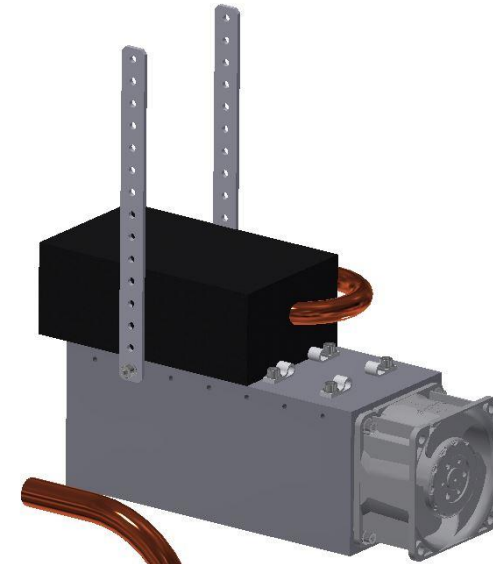
- ▶ R404a needs to be subcooled (below condensation/evaporation temperature) to avoid flash gas in TX valve, harmful for valve

- ▶ no subcooler
- ▶ ambient room temperature high (> 26°C during summer)
 - subcooling is very low in average 0,3 K
- ▶ horizontal receiver (vertical mounted would be better)

(Temporary) fixes:

- operate fan from air cooled condenser to increase heat discharge from liquid line by forced convection
- Increase condensation temperature from 26°C to 32°C (reduces chiller efficiency)
- Get cooler air from main hall to fan inlet
- Active subcooling

by heat pipe (simple, but did not work)
peltier cooler (ordered, to be installed)

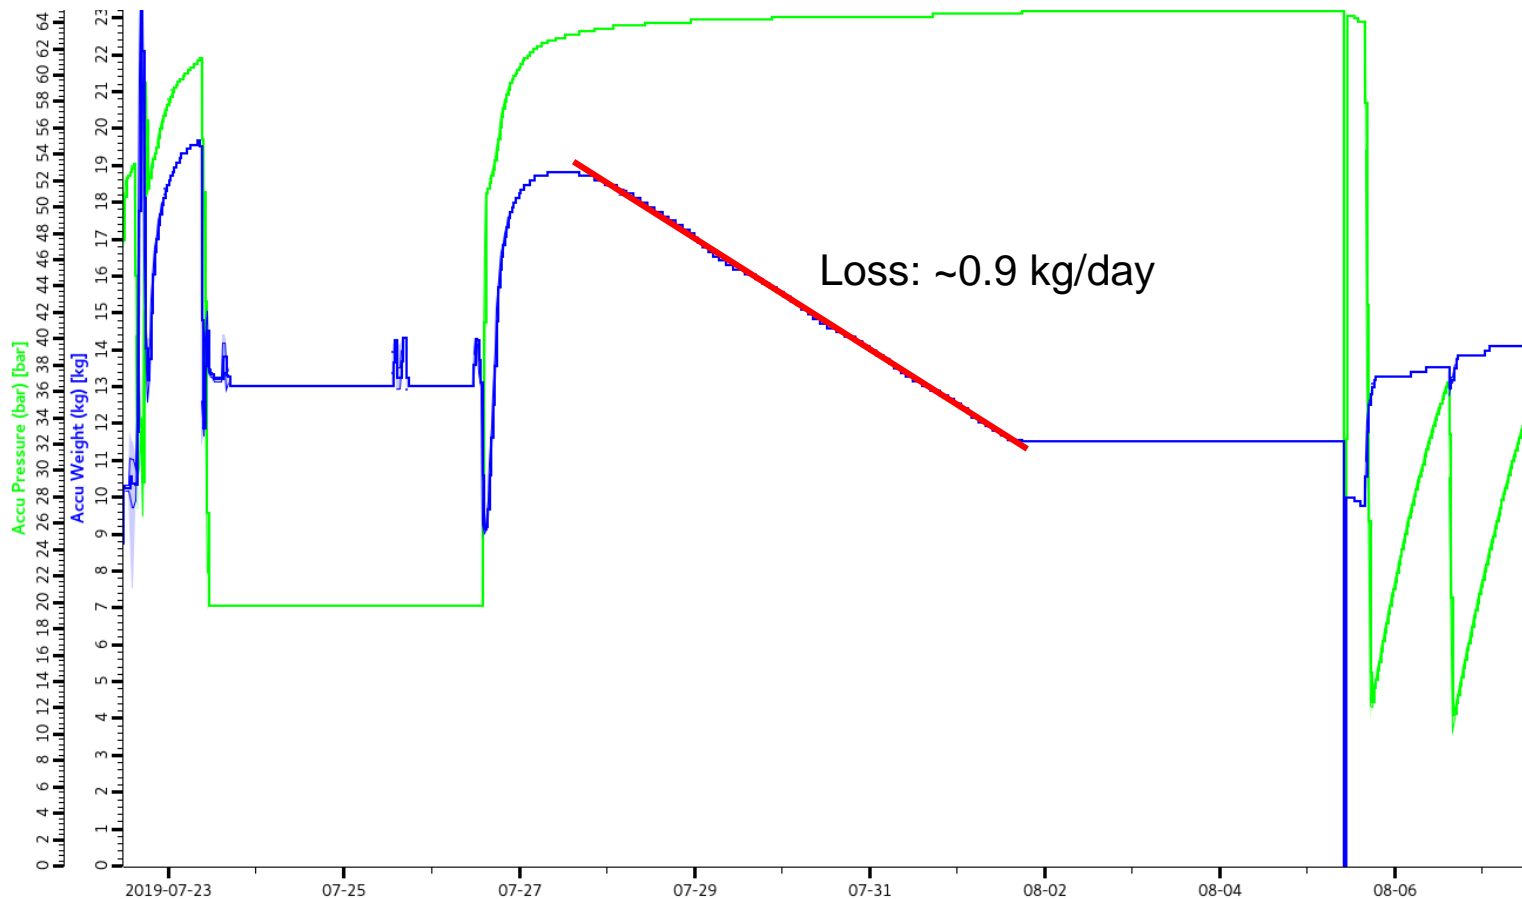
Maintenance

After maintenance IBelle was refilled, tested and left off (warm!)

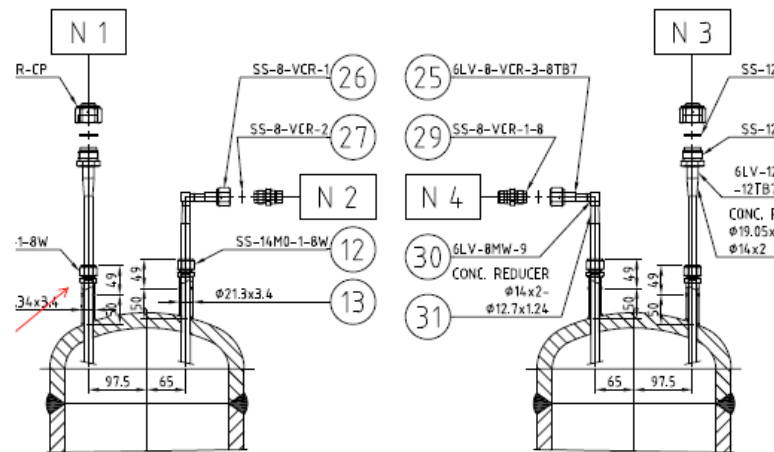
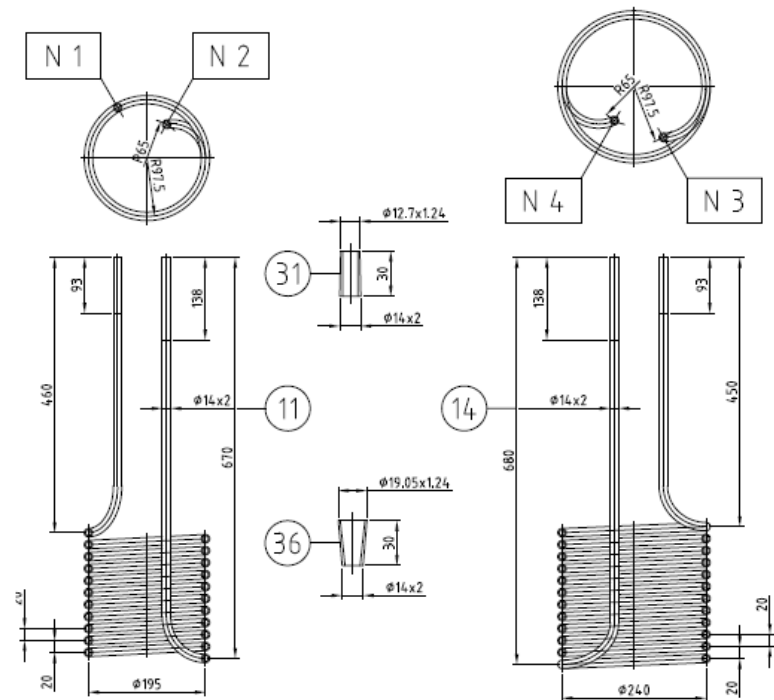
Accu

one leak confirmed: Feed through of R404a line of B unit to cooling coil in accumulator (which is not used)

Unfortunately this joint is difficult to fix.

Proper repair needs orbital welding (to be done by a company)
