Ladder Assembly

Series gluing of 11 ladders using
improved gluing procedure

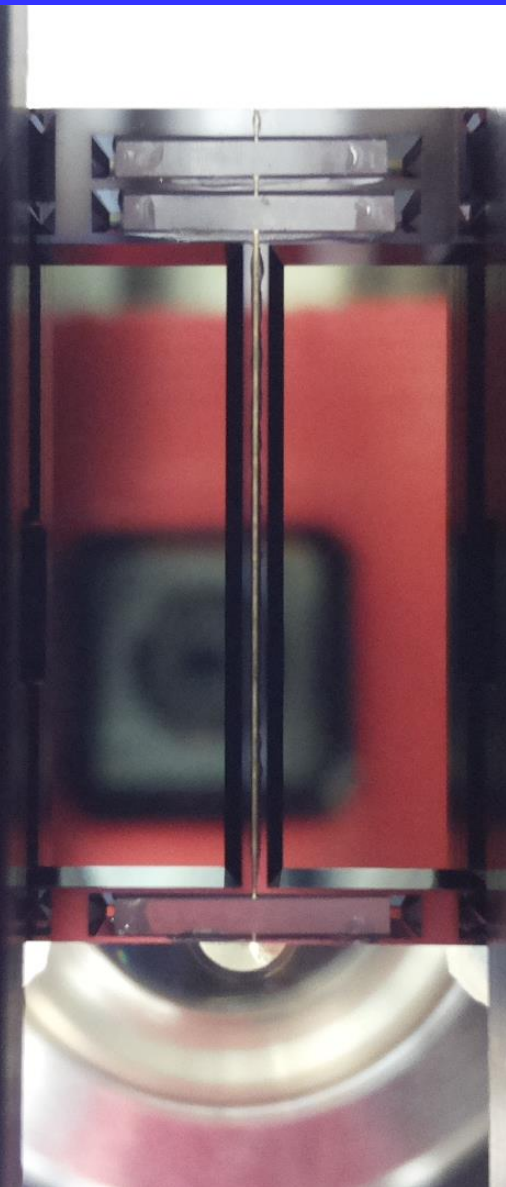
View of stiffeners right after insertion
Still possible to do (manual) corrections

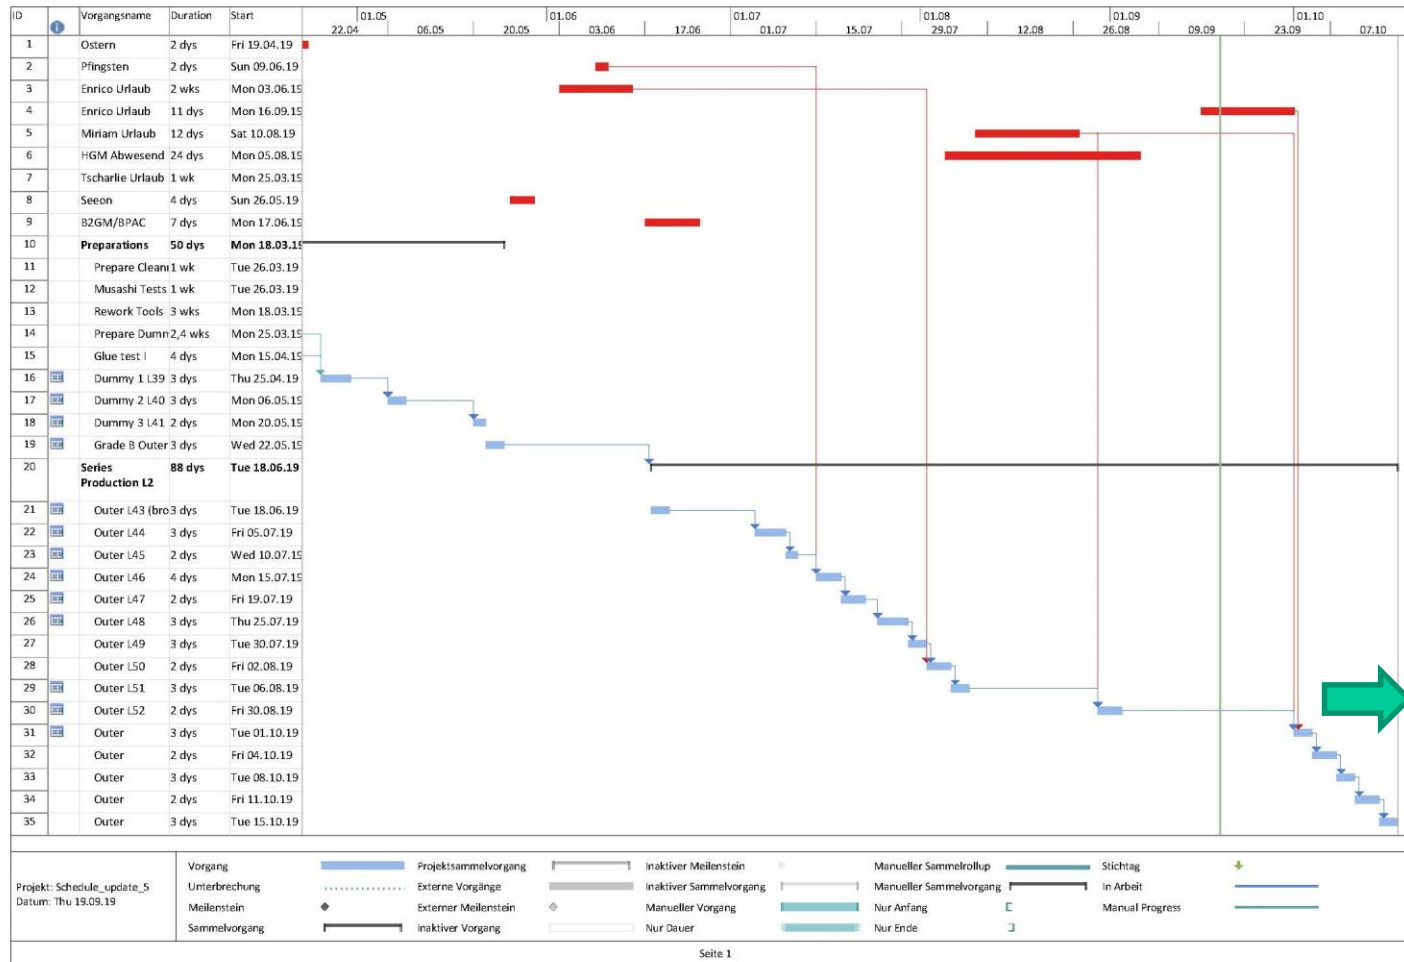
Ladders glued

#	Nr	fwd	bwd	grade	elec. Test	comment	
	1LK 42	W02 OF1	W03 OB1	B	ok		
	2LK 43	W09 OF1	W09 OB1	A	ok	cracked during inspection	
	3LK 44	W32 OF2	W32 OB2	A	ok		
	4LK 45	W33 OF1	W42_OB1	A	ok		
	5LK 46	W33 OF2	W46 OB2	A	ok		
	6LK 47	W46 OF1	W45 OB2	A	ok		
	7LK 48	W13 OF2	W46 OB1	A	ok		
	8LK 49	W08 OF2	W08 OB1	A	ok		
	9LK 50	W46 OF2	W08 OB2	A	ok		
	10LK 51	W45 OF1	W42 OB2	A	ok		
	11LK 52	W43 OF1	W33 OB1	A	ok

Run out of tested modules August 30.

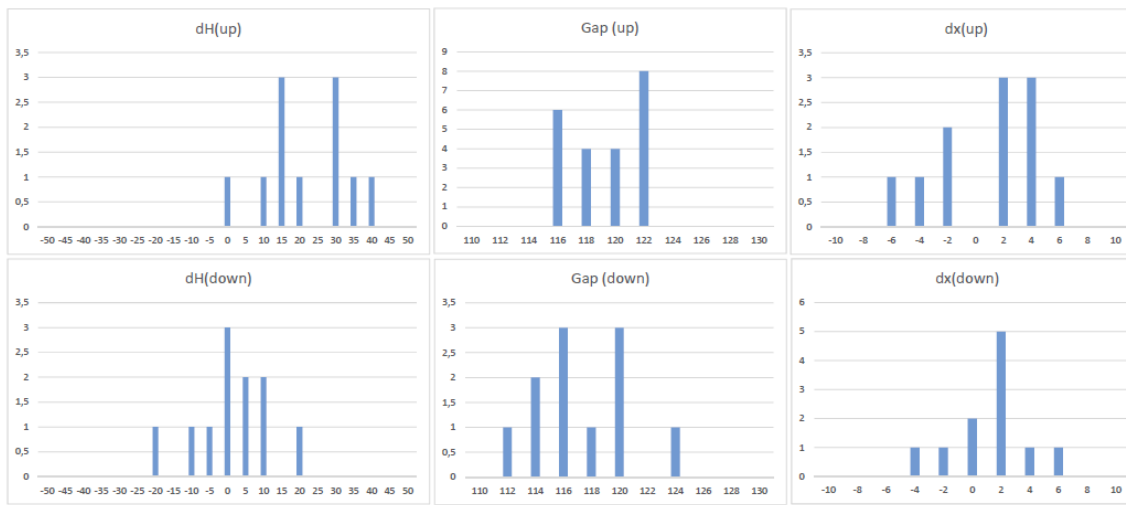
Alignment

dH (up)	dH(down)	gap(up)	gap(down)	dx(up)	dx(down)	
15,4	-6,2	115	114	5,7	4,7	
30,8	-0,5	116,8	117,5	2,8	1,7	
-4,9	-24,1	122	123,4	-3	-2,8	
8,3	-3,4	120,2	114,8	2,3	3,4	
13,8	0,8	114,2	111,9	0,2	0,3	
15	-4,3	119,7	115,4	0,7	0,1	
39	16,9	114,8	114,4	3,3	0,7	
27	6,2	119,8	113,6	-2,5	-1,3	
29,5	2,9	120,2	118,2	-6,1	-0,4	
25,5	8,9	116,9	118,1	0,7	0,4	
14,4	-13,3	121,8	119,2	-5,7	-5,6	
19,44	-1,46	118,31	116,41	-0,15	0,11	Mean
11,74	10,51	2,72	3,10	3,60	2,67	RMS

Up: at small balcony

Down: at wide balcony

All figures in μm
