SNS Operational Experience

J. Mammosser - on behalf of the SRF/Cryo
Groups

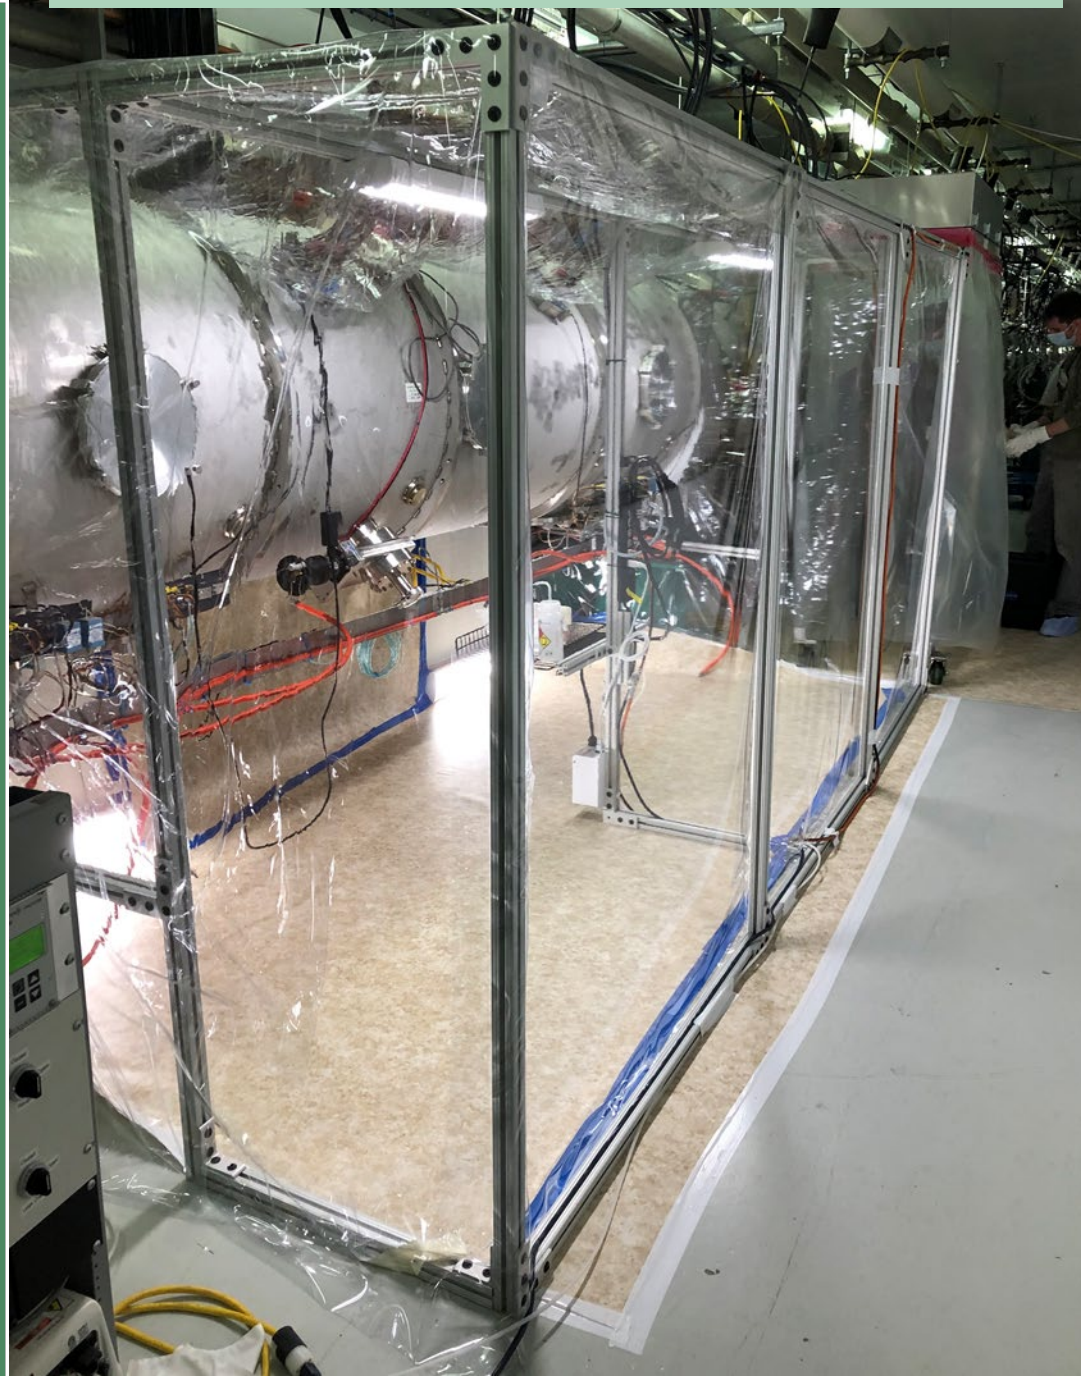
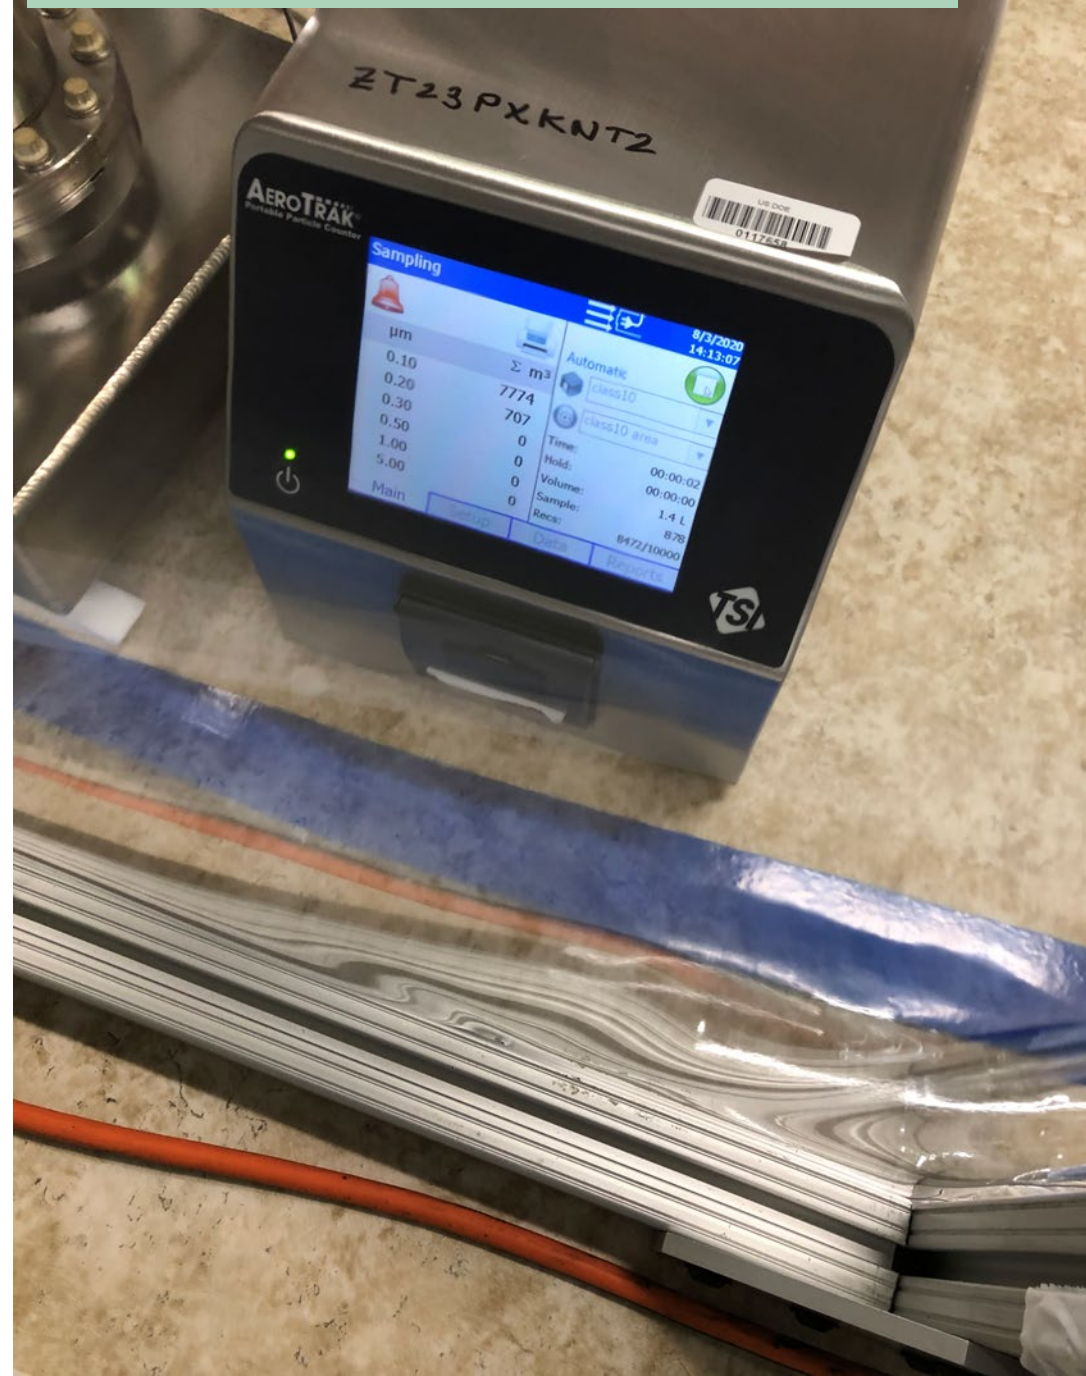
Clearroom Developed for Tunnel Repairs

Particle counting to Class 10

- Due to the recent increase of beamline maintenance activities, SNS developed methods for making beamline in-situ repairs in the tunnel
- During the August 2020 maintenance down we attempted replacing two FPC on CM21
 - A portable cleanroom was fabricated in-place and established ISO 4 conditions
 - Tooling was developed to remove and insert couplers
 - The process was successful and now has been applied during the December 2020 down on CM18
