WHAT CAN GO WRONG ...

SOME EXAMPLES

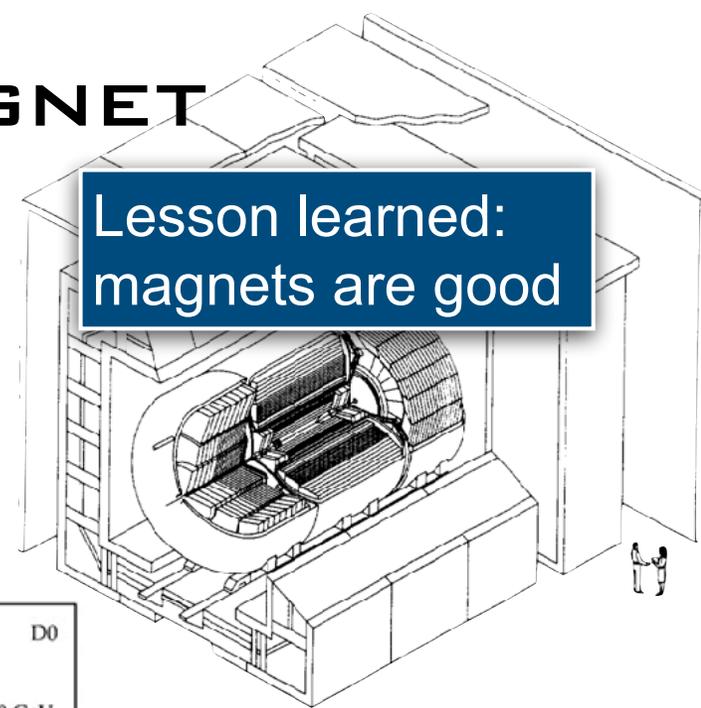
D0 WITHOUT INNER TRACKING MAGNET

- D0 Experiment at Tevatron constructed to study proton-antiproton collisions
- **Top quark discovery** in 1995 together with CDF experiment
- Original design for Run I: no magnet for tracking
 - “Focussing on parton jets for deciphering the underlying physics than emphasis on individual final particle after hadronisation”
 - Very compact tracking system
 - Uranium-liquid argon calorimeter for identification of electrons, photons, jets and muons
- Effect of low momentum charged particles greatly underestimated resulting in analysis difficulties.

Run II system included a silicon microstrip tracker and a scintillating-fibre tracker located within a 2 T solenoidal magnet.

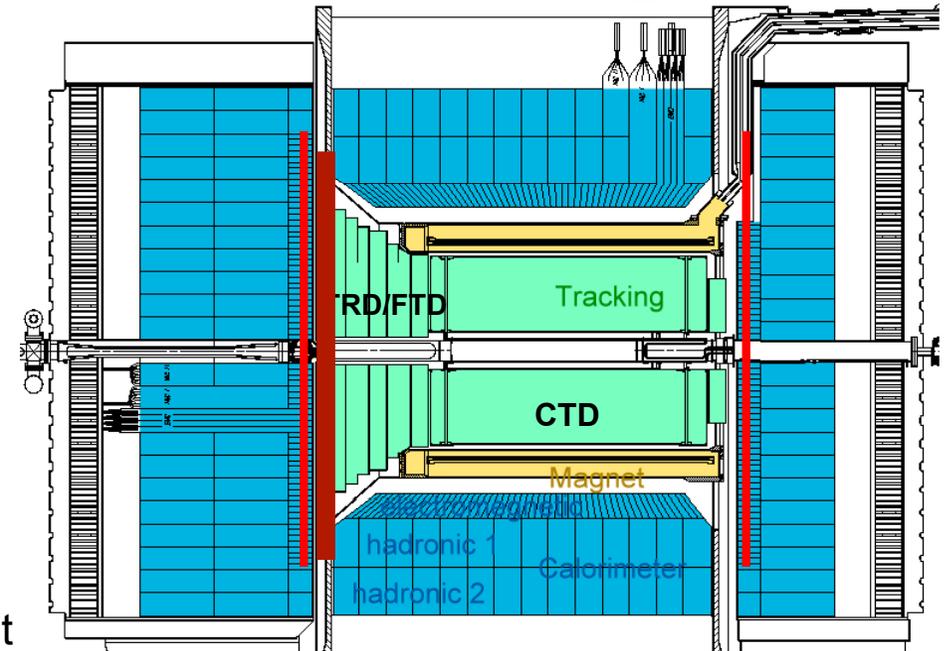
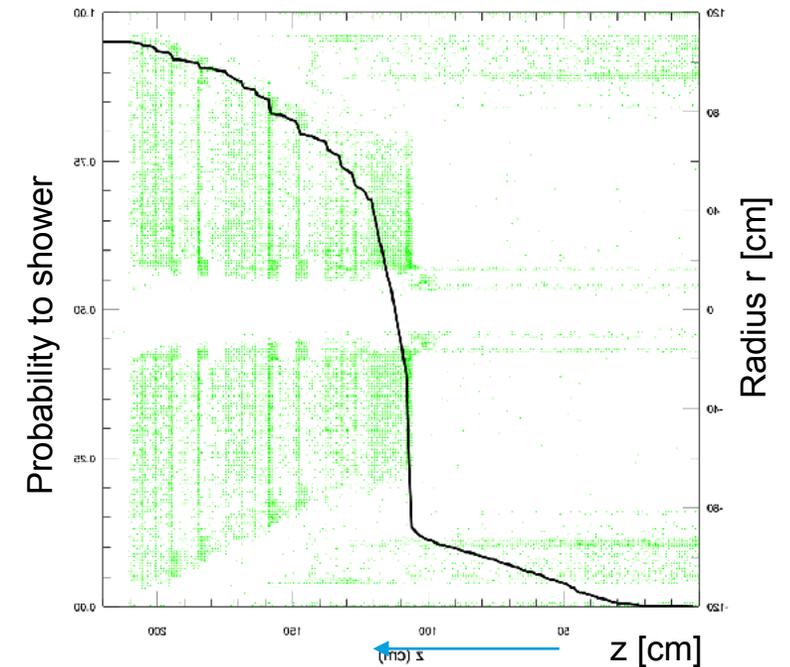
ZEUS TRD

- Zeus Transition Radiation detector for electron identification.
- Aim: h/e rejection ratio of about 10^{-2} for electron tracks embedded in jets (1 - 30 GeV/c).
- However - central tracking detector (wire chamber) had 2cm end-plate for wire fixation
 - Electrons 100% probability to shower and thus were not present in showers anymore
- Reason for mishap: no proper Monte Carlo simulation tools available at time of detector design
 - TRD used for Here Run I Replaced by Straw Tube Tracker for Run II

Lesson learned:
Monte Carlos simulations
should include everything

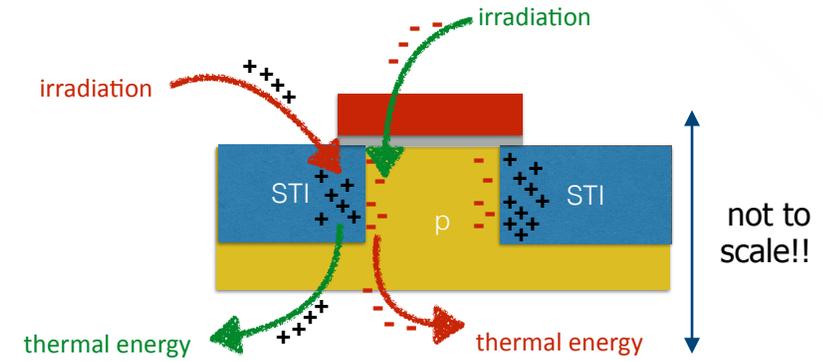
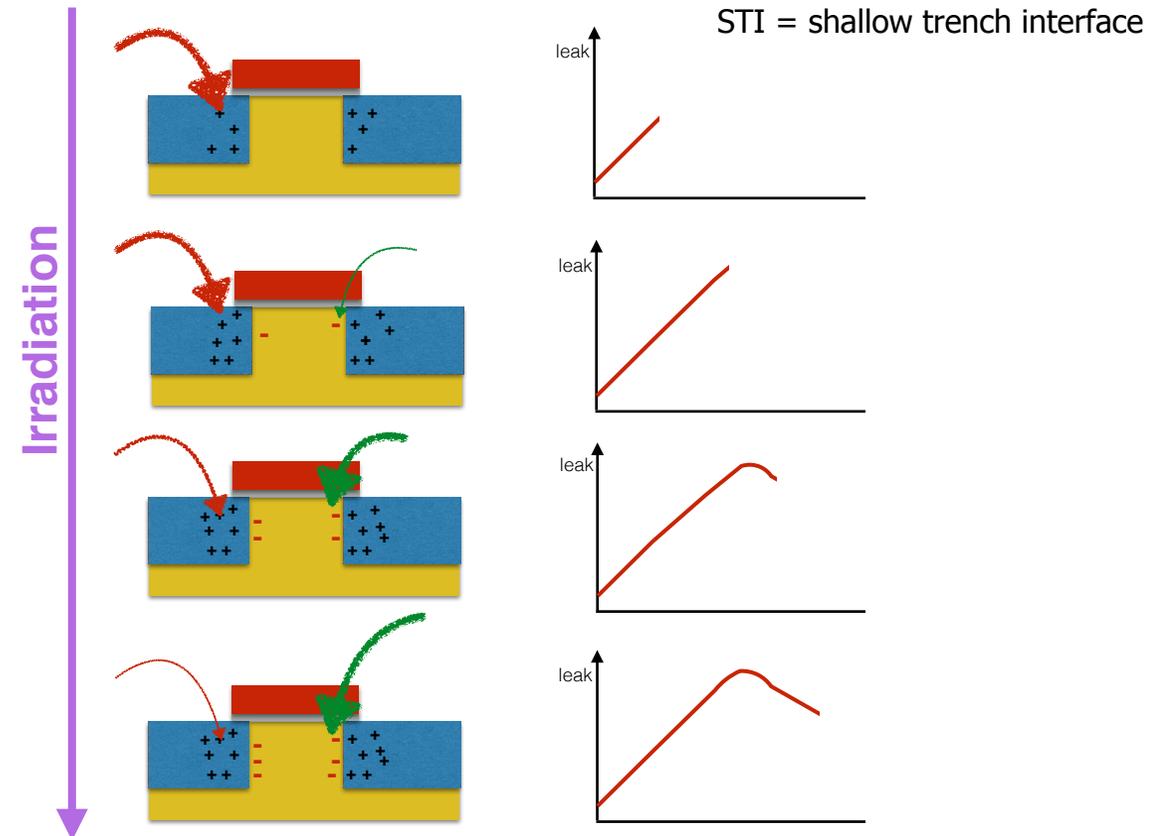
TID BUMP

Surface effects: Generation of charge traps due to ionizing energy loss (Total ionising dose, TID)
(main problem for electronics).

- The leakage current is the sum of different mechanisms involving:
 - the creation/trapping of charge (by radiation)
 - its passivation/de-trapping (by thermal excitation)
- These phenomena are dose rate and temperature dependent!
- Charge trapped in the STI oxide
 - +Q charge
 - Fast creation
 - Annealing already at T_{amb}
- Interface states at STI-Silicon interface
 - -Q for NMOS, +Q for PMOS
 - Slow creation
 - Annealing starts at 80-100C

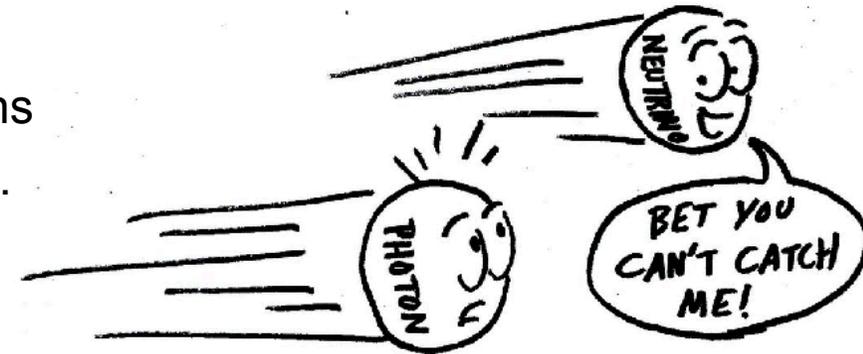
CABLE PROBLEM WITH PRESS COVERAGE

- Oscillation Project with Emulsion-tRacking Apparatus — **OPERA**: instrument for detecting tau neutrinos from muon neutrino oscillations
- In 2011 they observed **neutrinos** appearing to travel faster than light.
 - Very controversial paper also within collaboration

- Kink from a GPS receiver to OPERA master clock was loose
 - Increased the delay through the fibre resulting in decreasing the reported flight time of the neutrinos by 73 ns,
 - making them seem faster than light.

After finding the problem, the difference between the measured and expected arrival time of neutrinos was approximately 6.5 ± 15 ns.
