# Successes to rework CBM-STS detector ladders and modules

GSI, for the MT annual meeting

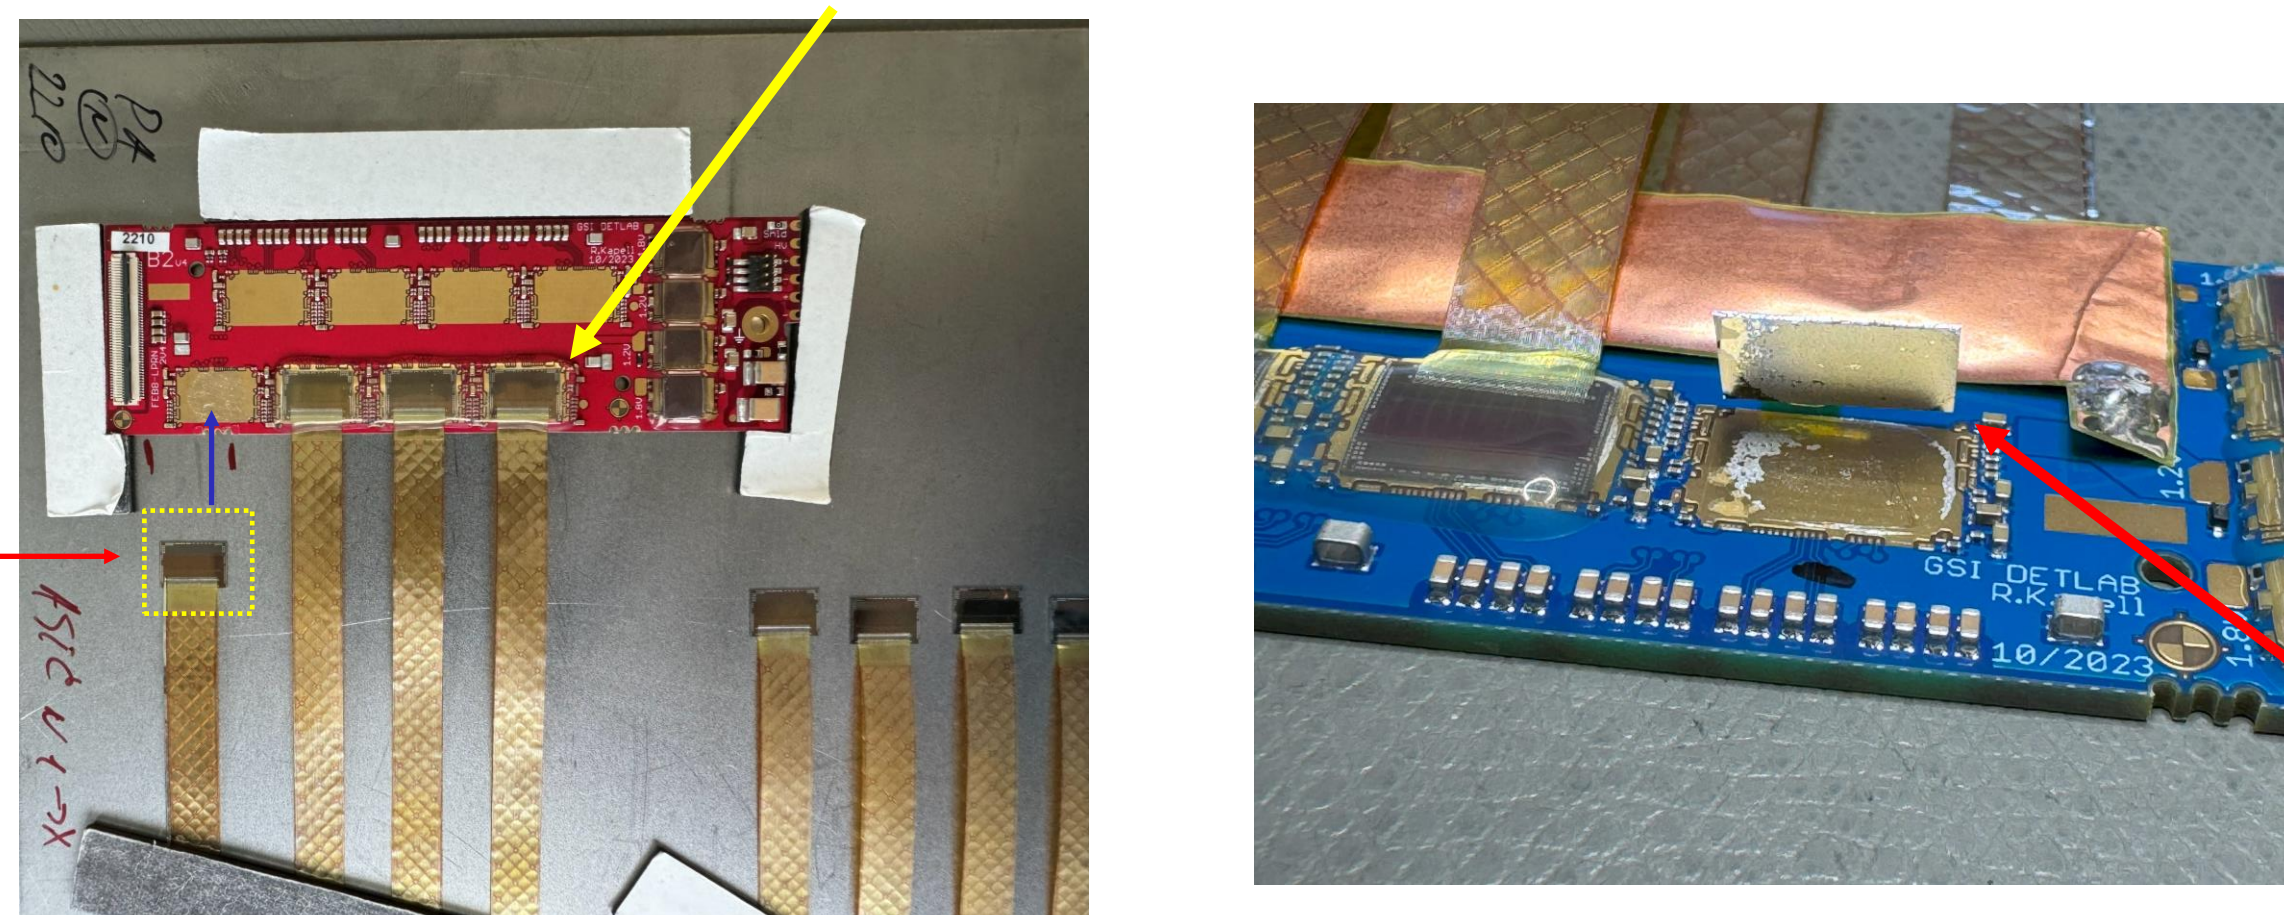
The LDO and readout chips are wire-bonded on the PCB.

The spare chip cable must be installed in a clean pad, replacing the damaged one
