1.3 GHz 9-cell cavity T-mapping and surface inspection results at LANL

**Tsuyoshi Tajima, A. Canabal, G. Eremeev, A. Bhatti,
R. Roybal, F. Krawczyk, J. Sedillo, P. Chacon**

TTC meeting, New Delhi, India, 20-23 October 2008

AES-03 cavity inspection results

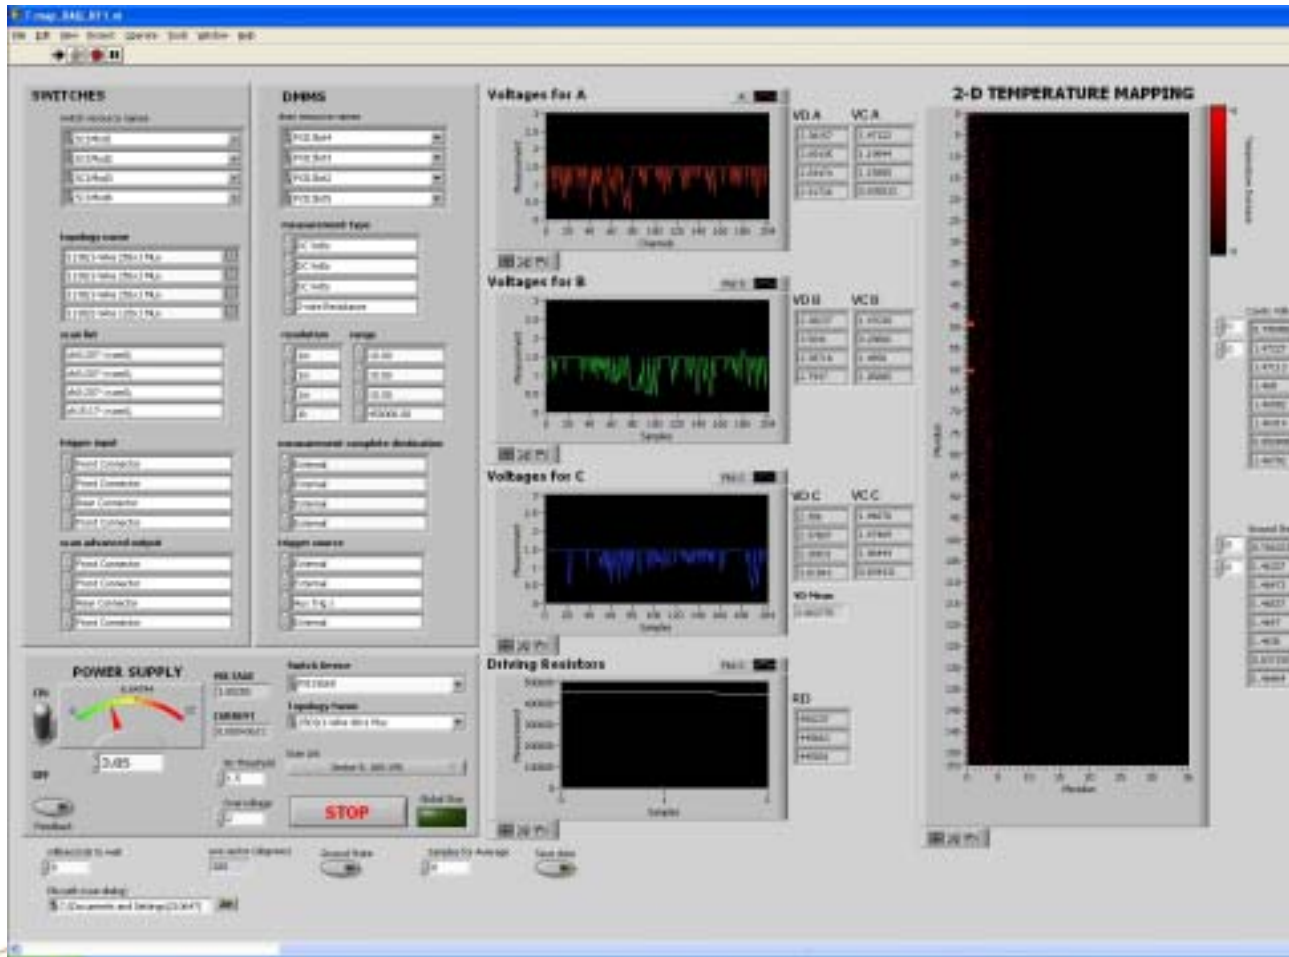
Screen shot of the T-mapping program

- The first 2 tests were carried out in June 2008. The second test was done without breaking vacuum, but with thermal cycle. We did not have time to disassemble and re-apply grease to the sensors.
- Tests summary
 - Some heating spots were observed.
 - Only sector-by-sector 2D maps were obtained.
 - Four sectors out of 9 were not tested due to some disconnection problem.
 - A noise problem prevented full mapping.

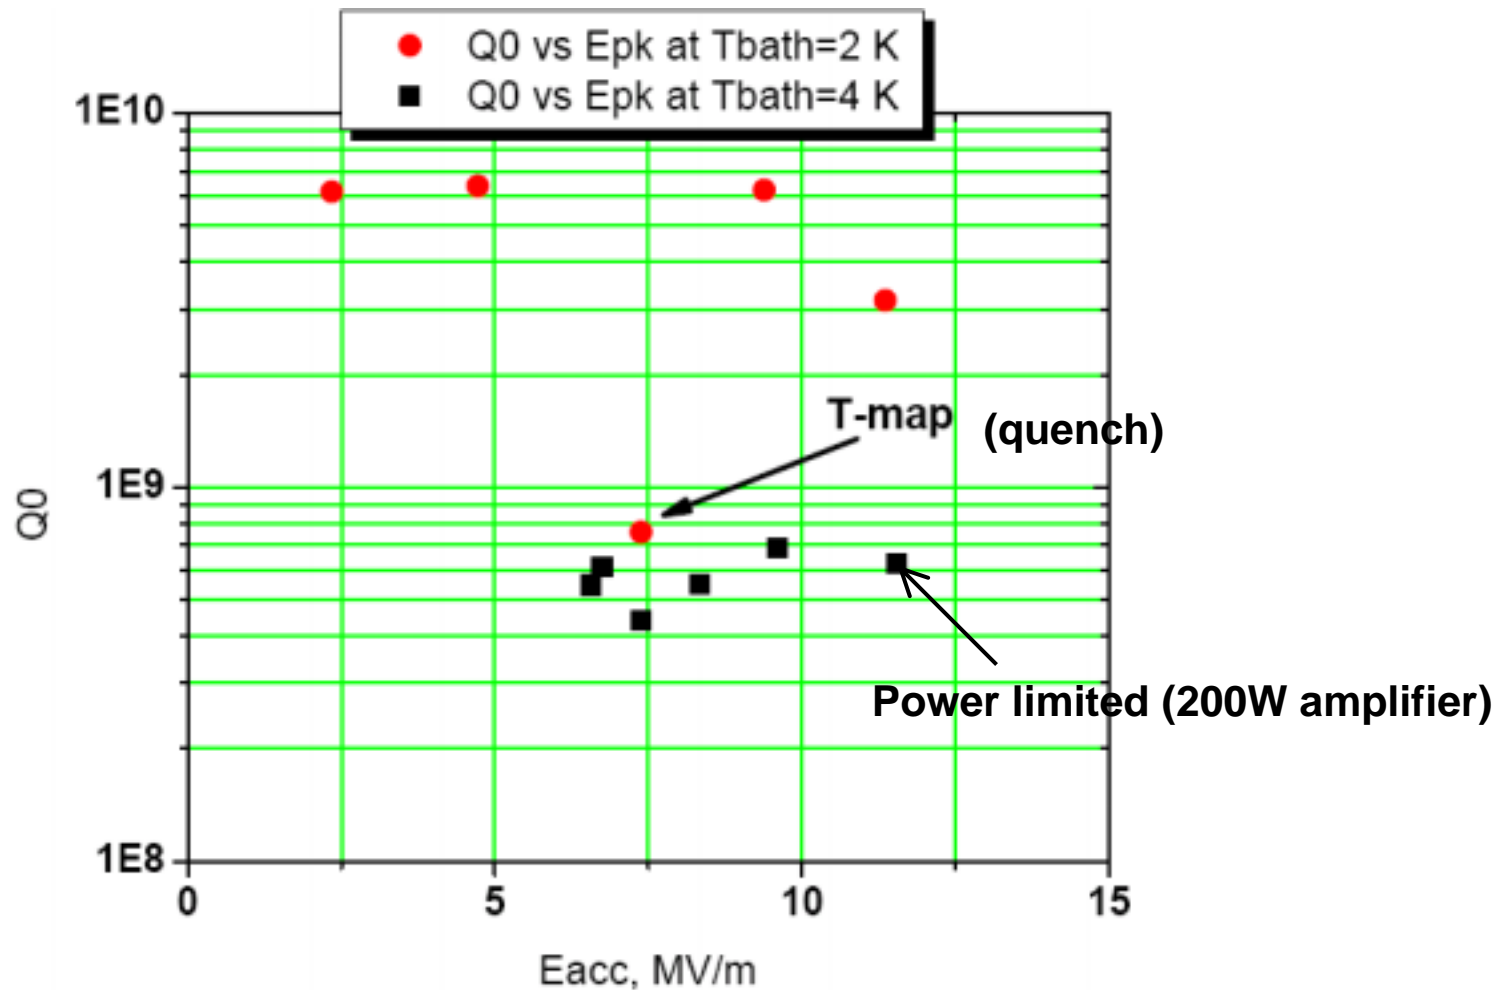
4K data and data at ~2K with part of top cell above liquid (E_{acc} might be wrong)

We observed one hot spot. (only 0°-110° were monitored.)

- Cell 2 top half at 50° showed heating
- Only sector 2 (40°-70°) data are shown on the right map.
- Unfortunately, the T-map for 120°-350° range where we found most of the heating in the June 2008 tests did not work possibly due to disconnects at the connectors in the cryostat.
