TTC Cornell Talks

1-cell test results from new vendor
cavities

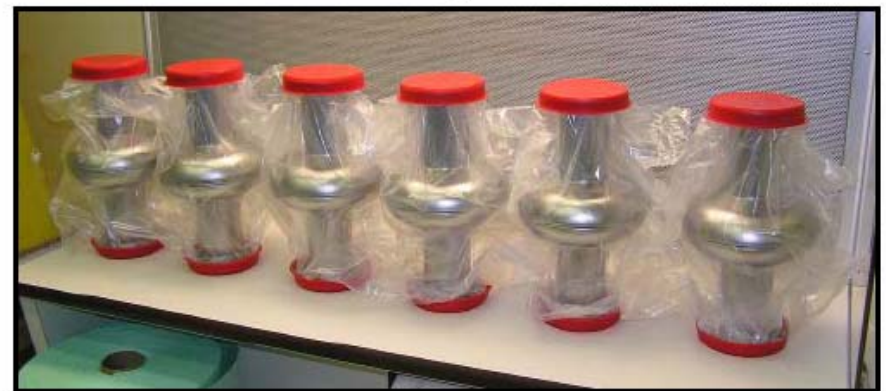
Figure 9: Six, Single-Cell ILC Cavities

4/5 Single Cells Tested (#6 to be tested) No Quench, $E_{acc} > 25$ MV/m

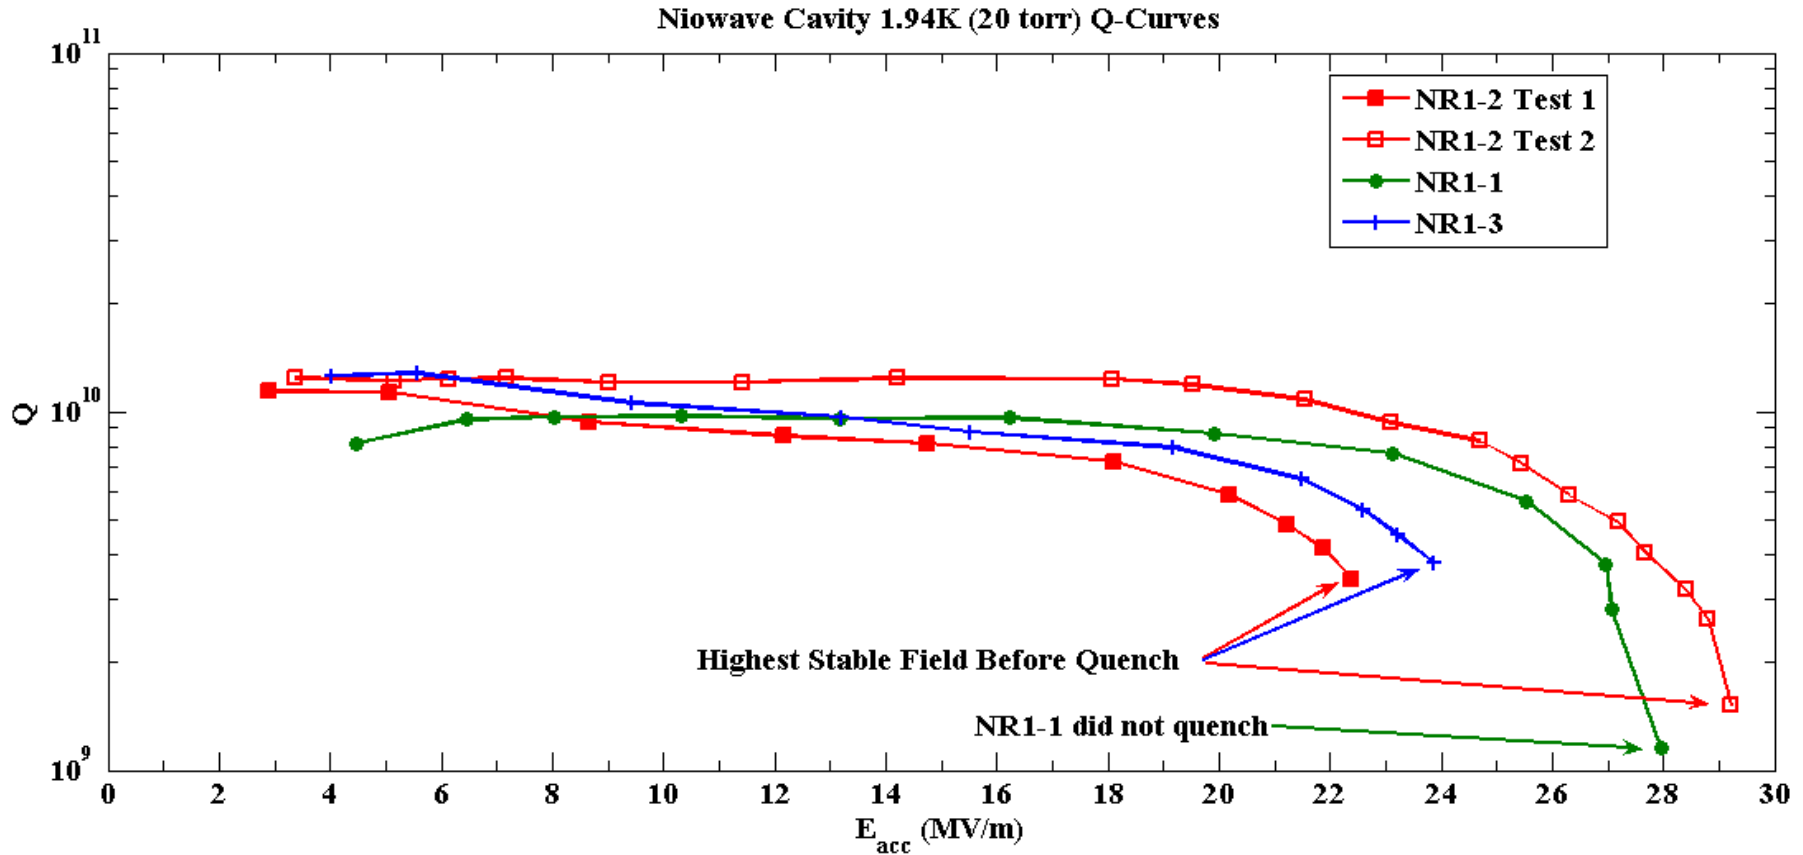
Cavities (limit)

1 (Q-slope), 2 (Qu), 2' (Qu), 3 (Qu)

- Cavity 1, BCP 75 μm after fabrication
 - Q-slope to 28 MV/m, no quench, return to FNAL
- Cavity 2, BCP 60 μm after fabrication
 - Q-slope to 22 MV/m, then quench

- Quench location identified with 2nd sound
 - optical microscopy with Questar shows bump (s) –see figure
 - (but not on weld)
- Cavity 2' BCP Total 180 μm

- Q-slope to 29 MV/m, then quench
 - Same location, only one bump remaining
- Cavity 3, BCP 60 mm
 - Q-slope to 24 MV/m, then quench
 - Quench location identified with 2nd sound
