Recent update on H0 trigger

HO Trigger Weekly Meeting

Pooja Saxena

June 1, 2017

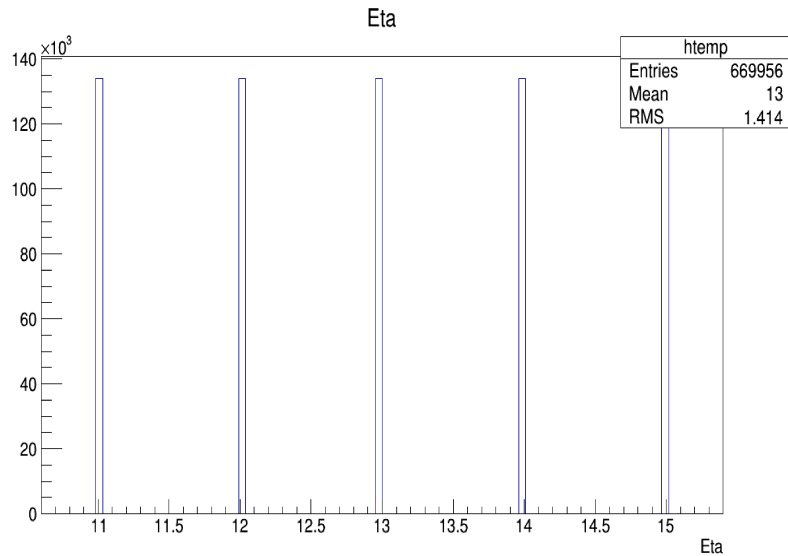
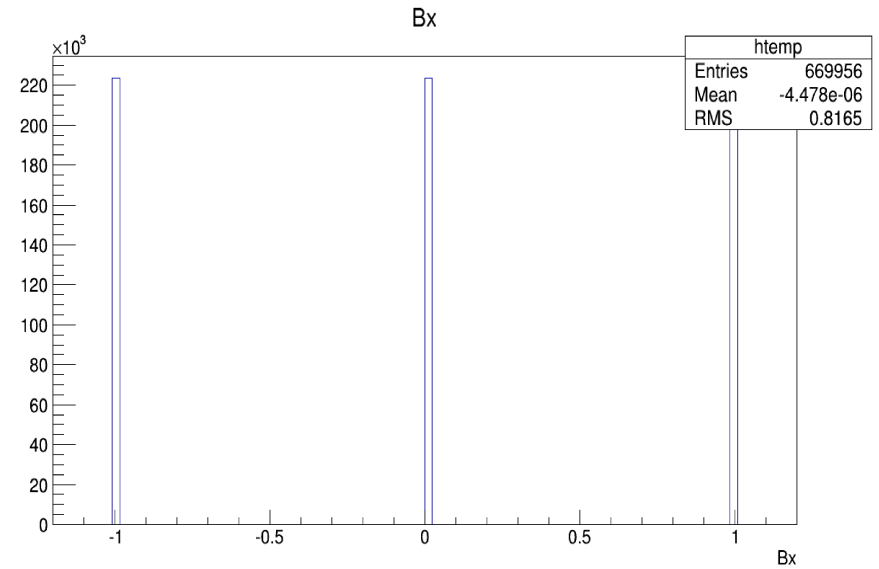
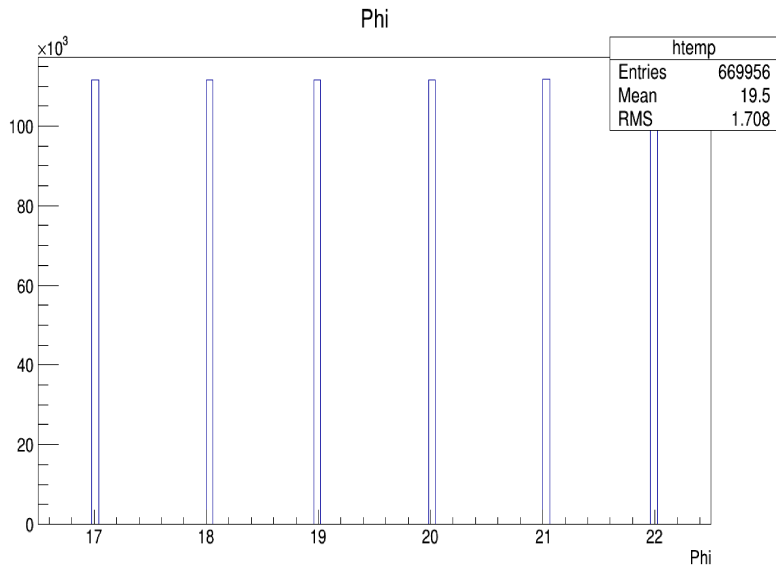
TwinMUX HO Unpacker

- Eta, phi & BX distribution as expected

- Setup the unpacker from CMSSW_808 to CMSSW_900
 - Many changes took place from 808 → 900
- Analyzed following dataset with unpacker:
 - Run: Run2017A (run no:295463)
 - Dataset: /ZeroBias
 - Unpack only YB2/S04

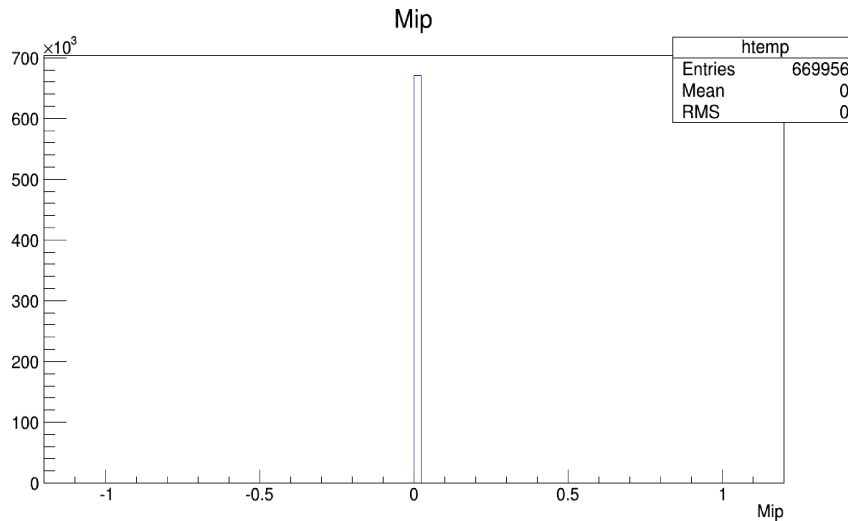
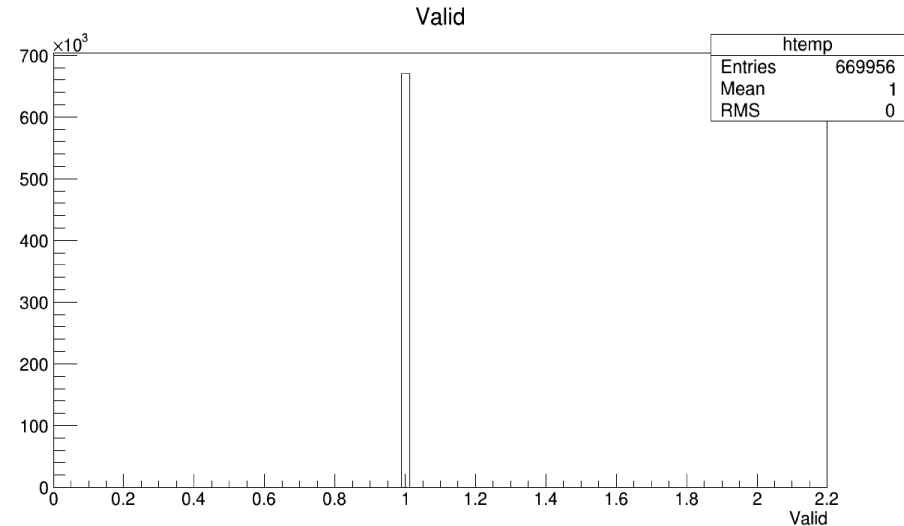
TwinMUX HO Unpacker

- As readout delay was off, good hits were not expected, might explain the distribution of mip.
- Also, as MIP is always 0, valid is always set to 1.
 - Analyzing more into it..

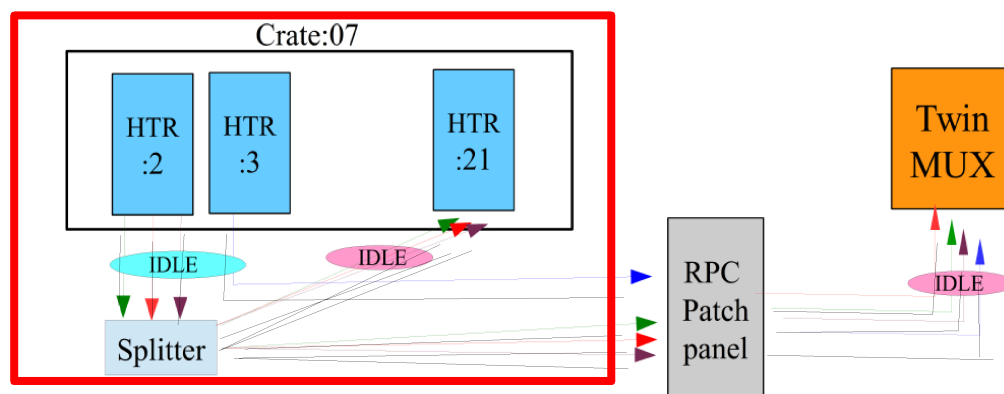
- Followed from modified htr.cc with debugging feature by Drew, we did tests with the splitted signals on HCAL side on May 5^[1]
 - > **Summary:** Everything looks OK and oSLB data was perfectly synchronized over the 3 fibers from oSLB in slot:2
