EUROPEAN
SPALLATION
SOURCE

Current Status of MicroTCA at ESS

PRESENTED BY FAYE CHICKEN

2024-12-10

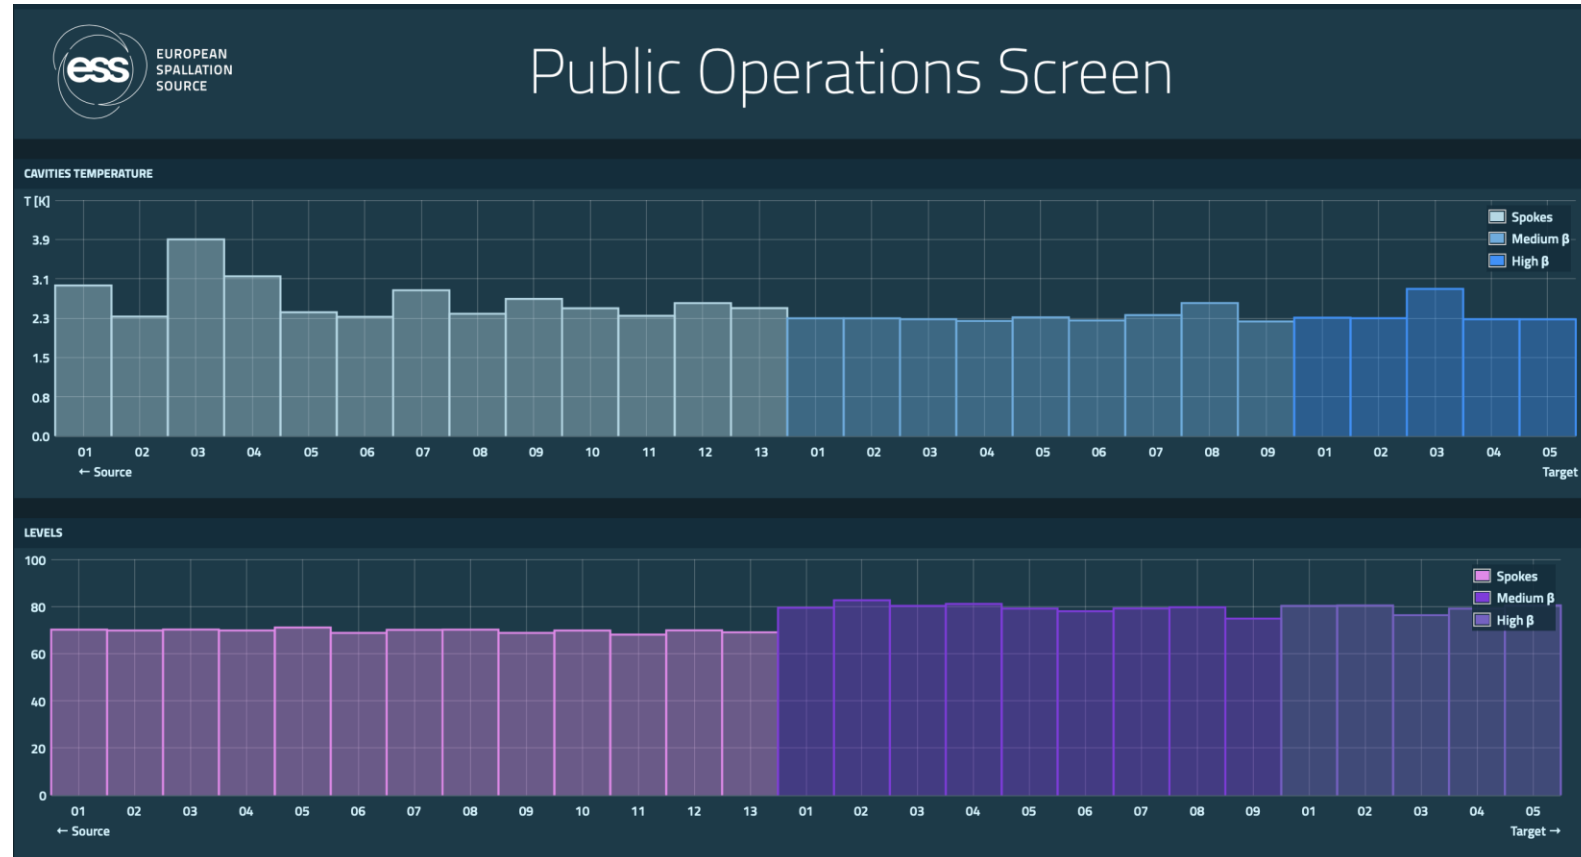
Current Status of ESS

- Currently preparing for commissioning of the accelerator to the beam dump
- Cool down of the cryo modules to 4K, and to continue ready for RF conditioning at 2K
- First Beam on Target expected late 2025
- Work on instruments continues, with first neutrons expected in 2026
