SIS8300L Design Status

Frank Ludwig – DESY for the LLRF Team

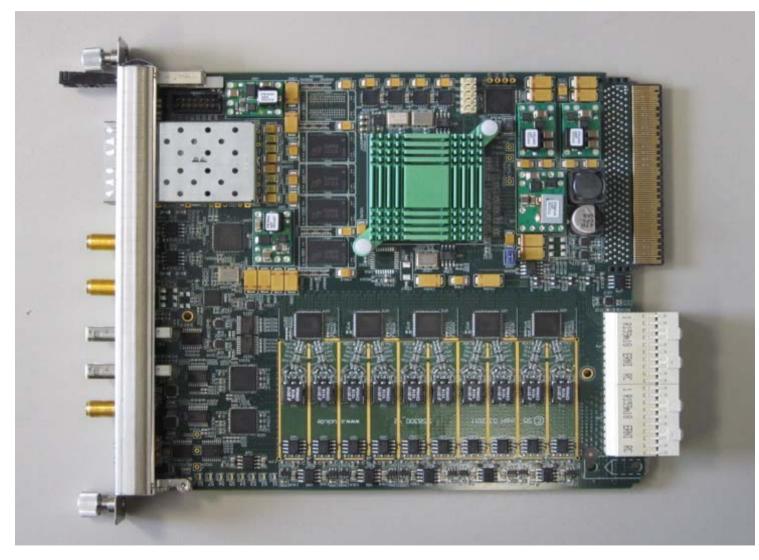
Starting Point - SIS8300_V2

(1) FPGA and RAM ----

FPGA has to be changed to type Xilinx Virtex 6 VLX130, 70% done (more DSP slices, 3Gbps-> 6GBps link, compatible to uTC V7)

RAM has to be changed to DDR3 type 5x16 chips (Nanya NT5CB256M16BP-CG), 70% done

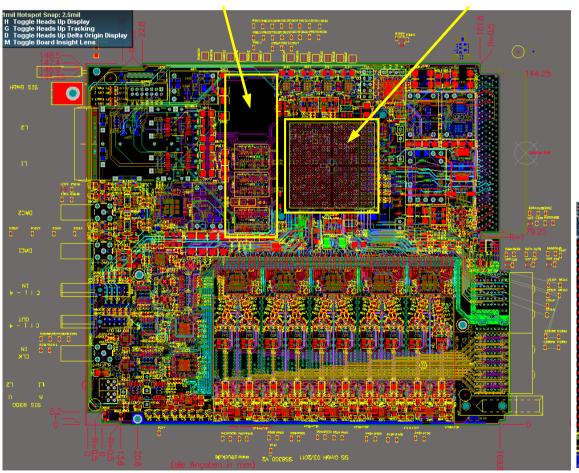
3Gbps -> 6Gbps (via feed throughs recommended from Xilinx) needs space

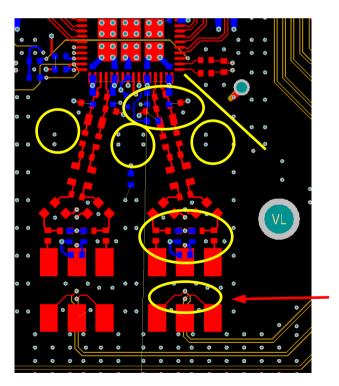
(2) Improving CMR ----- (FL, 18.04.12)

√ - Replace 10x AC input transformer T41...T61 to TC1-1T+ (mini-circuits), no universal footprint (improved CMR by >10dB due to better imbalance), primary middle side not connected to GND

√ - CLK shielded with more vias (yellow marked)

X - Improve differential signal routing symmetries (yellow marked)

can not rearranged because of compatibility to Z3 pin assignment

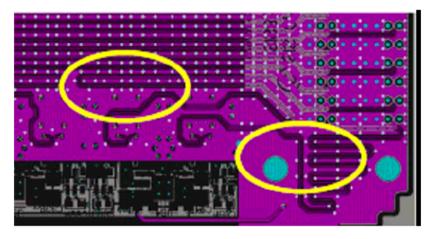
(3) Remove DC-length compensation ----- (FL, 18.04.12)

- DC channel support stays, but all length compensation can be removed.

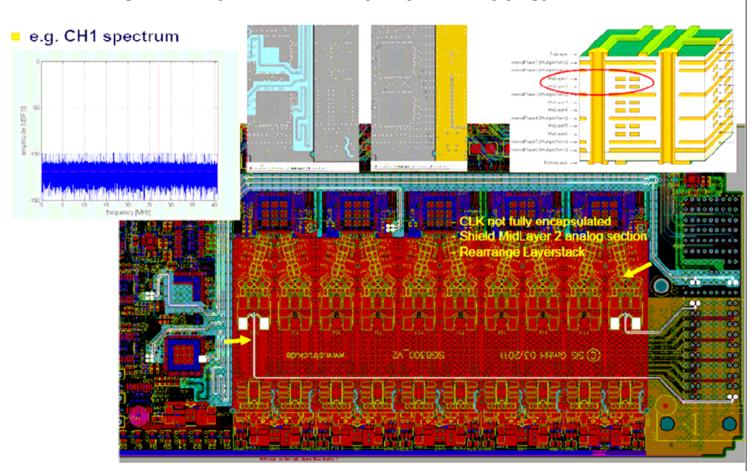
(5) (CLK crosstalk on channel 0,1,9) ---- is not proven by measurements ----- (FL, 18.04.12)

- CLK has to be fully encapsulated
 - Shield Midlayer 2 analog section or layerstack rearrangement
 - Shield Midlayer 1 analog section within split plane using polygones

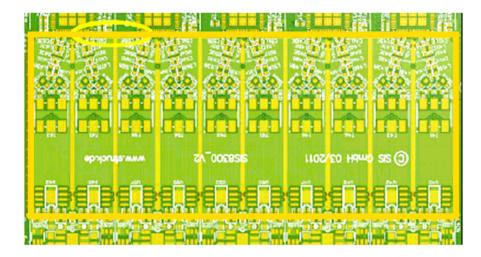
(6) Reduce Transformer channel crosstalk ----- (FL, 18.04.12)

- Wider solder stop and fixing wires for shielding on top
- Complete frame for solderstop timplate housing (assembly option)

lack of space on the top side of the AMC board

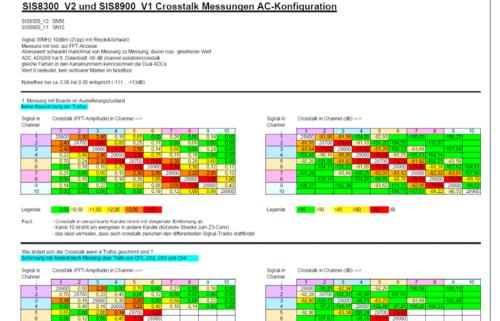
... courtesy of A.Grüttner (Struck)

Transformer to be shielded or bridged!

- bei geschirmten Trafos ergibt sich zwischen benachbarten ungeraden Kanälen ein Crosstalk von ca. -82..-83dB

Crosstalk dominated by CHx coupling via LO in DWC.

bei geschirmten Trafos ergibt sich zwischen benachbarten geraden Kanälen ein Crosstalk von ≻95dB (kleiner als ADC channel/isiotation crosstalk

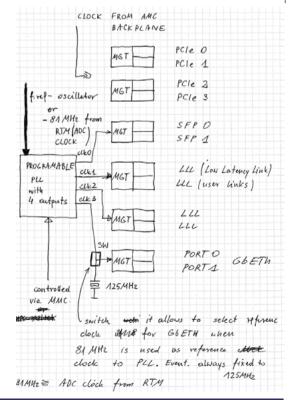
S15338 Functional Block Diagram

There will be boards based on Virtex 5,6 and 7, so we need flexibility to be able to set a different link speed. This is valid for SFPs and P2P (LLL) links. Means clock divider or switchable oscillators have to be used.

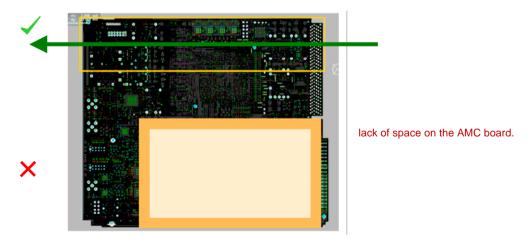
- Add more Multilayer Vias in the marked zone (top box) for bypassing Chassis to GND distortions from the ADC signal zone. Digital back currents will flow back more on top side.
