#### **RFD Cavity Processing Update**

Paolo Berrutti – Fermilab

TTC meeting, Riken Nishina Center – June 28th 2018

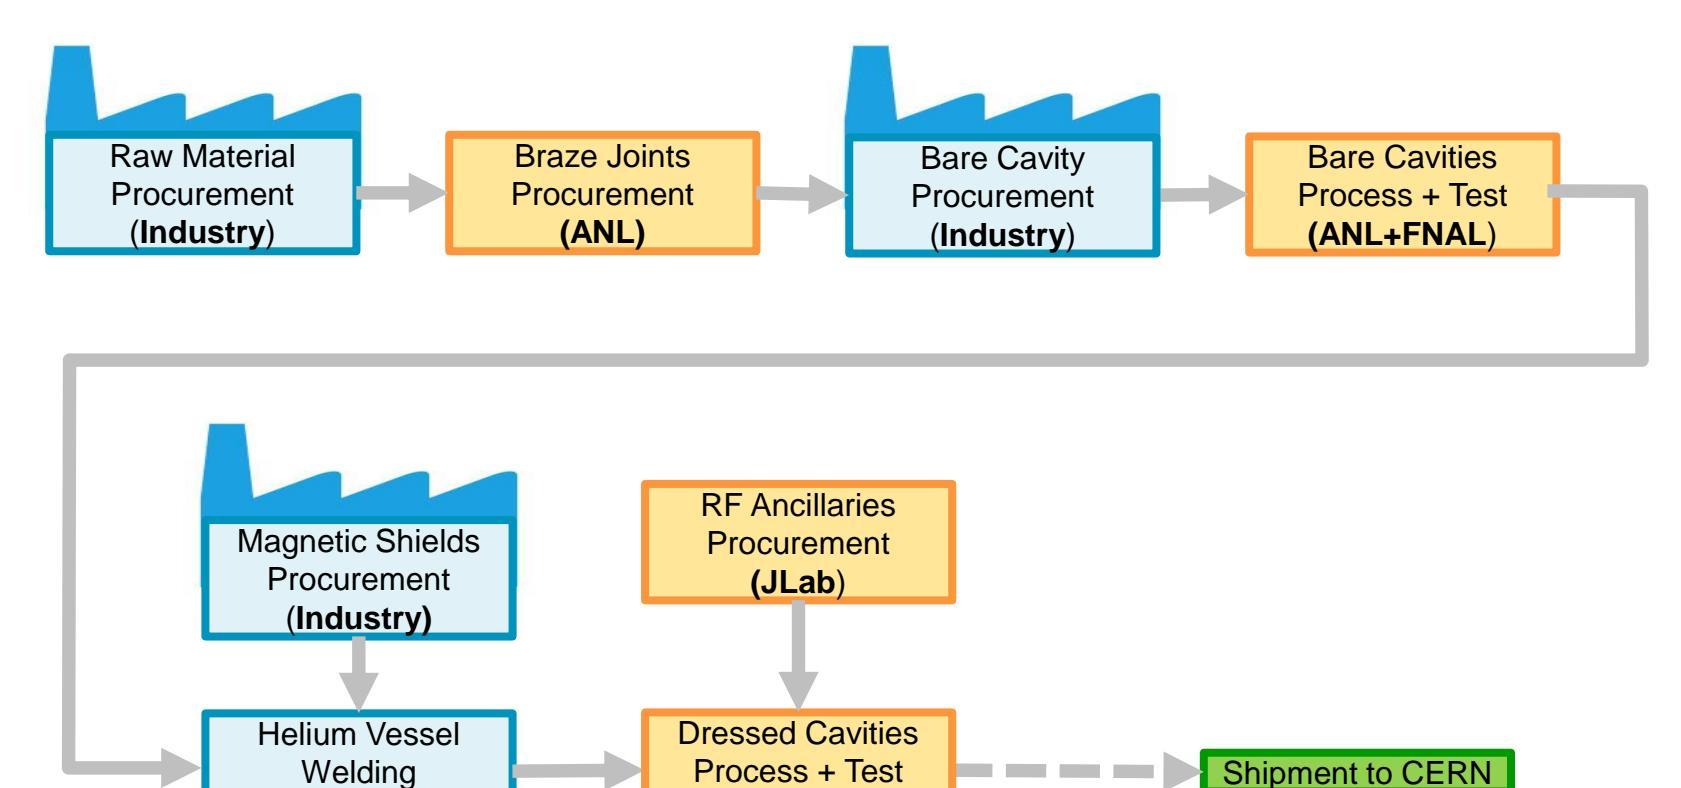
### **Fabrication and Testing Plan**

- Bare cavities procurement in industry
- Processing/Testing in laboratories (ANL and FNAL)
- Centralized management at Fermilab (Issue PO's, Perform QC)

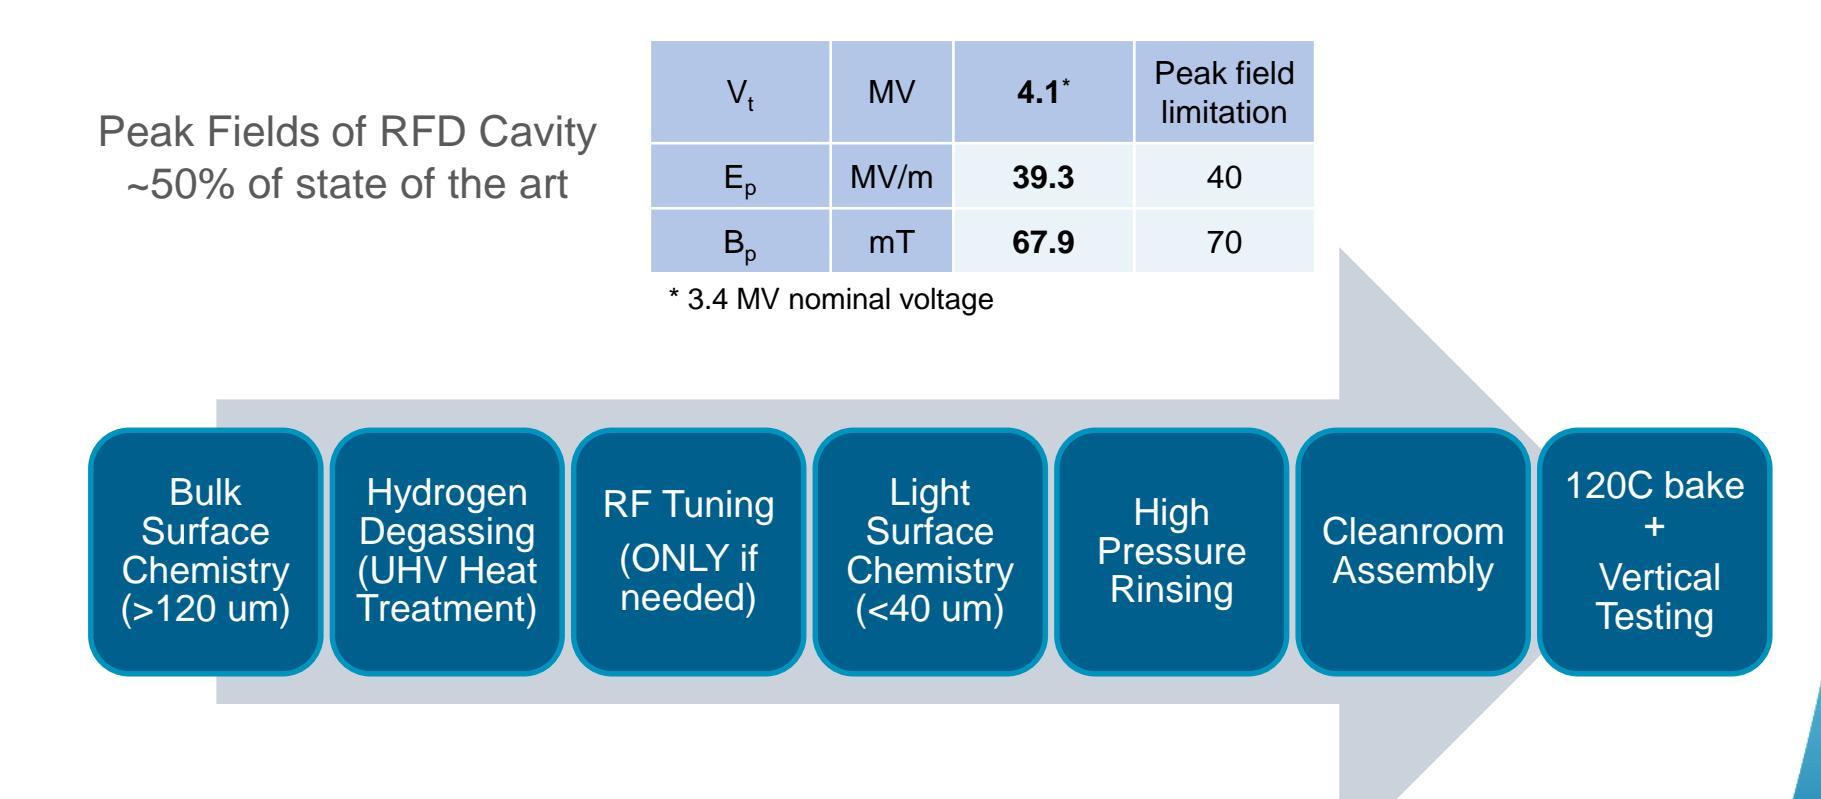
#### **Bare Cavities Processing and Testing Plan**

- Buffered chemical polishing based SRF cavity processing plan
  - Long history for complex geometries not suitable to electropolishing
- Standard SRF Cavity Cleanroom and Heat Treatment Techniques adapted to RFD geometry
