PXD PatchPanel Overview

Max Planck Institute for Physics

2018-10-09

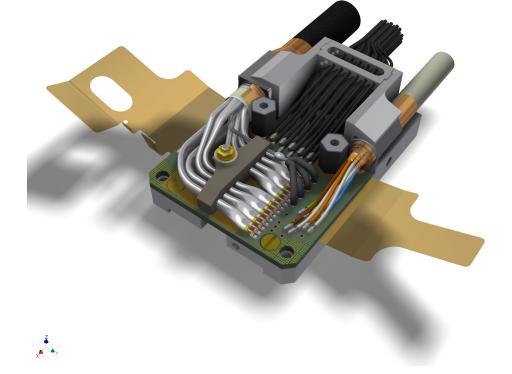
- very complex cable, three cables (Infiniband, Glenair and Ethernet) mapped to one 100 pin connector
- long development time
- many people involved for development, documentation, commissioning and testing Stefan Rummel, Tscharlie Ackermann, Ronald Maier, Christian Kiesling, Stefan Horn, Carina Schlammer, Christoph Knust, Felix B. Müller, Enrico Töpper, David Kittlinger, Philipp Leitl, Hua Ye, Felix J. Müller, Varghese Babu, Maiko Takahashi

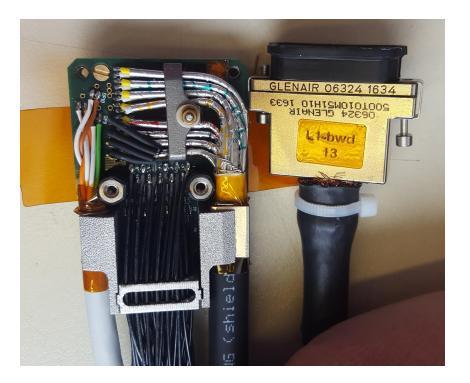
- Right after delivery the cable is labeled.
- The cover is opened.
- The soldering is documented with a picture.

- The cables are sent to Stefan for testing the connections and assignment of lines with a cable tester.
- Several line swaps and shielding issues were already detected in this state.
- This lead to improvements of the isolation to the housing.

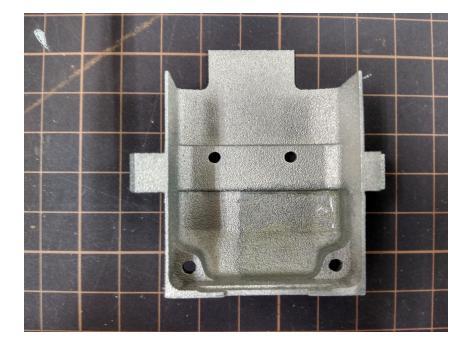
2 layers of Araldit inside the cover

PatchPanel Production - Isolation of Cover

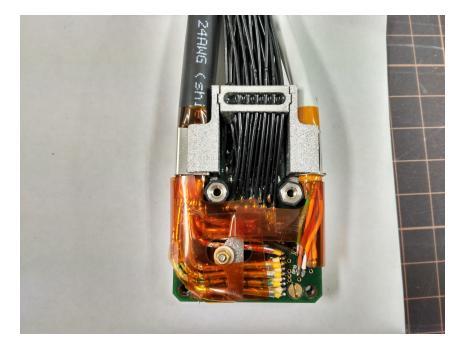
Kapton tape at the wire bending

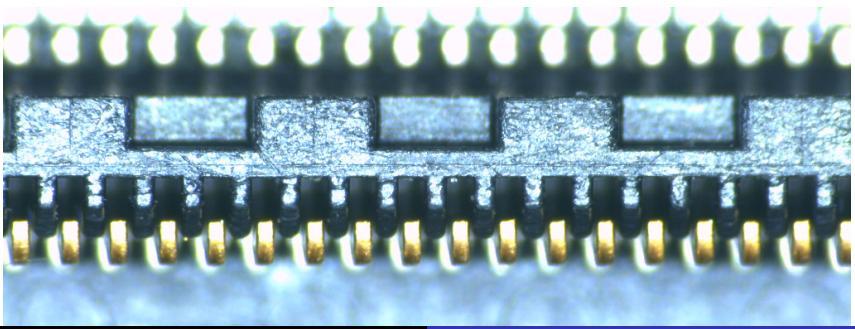
- The potted PatchPanels are tested with a test module again before connecting to a hot module.
- Same procedure:
 - Power up of module and checking for the voltages and currents.
 - Configuration of the module to check SC connections.
 - Taking pedestal data to check the HS connections.
 - Additional step: check the pins of the Samtec connector with a microscope.
 - Test module does not have to be grade A. Known shorts in the matrix are still ok.
- The final test can be done in labs or even at KEK.
