New VEP System with Novel Cathode and Fundamental Investigation of Inhomogeneous Removal in VEP

Shigeki KATO, KEK

- Designing of our VEP systems started in Mid 2013 in KEK and MGI.
 One system are in operation.
- Novel cathode "Ninja" developed by MGI was adopted to MGI VEP systems.

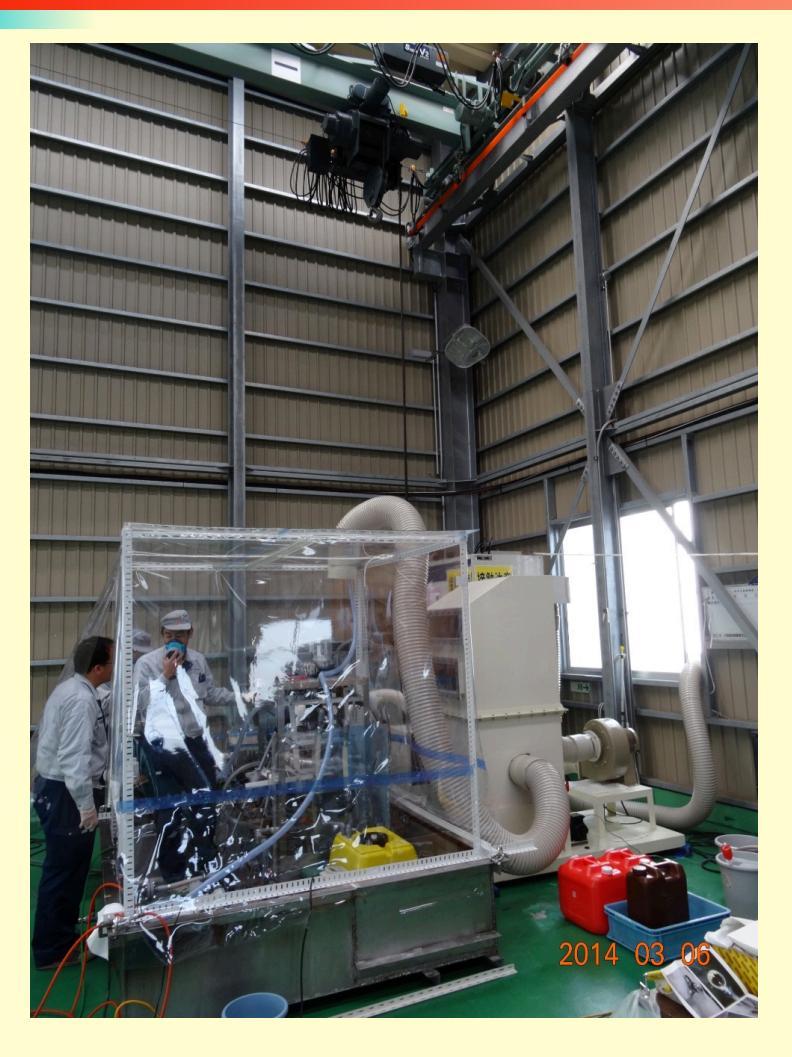
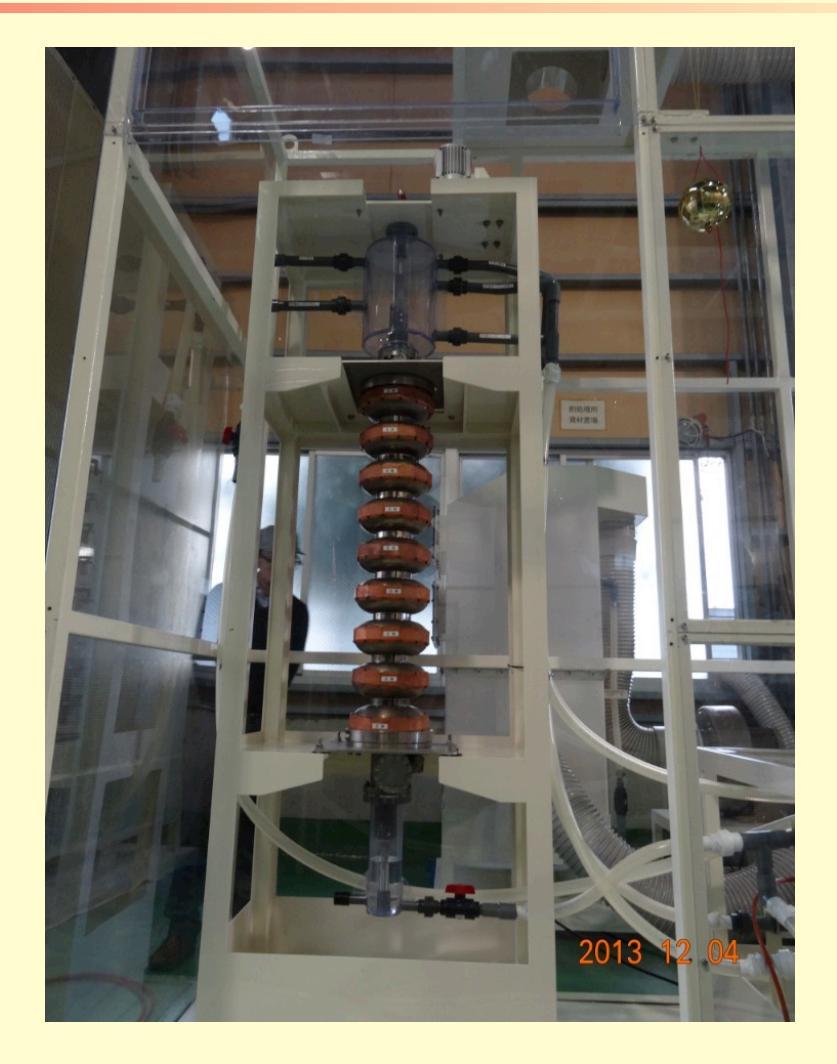
VEP Facilities in MGI

VEP facility for single cell cavity is being used.

VEP facility for nine cell cavity will be launched in coming May

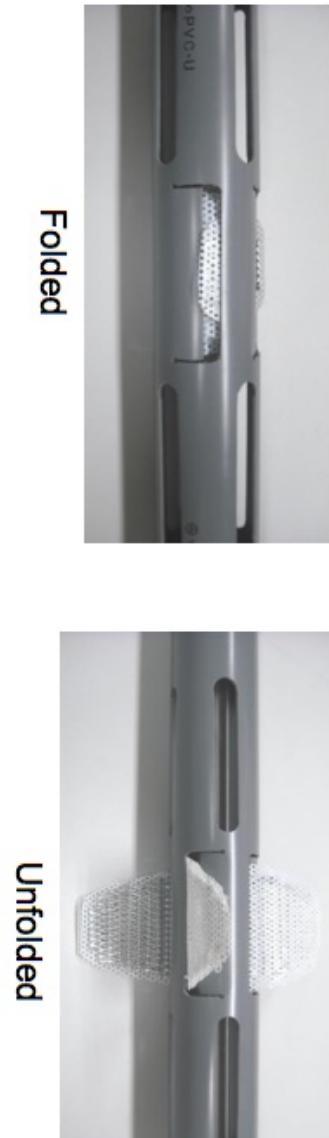
WKEK Patented Agitation Wings "Ninja" by MGI

Foldable agitation wings are hidden for cathode insertion and expand in use.

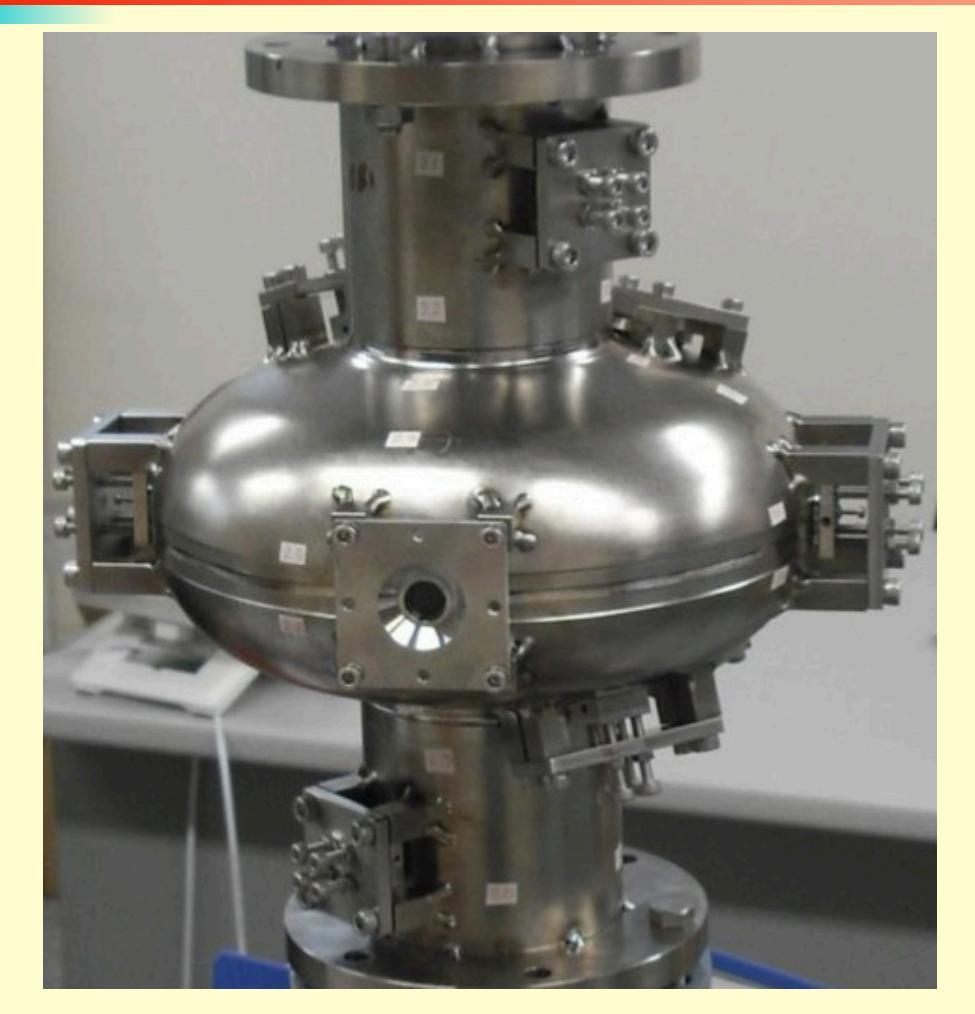
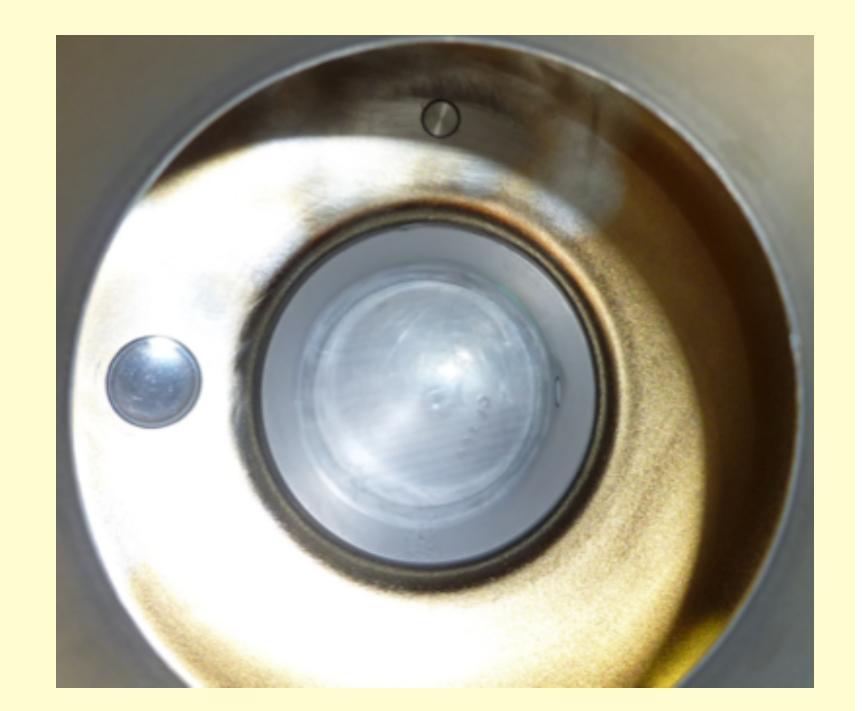
Nb Coupon Cavity for VEP Optimization

Capability of EP Current Measurement of Each Coupon Sample

- 6 Sample Coupons :Top Beam Pipe, Top Iris,
 2 x Equator, Bottom Iris, Bottom Beam Pipe
- 4 View Ports : Top Iris, 2xEquator, Bottom Iris

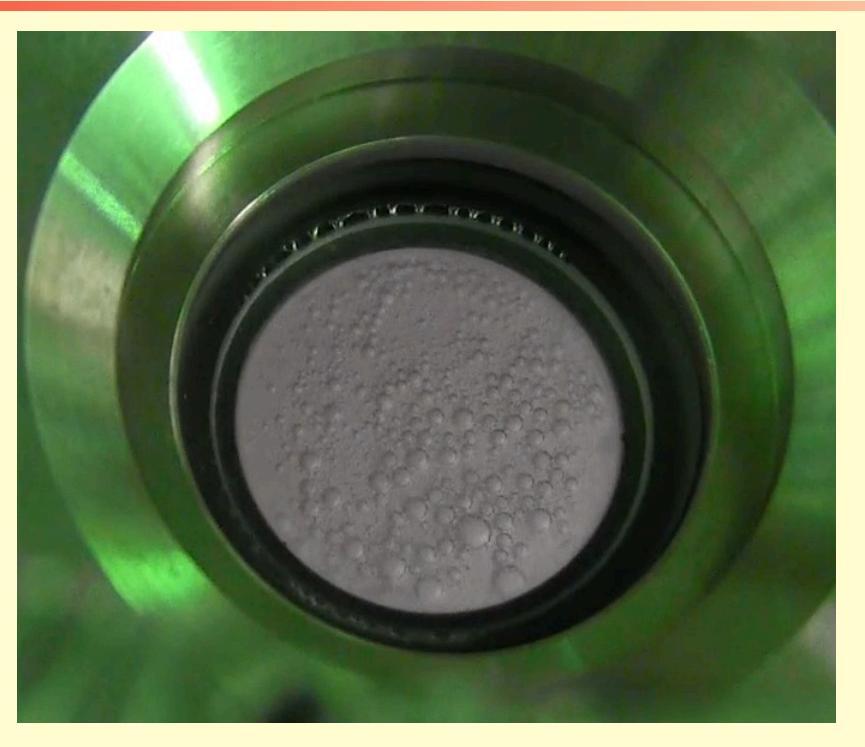
Movie during VEP at Top Iris

- Large quantity of H₂ bubbles at top iris but much less H₂ at bottom iris.
 This would be significant especially for Ninja.
- Existence of H₂ gas bubbles to cause "micro agitation" is the key to understand rough topography and large EP current, that is, large removal rate on the surface where H₂ attack strongly occurs especially at the top iris.

Current oscillation seems to be determined by H₂ bubble attack.

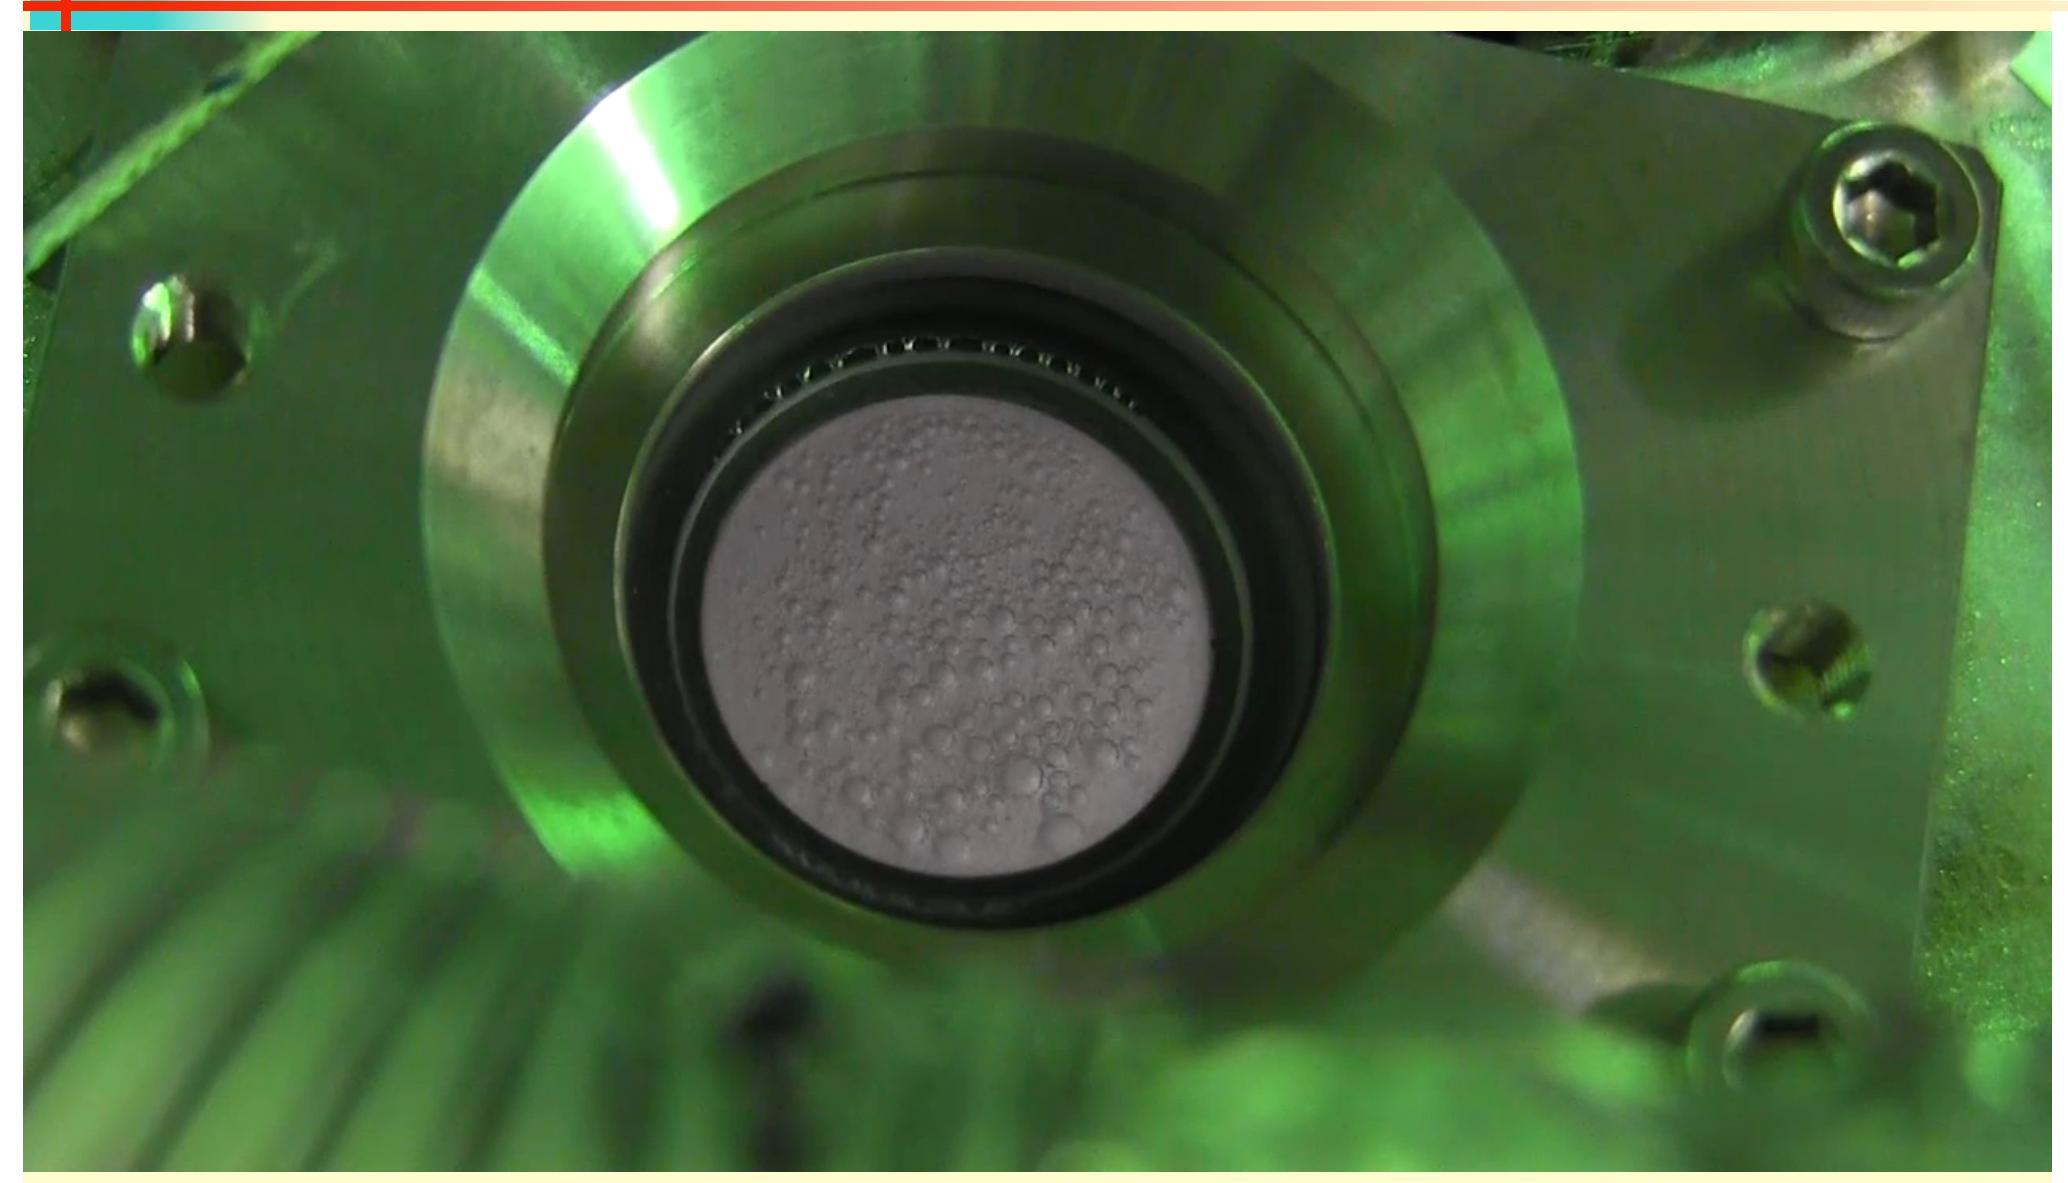
1 min Movie during VEP at Top Iris

1 rpm with EP flow of 5L/min

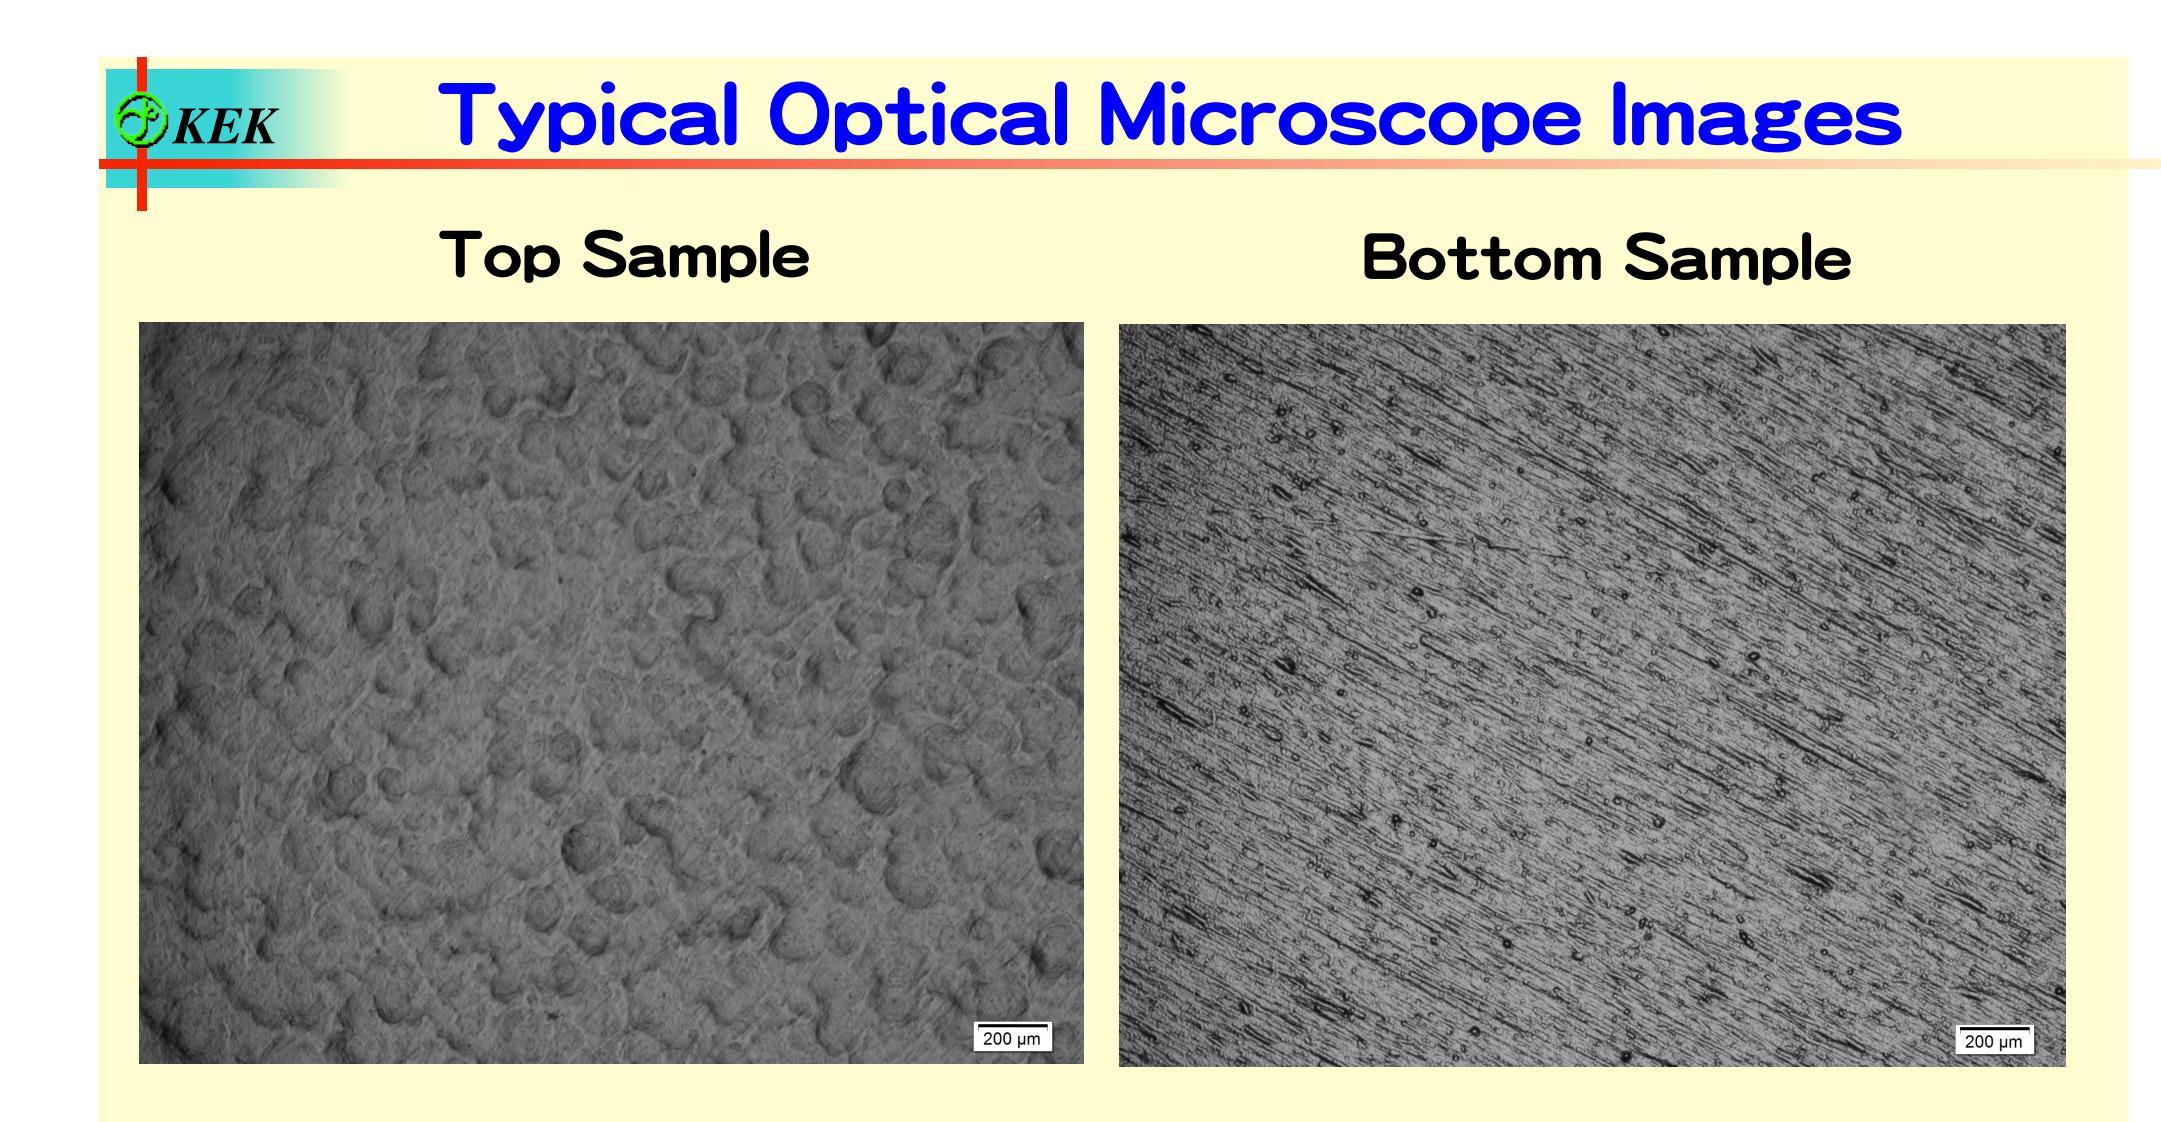
Rougher surface at the top surface due to H₂ attack.

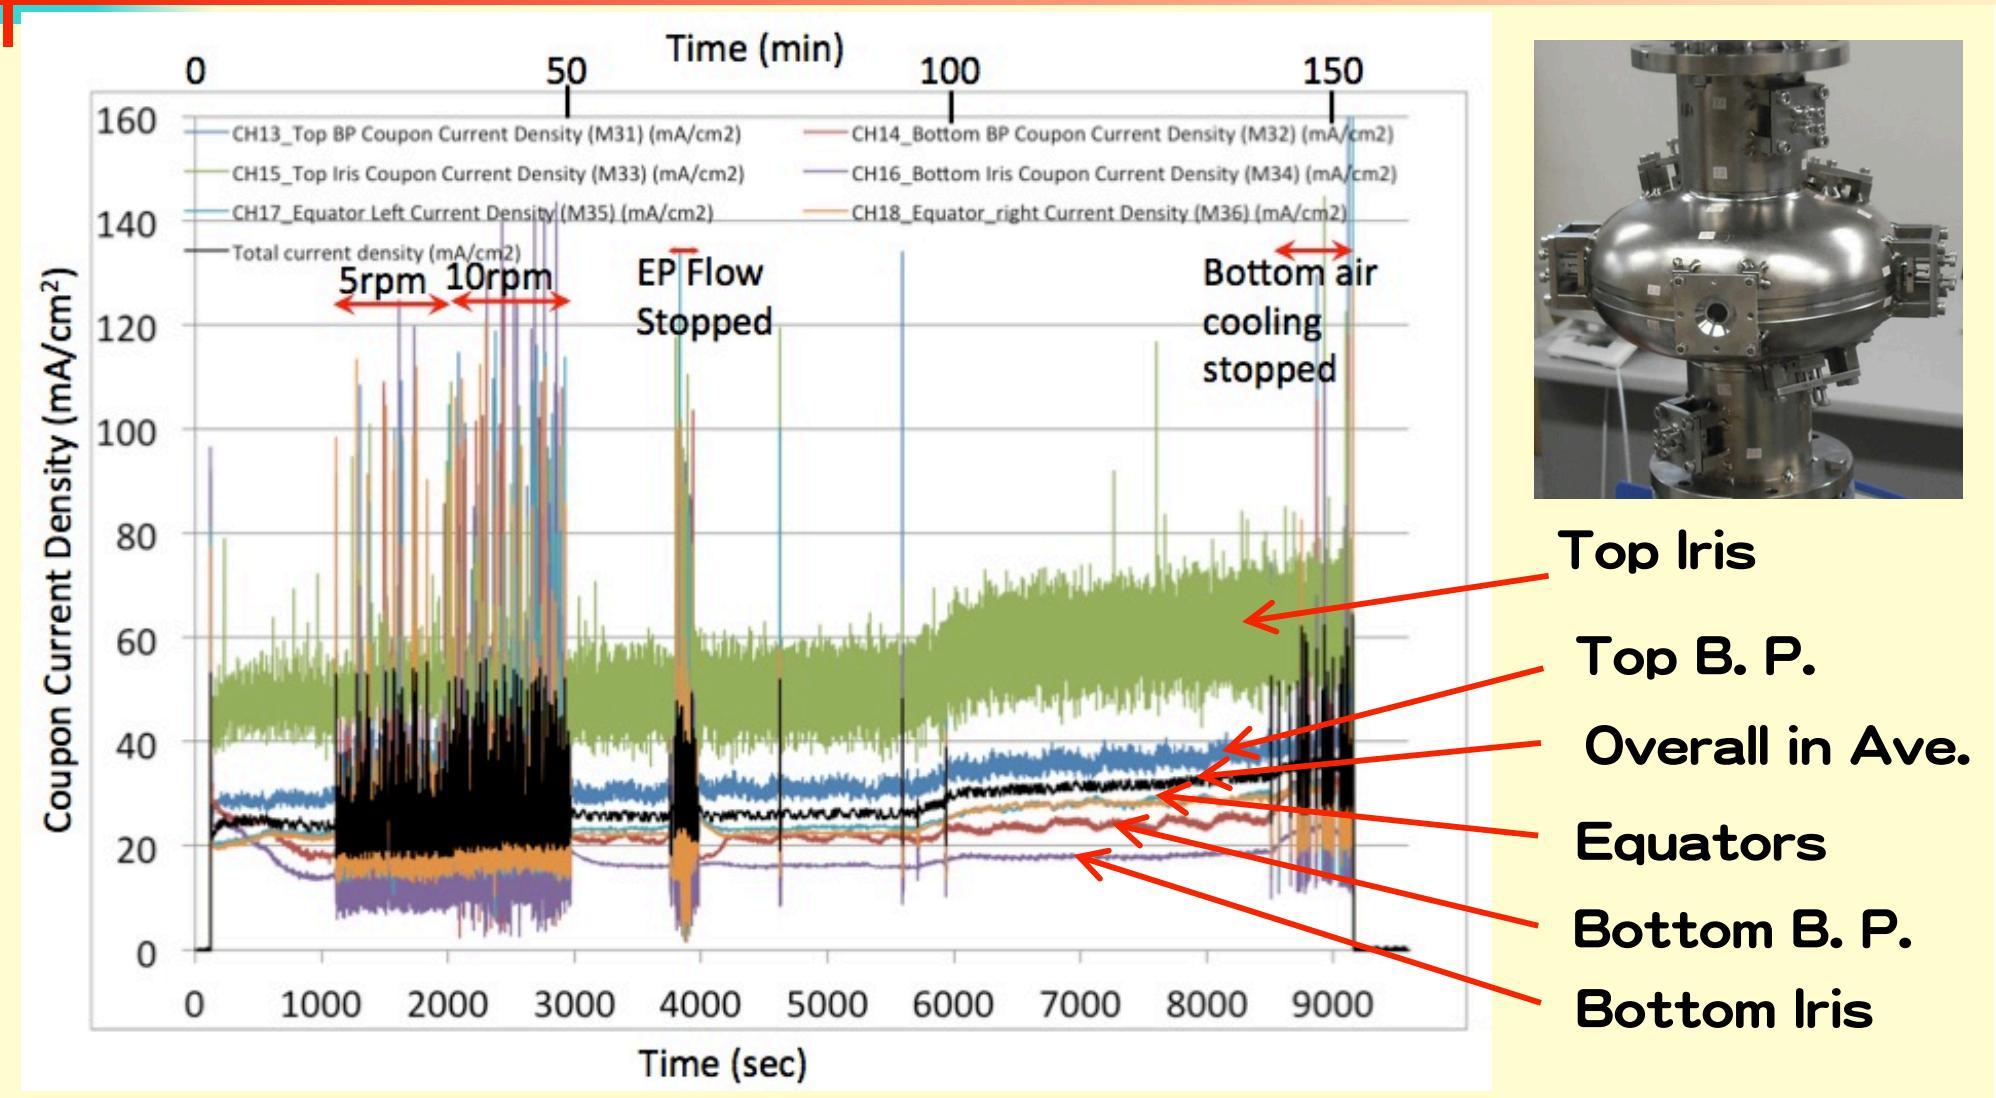
Overall Coupon Current Profile for 2.5h

Top iris showed the highest current density and bottom iris did the lowest.

• Top iris always showed the largest oscillation.

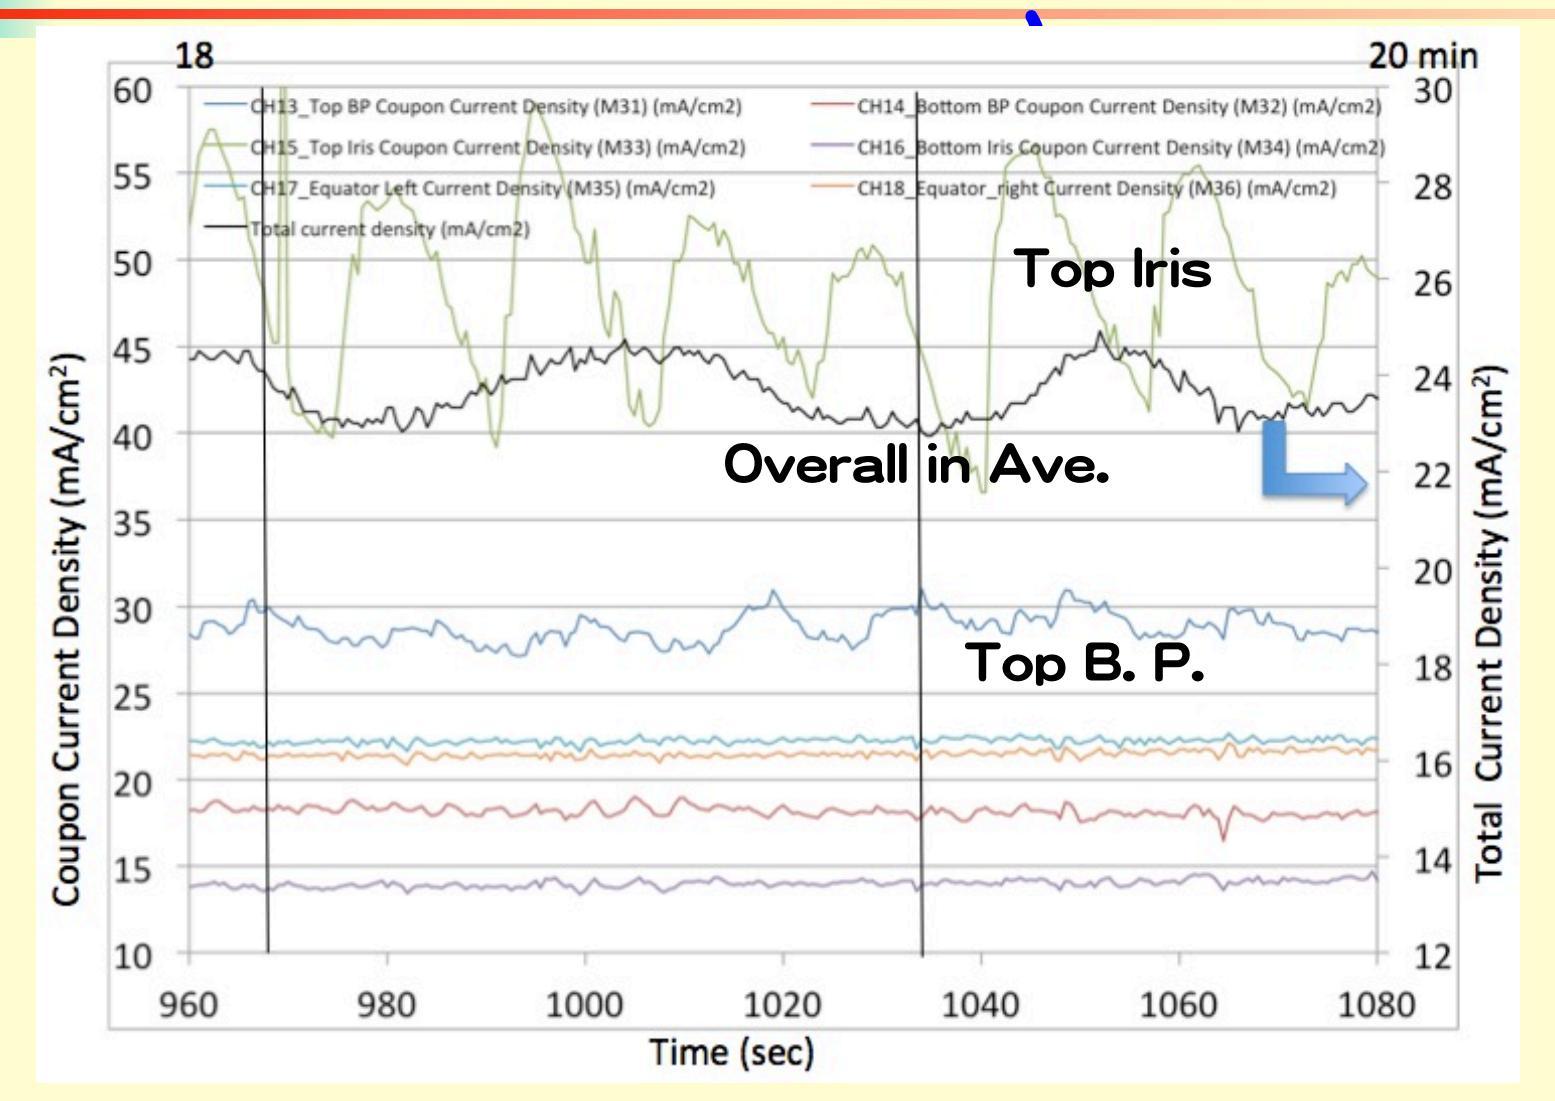
1 rpm Coupon Current Profile for 2min

Saw-tooth like current peaks at the top iris match the wing rotation.

\diamond A large quantity of H₂ gas bubbles mildly concentrate on the top iris.

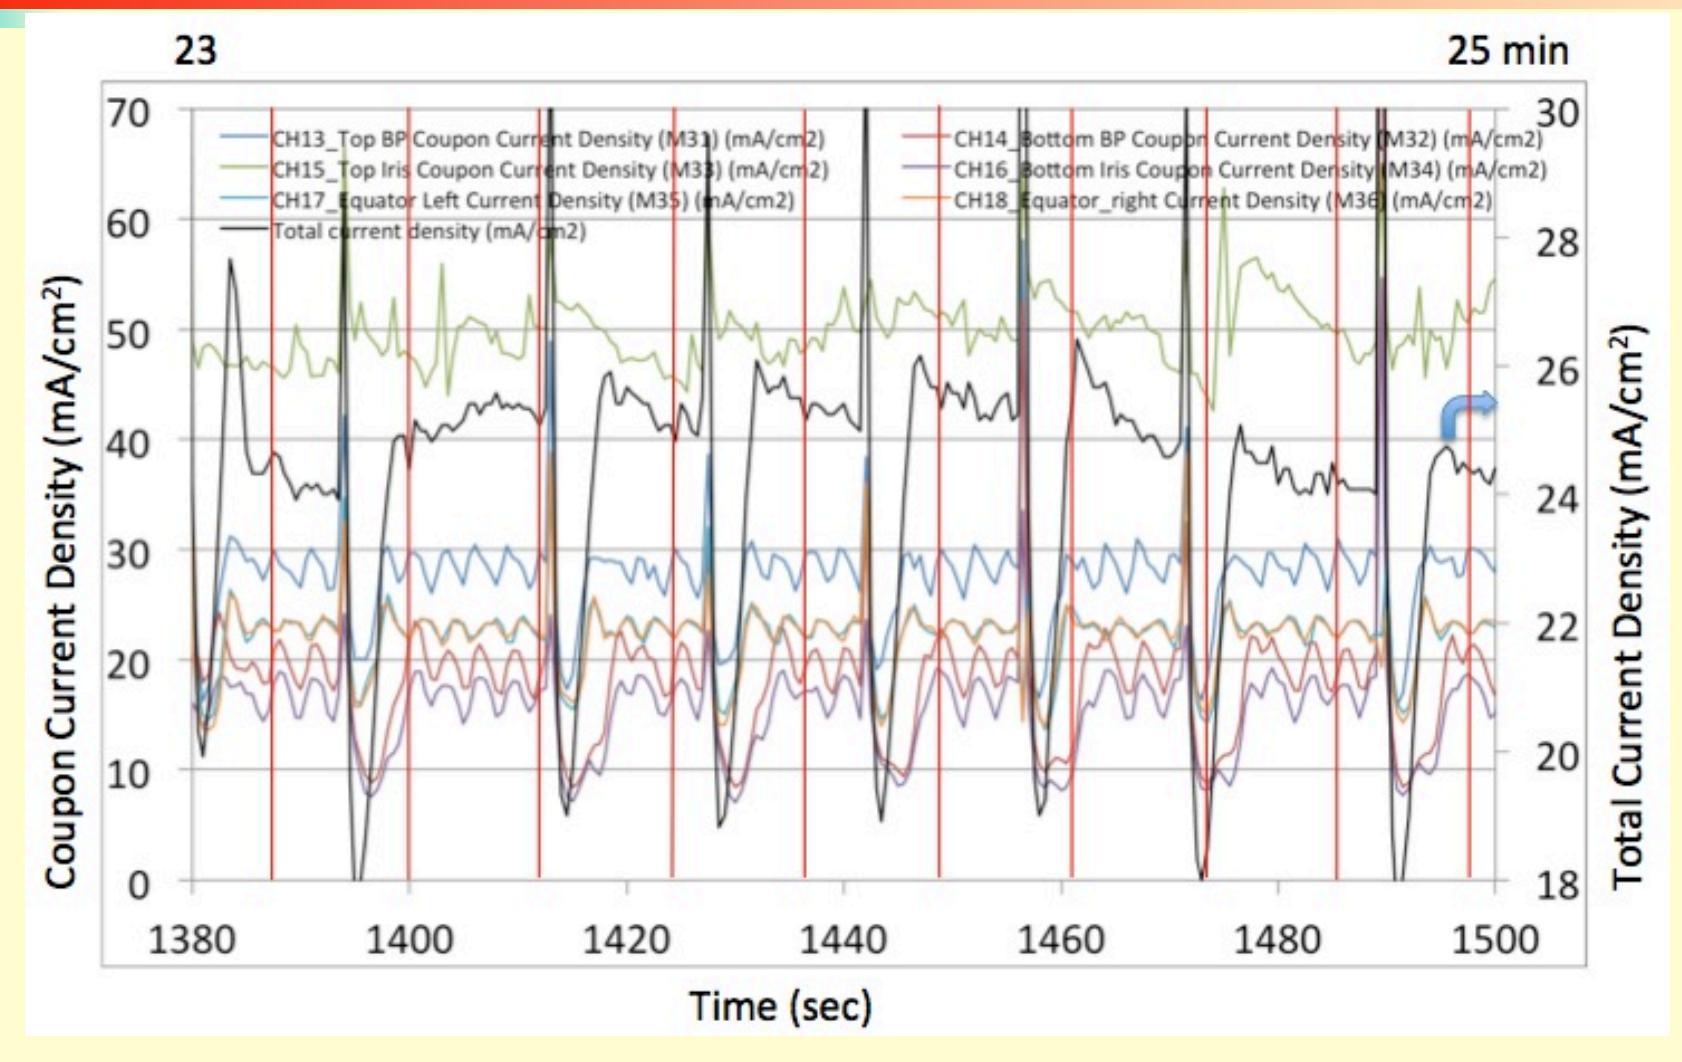
KEK 5 rpm Coupon Current Profile for 2min

Rotation does not match with the large current spikes.

The small current peaks do match with the wing motion.

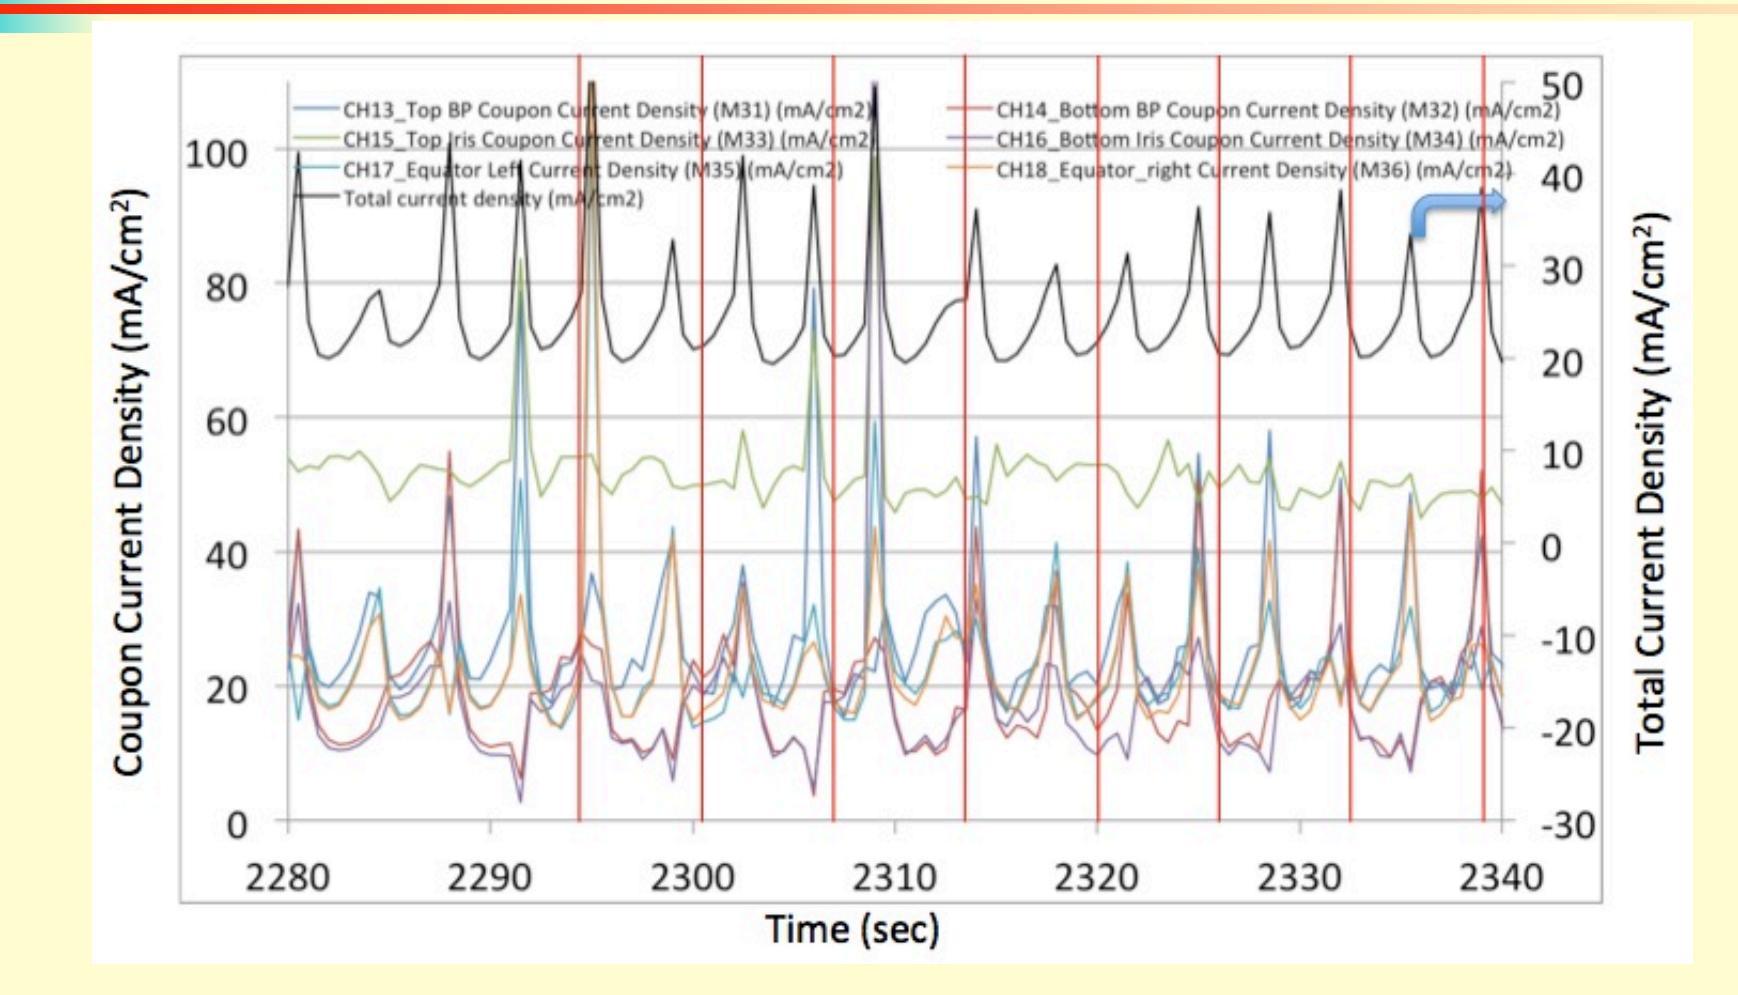
10 rpm Coupon Current for 1min

Rotation does not match with the current spikes.

- Less oscillation at the top iris but large oscillation at the others.
- Higher rotation speed causes mixing H₂ gas bubbles in EP acid and makes the bubbles approach to allover the cavity inner surface.

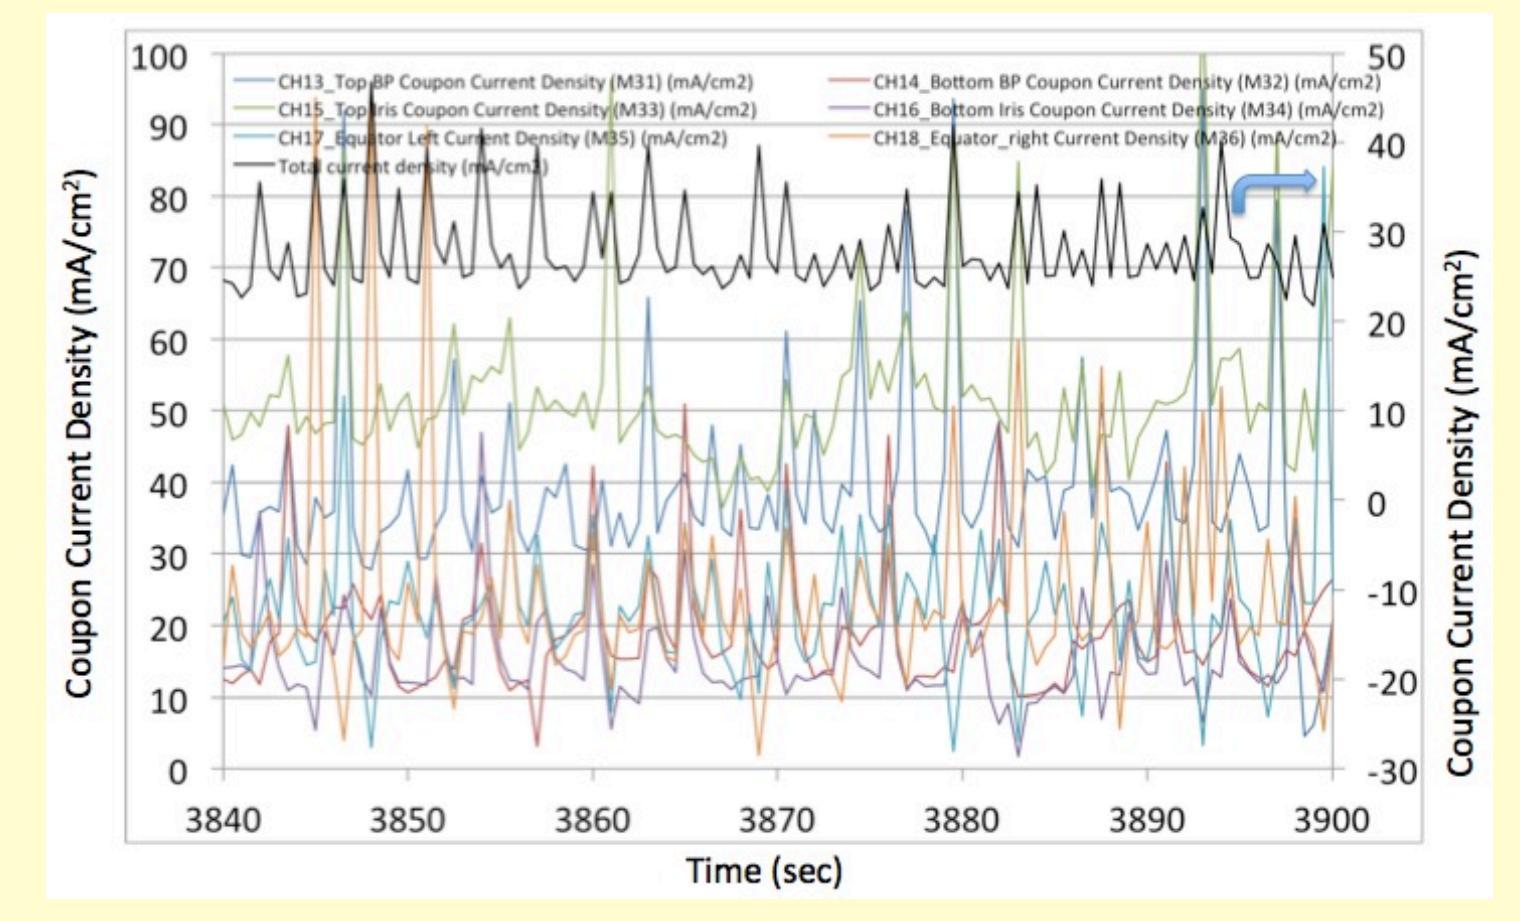
1 rpm Coupon Current Profile for 1 min without EP Solution Flow

Rotation does not match with the current spikes.

- Many of small current peaks at different coupons synchronize.
- Aggressive EP enhancement occurs because of sudden increase of H₂.

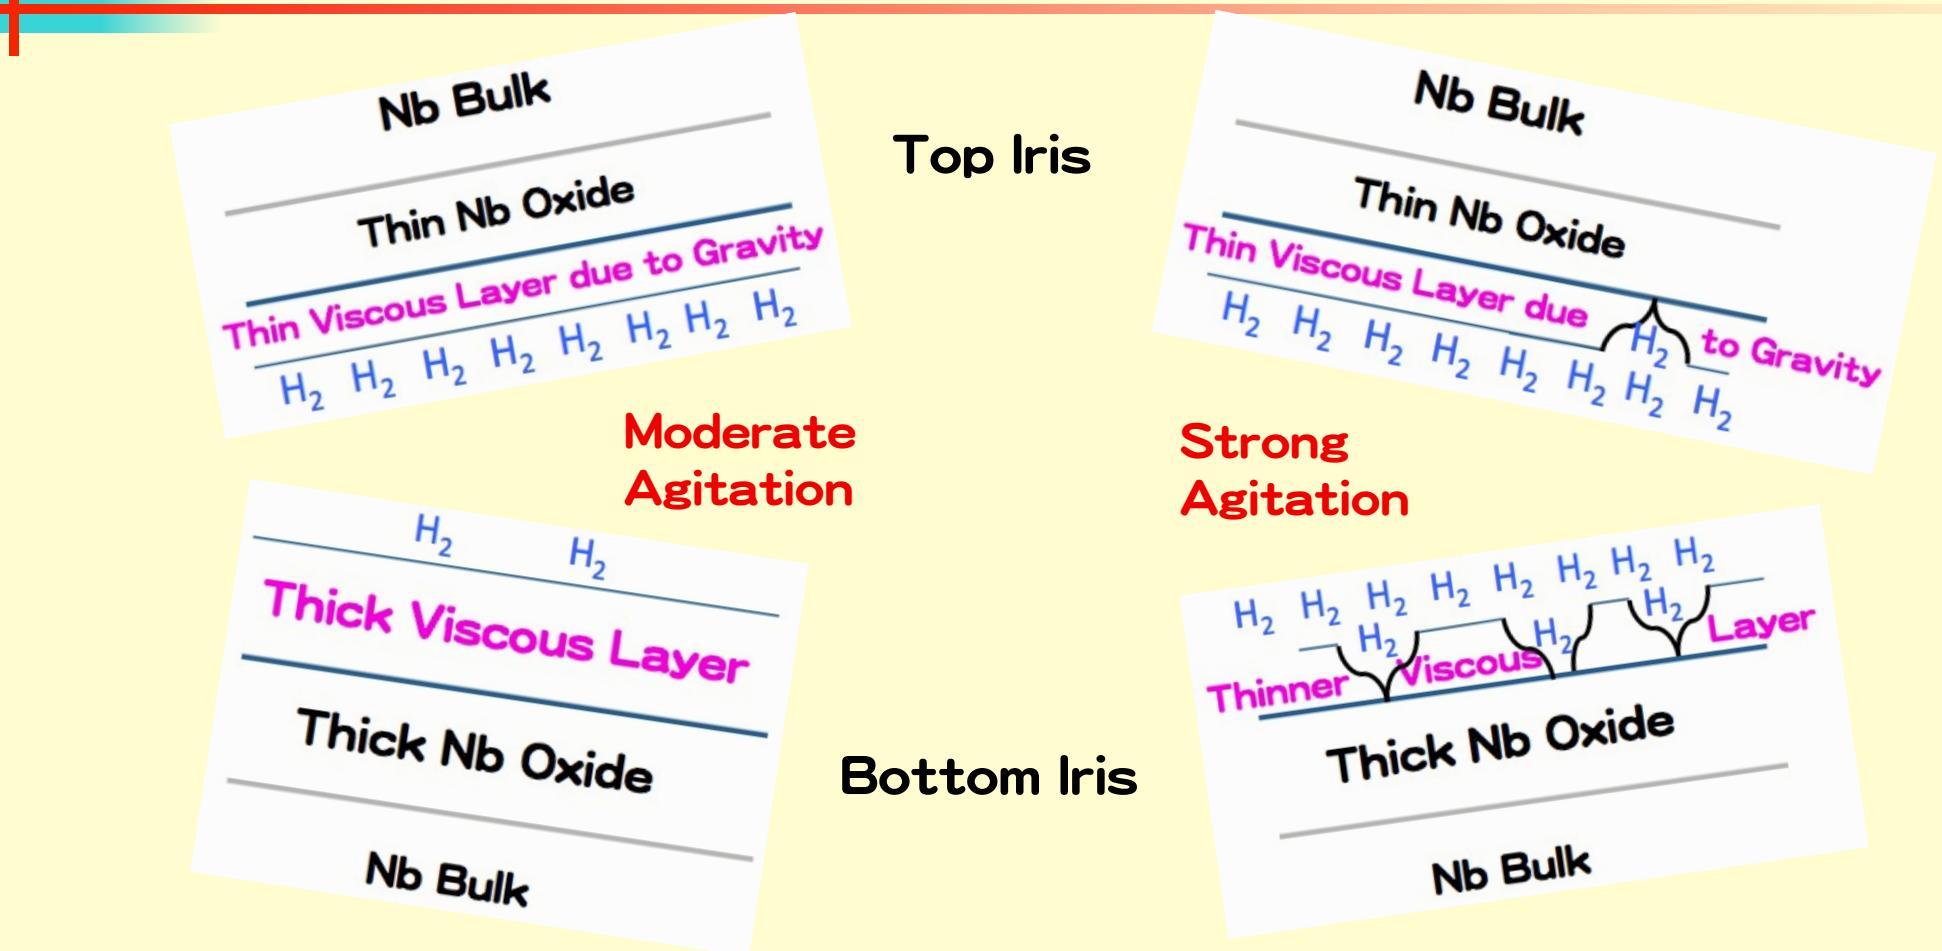
Schematic Model of Explanation

Strong H₂ attack, that is, micro agitation that may make local damage of viscous layer causes rougher surface and high removal rate.

Many current spikes might be because of the local damaging.

Concerning MGI VEP system, I need to recommend MGI to use a limited size of Al cathode with the same wings to mitigate direct H₂ attack to the top iris.
