# Optical inspection by OBACHT (DESY) and other inspection elsewhere from other laboratories

Aliaksandr Navitski  
aliaksandr.navitski@desy.de

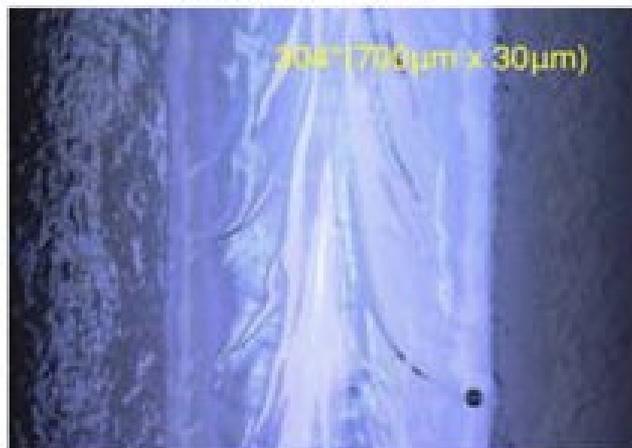
after 2<sup>nd</sup> V.T.

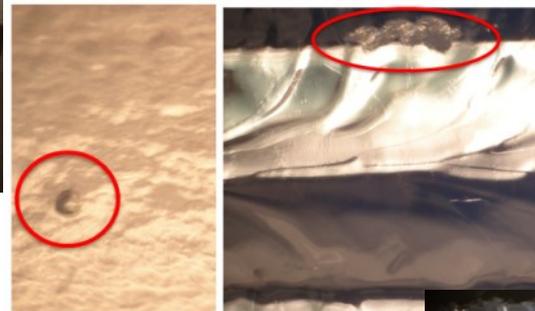
AES06  
 Defects causing no  
 quench at 30 MV/m
